IMPORTANT PRODUCT SERVICE BULLETIN

This Notice Applies to Ronin Power Ascenders with identification label located over the motor

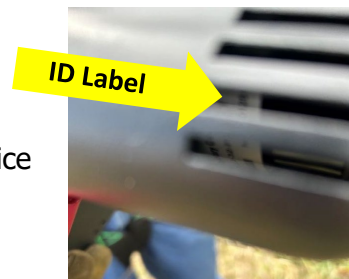
Spartaco Tool Group recently documented instances where heat from the motor has caused the ID label to peel partially away from the unit and come in contact the motor cover vents.

This condition could create motor damage due to foreign object debris entering the vent area.

Step 2 Inspect the motor through the vent holes to identify if the label is on the motor. If label is observed move to the Label Removal Procedure, if there is no label install rubber motor cover back on unit and no additional service is required.
