Hazardous Building Materials Assessment

**Port of Tacoma
Tacoma, WA**

**Assessment Date:
10 June 2025**

| Project Title | Port of Tacoma – Crane 2403 HBM Assessment Hazardous Building Materials Assessment |

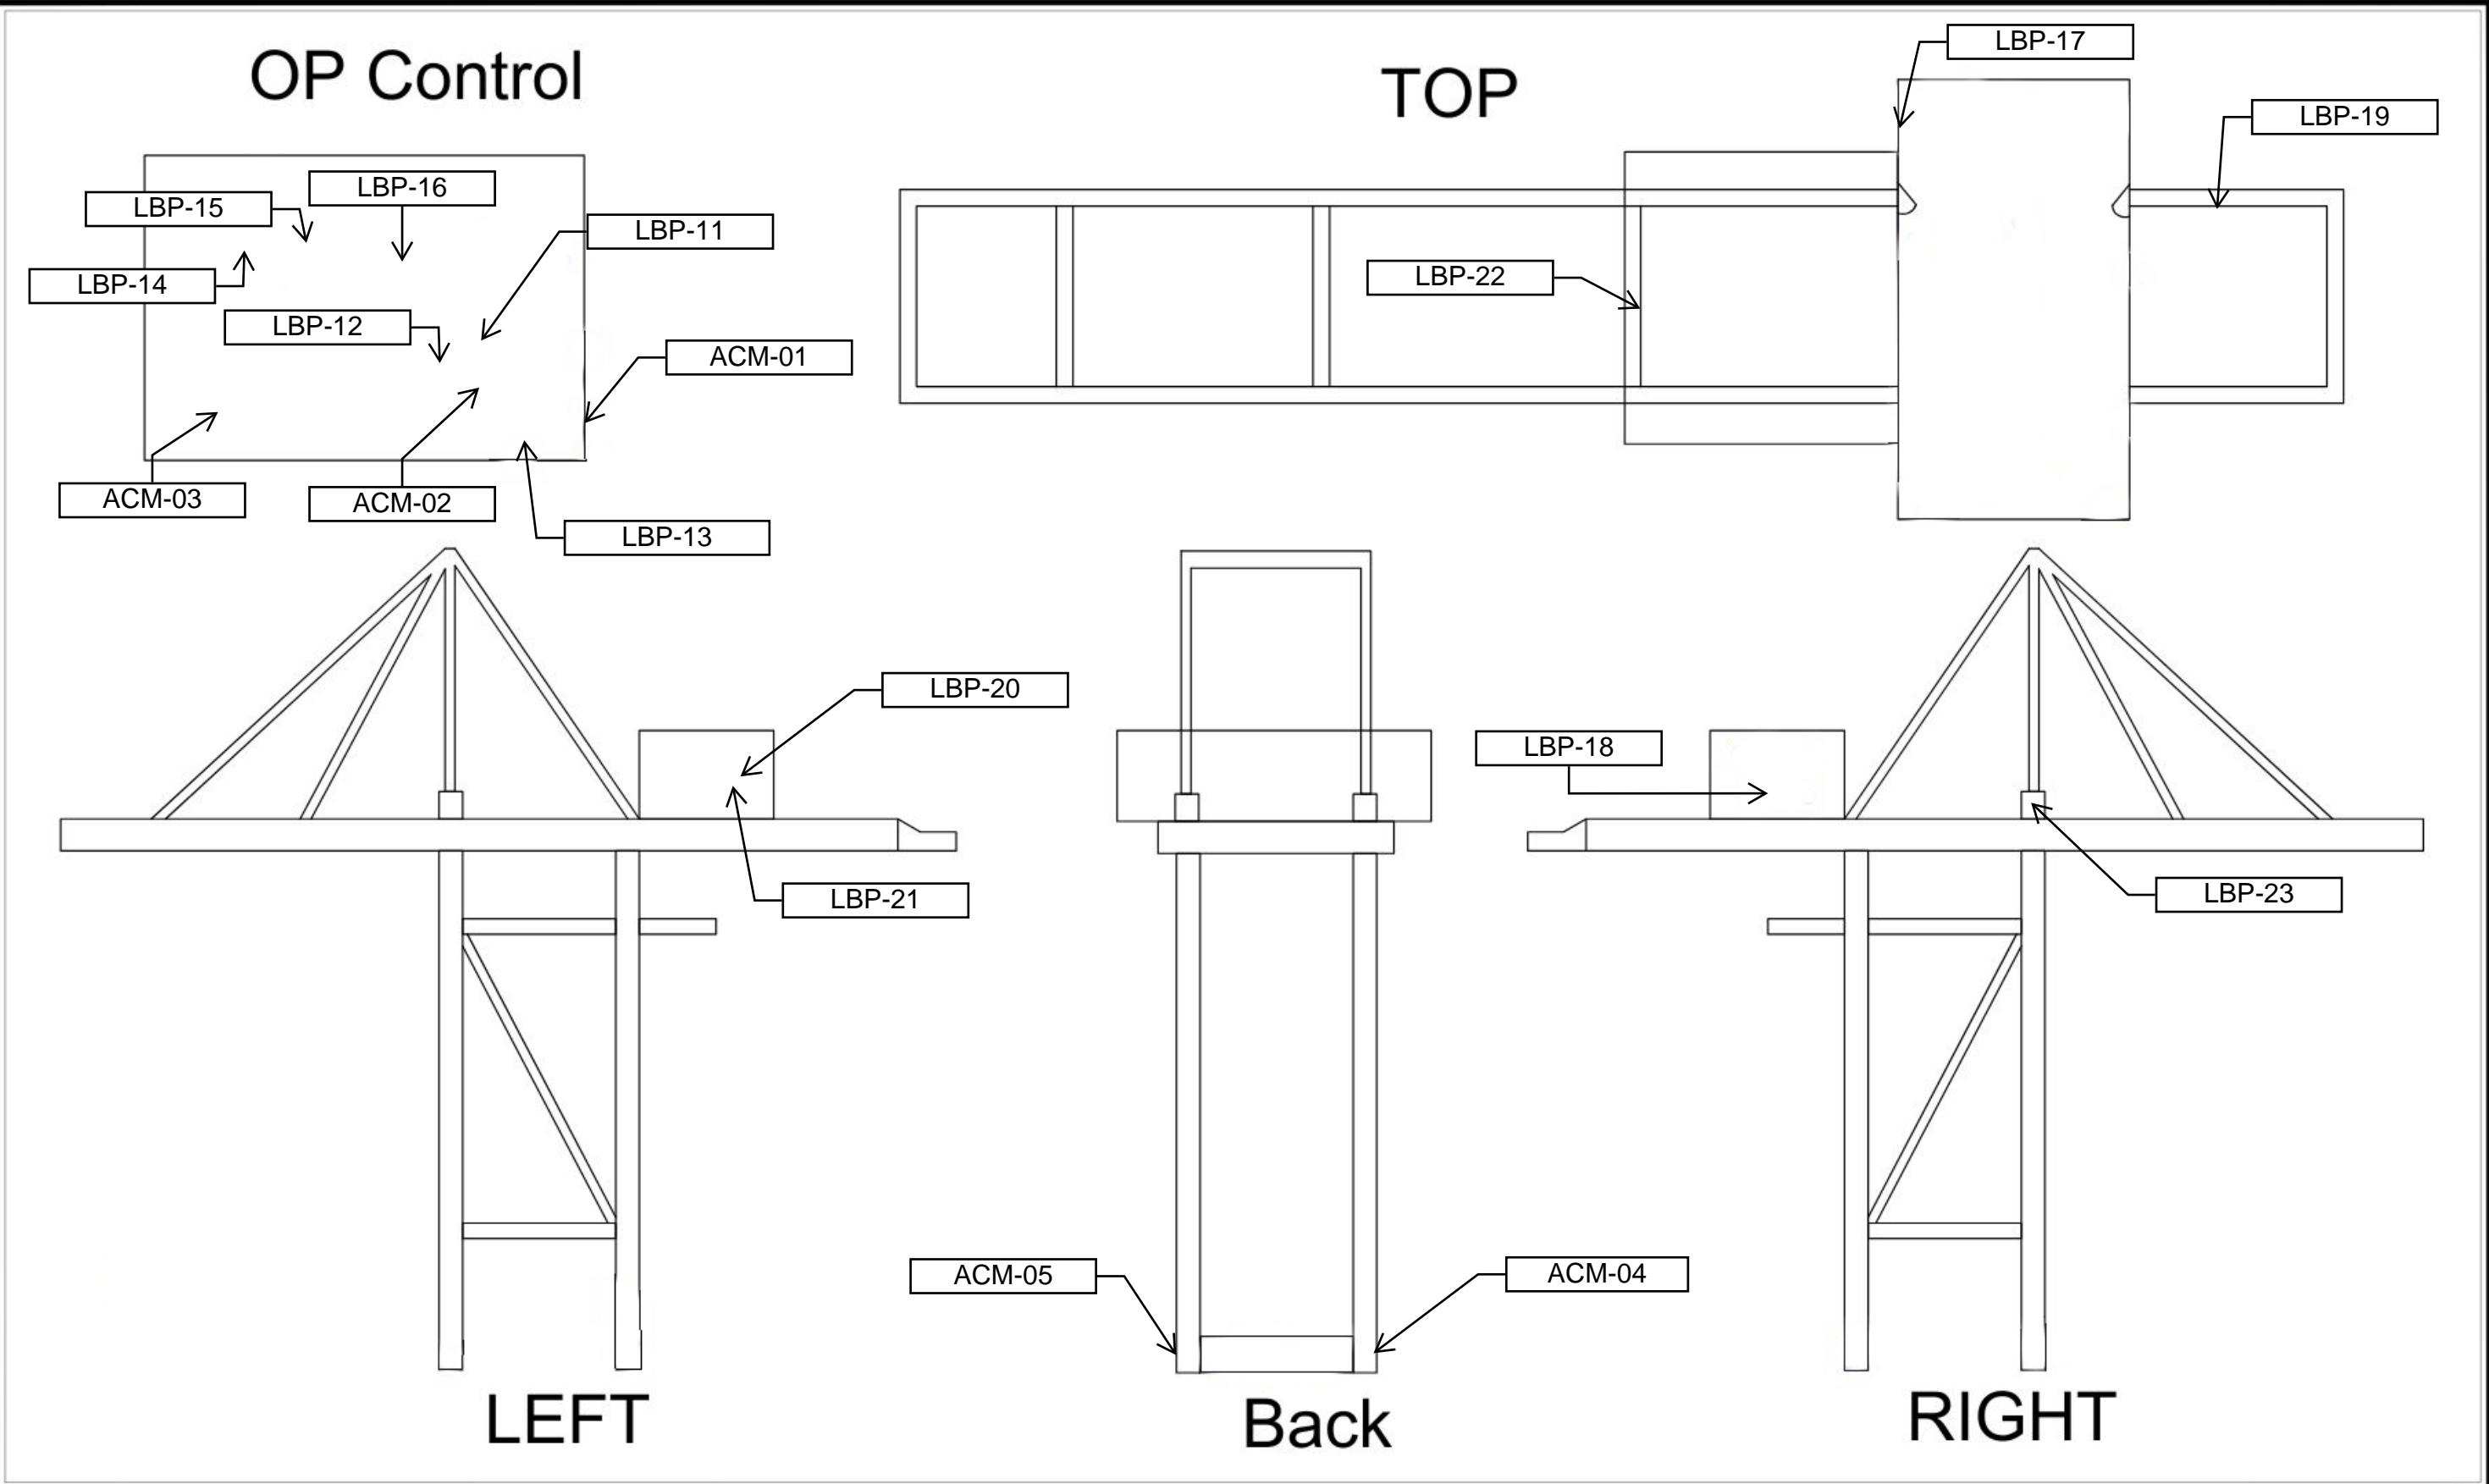
Figure 1 Sample Locations: Lead Paint & Asbestos Assessment

Locations of the areas tested are shown in Figure 1.

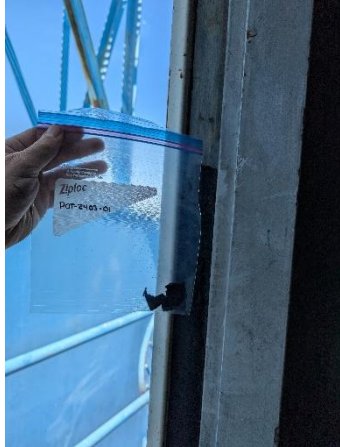
Sample ID: POT-2403-01

| Sample ID | Material Description | Concentration | Material Quantity Estimate (if applicable) |
|---|---|---|--|
| POT-2403-01 | Layer 1: Black foamy material | ACM (%): ND | NA |

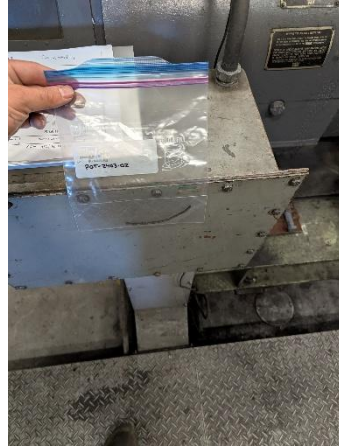
Sample ID: POT-2403-02

| Sample ID | Material Description | Concentration | Material Quantity Estimate (if applicable) |
|---|---|---|--|
| POT-2403-02 | Layer 1: Black soft elastic material | ACM (%): ND | NA |

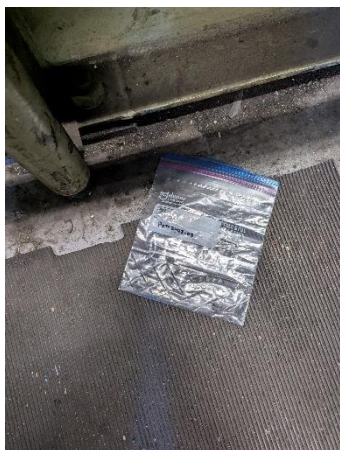
Sample ID: POT-2403-03

| Sample ID | Material Description | Concentration | Material Quantity Estimate (if applicable) |
|---|---|---|--|
| POT-2403-03 | Layer 1: Black rubbery material | ACM (%): ND | NA |

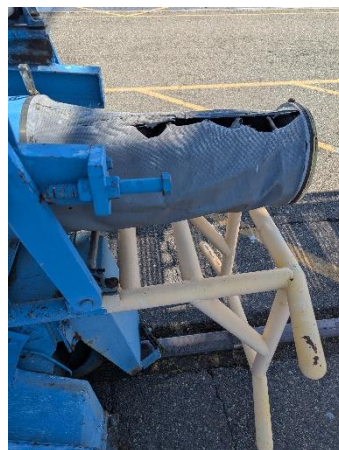
Sample ID: POT-2403-04

| Sample ID | Material Description | Concentration | Material Quantity Estimate (if applicable) |
|---|---|---|--|
| POT-2403-04 | Layer 1: White fibrous mesh with white gray coating material | ACM (%): ND | NA |

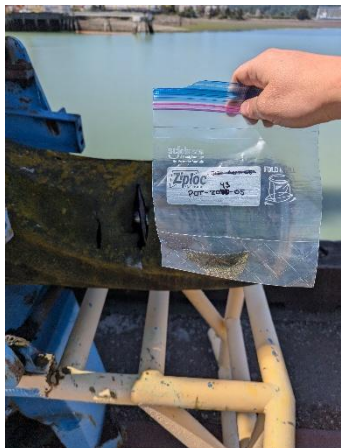
Sample ID: POT-2403-05

| Sample ID | Material Description | Concentration | Material Quantity Estimate (if applicable) |
|---|---|---|--|
| POT-2403-05 | Layer 1: Black interwoven fibrous material with debris | ACM (%): ND | NA |
