2023 FACILITY CONDITION ASSESSMENT REPORT

Port of Tacoma – Terminal 7 Berth D

FINAL REPORT

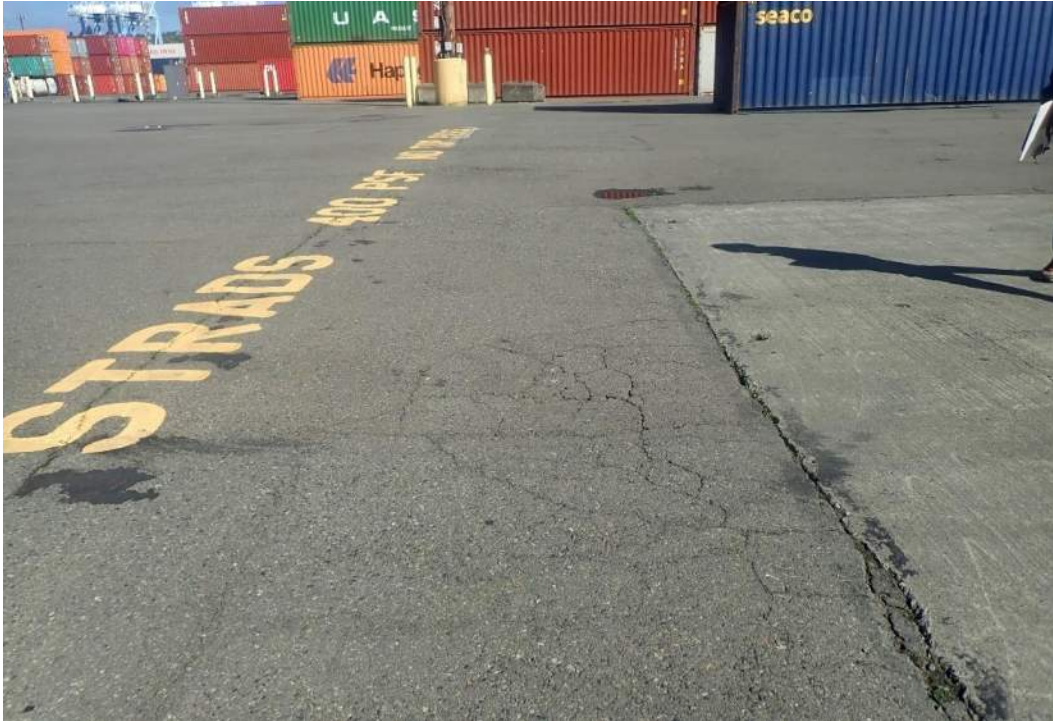
The asphalt concrete pavement (ACP) is in **satisfactory** condition. Minor to moderate cracking, rutting, and divots were observed at multiple locations throughout the berth, as shown in Photo 4. Minor ponding was observed at Bent 1 through Bent 3 between piles P1 and U1, shown in Photo 5. Moderate cracking and potholing was noted along the interface of Berths C and D, as shown in Photo 6.

Photo 4: Asphalt Overlay with Map Cracking

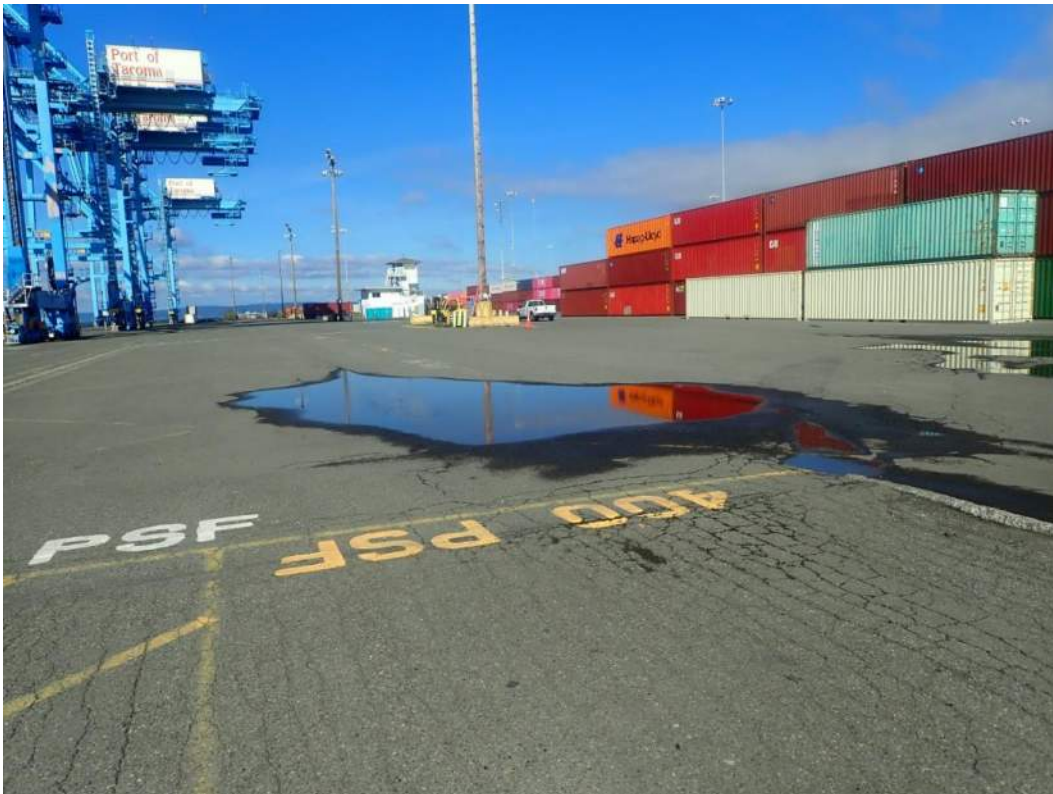
Photo 5: Deck Ponding from Bent 1 to 3

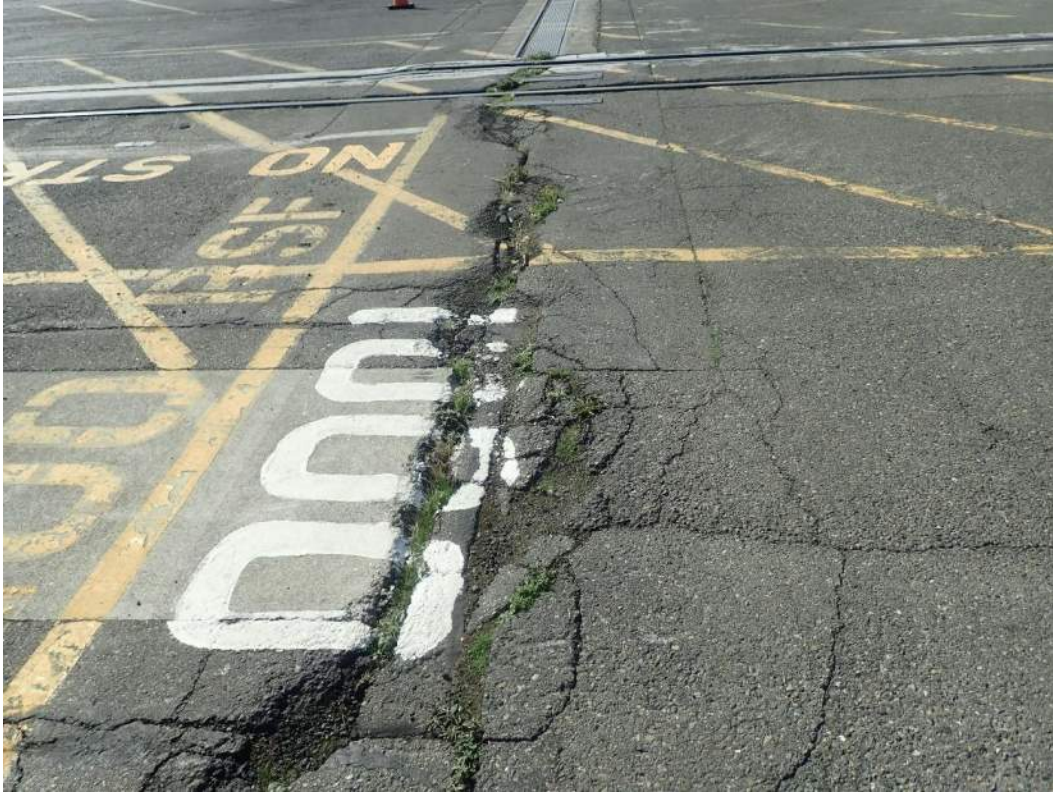
Photo 6: Berth C to Berth D Transition Asphalt Overlay with Cracks and Potholes

- Repair bollard footings with major/severe spalling and cracking
- Install bolts at UHMW-PE/chock connections
- Install missing UHMW-PE rub strips on fender timber piles
- Replace ladders that have severe damage
- Replace decayed portions of the timber bullrail
- Repair concrete piles with major/severe damage
- Replace timber fender piles with severe damage
- Repair pavement overlay at transition from Berth C to Berth D

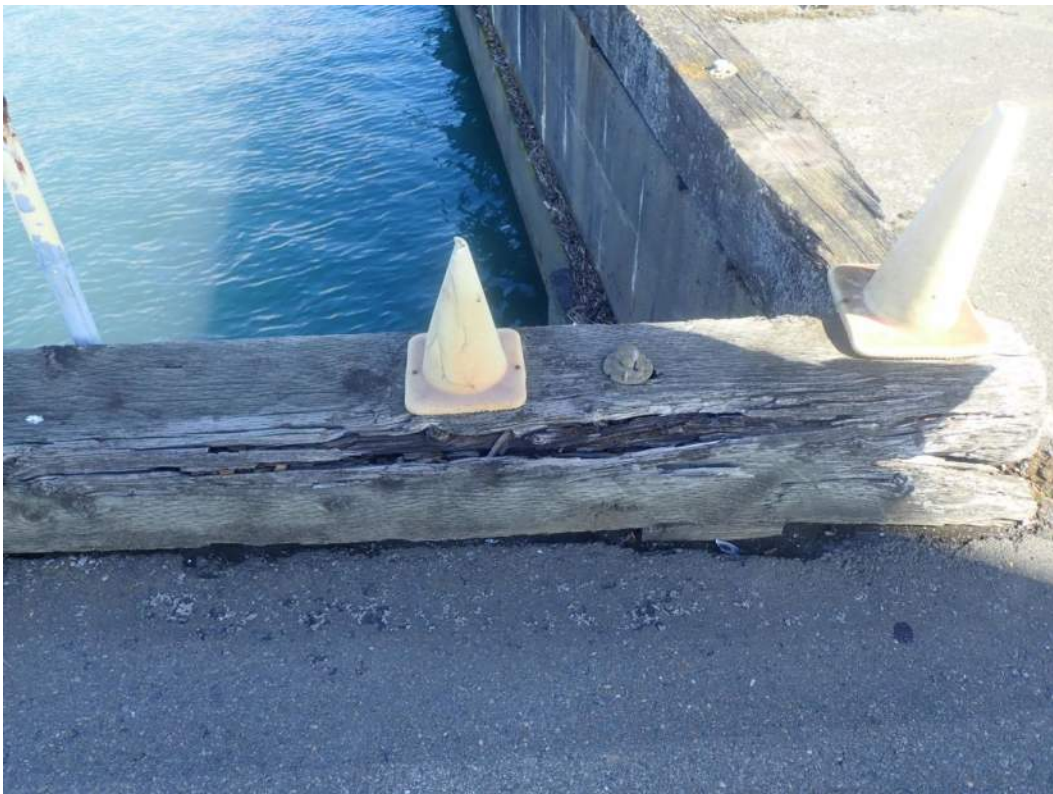
The timber bullrail is in **poor** condition. Checks, splits, and gouges were observed at several locations along the berth face, the northern edge of the berth, and along both sides of the trestle. Newer bullrails were observed from Bent 1 to 9. Minor to moderate decay, and rotten timber is prevalent on the bullrails between Bents 10 through 39 and the northern edge of the berth, see Photo 7. The bullrail between Bent 25 and 26 is only secured by one bolt, see Photo 8.

Photo 7: Typical Moderate Bullrail Decay

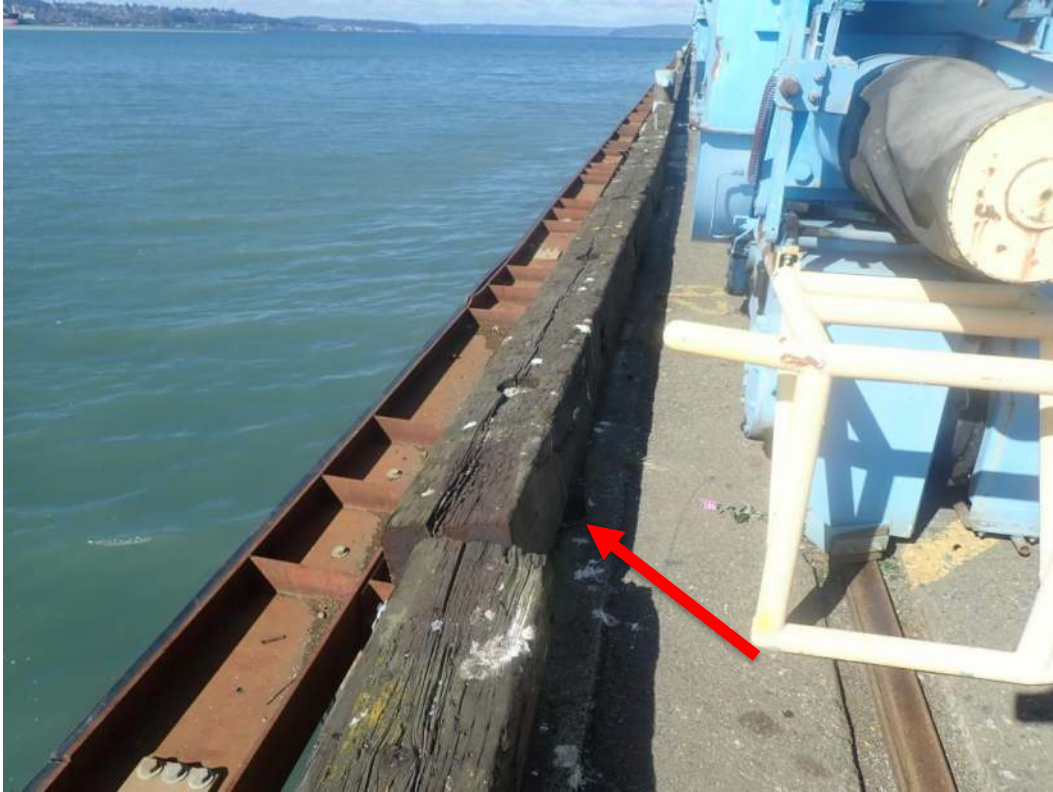
Photo 8: Bullrail Missing Hardware, Not Secure

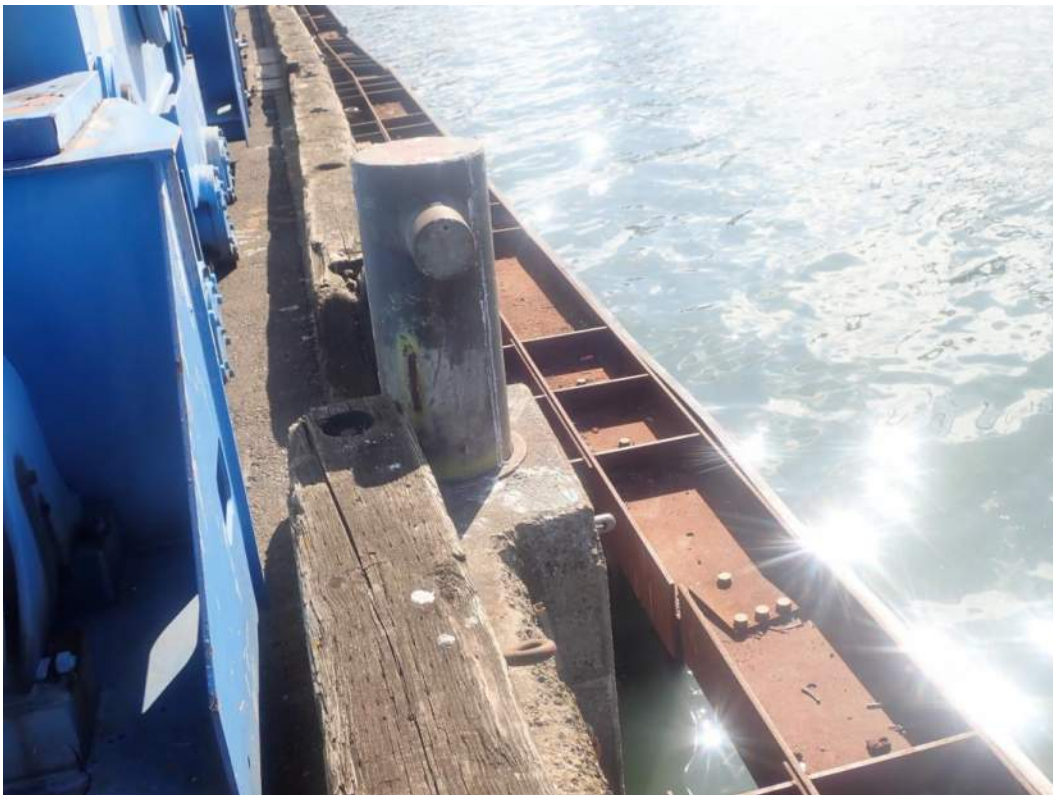
The overall condition of the mooring system is **fair**. Eighteen drop-in style pipe bollards are present at Berth D; sixteen along the berth face and two along the western face of the trestle. Minor damage including gouges, rust, and dents were observed at all pipe bollards (see Photo 9). Fourteen bollard foundations were observed to have minor to moderate damage consisting of cracked and spalled concrete, as shown in Photo 10. Three bollards were removed at Bents 1.5, 3.5, and 15.5. The remaining bollard foundation at Bent 46 has severe cracked and spalled concrete with exposed corroding rebar.

Photo 9: Typical Mooring Bollard

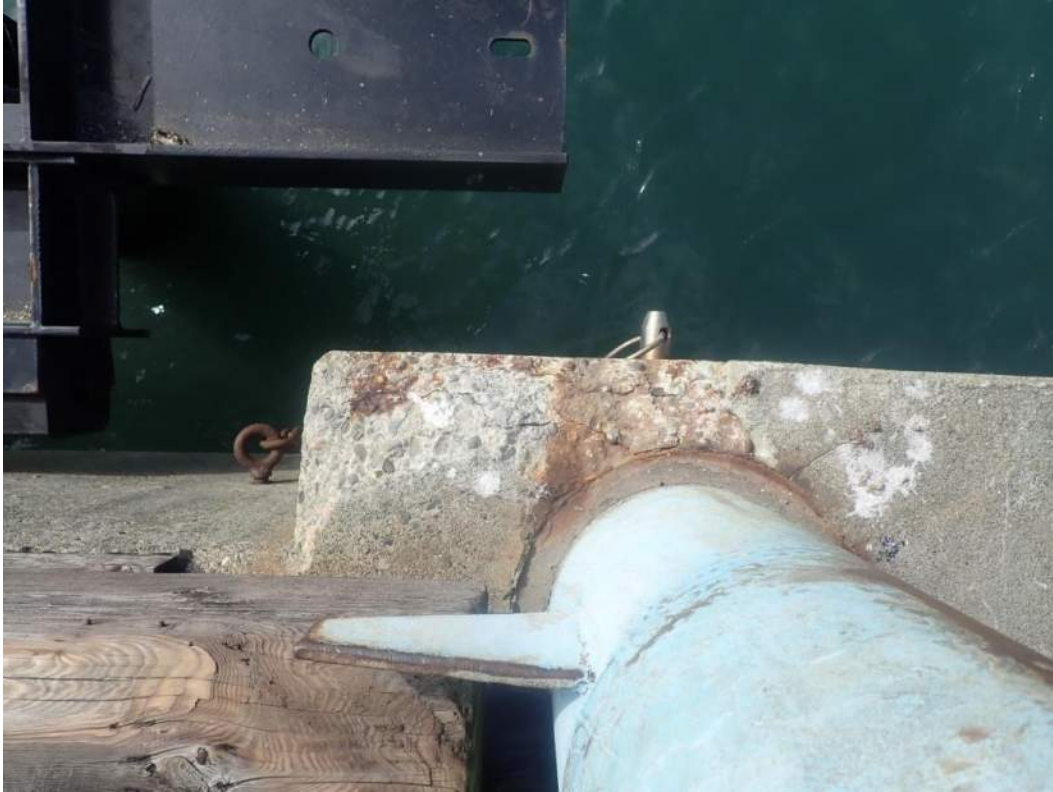
Photo 10: Typical Minor Spalling with Cracks at Mooring Hardware Foundation

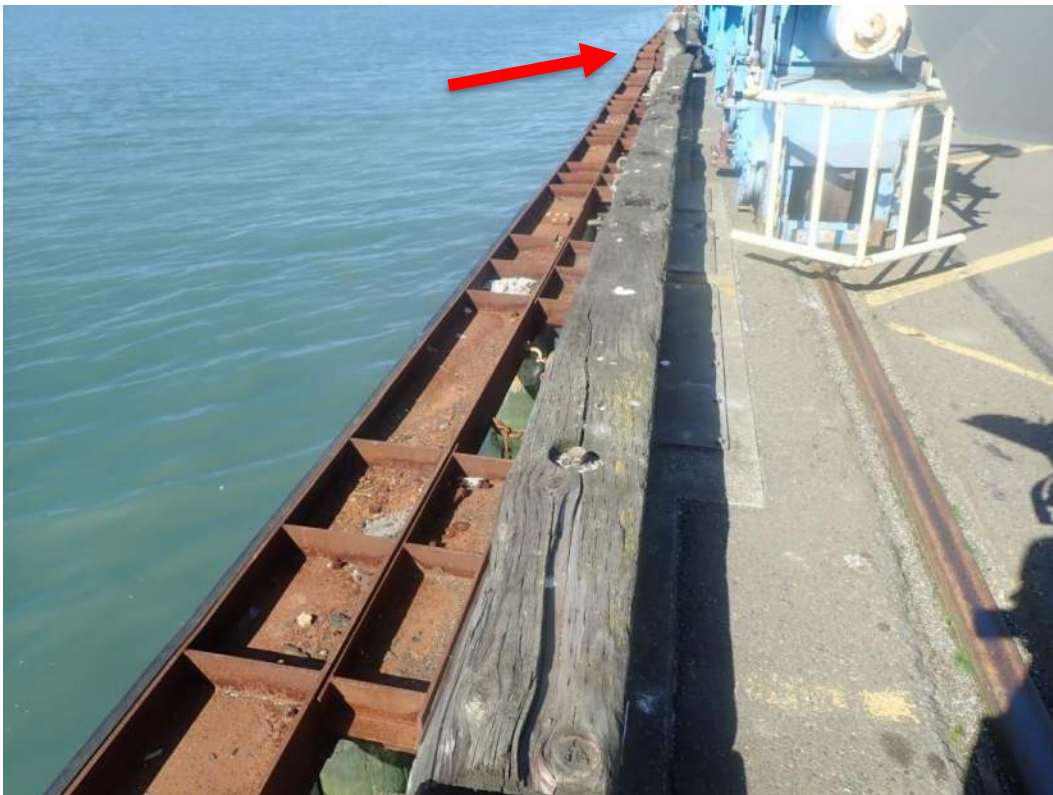
The fender system is in **fair** condition. Minor to moderate corrosion was observed along the full length of the steel wale. At two locations the rubber fenders are sagging and not aligned with the wale, see Photo 11. The wale has bent flanges from mechanical impact at Bent 5.5 and 6.5. UHMW-PE facing along the steel wale is missing bolts at several locations. UHMW-PE facing is missing on five piles between Bent 40 and 43. One stay chain at Bent 39 connecting the steel wale to the concrete wharf is completely broken off. Severe damage was observed at two locations (Bent 7 and Bent 35.8).

Photo 11: Wale Corrosion and Misalignment

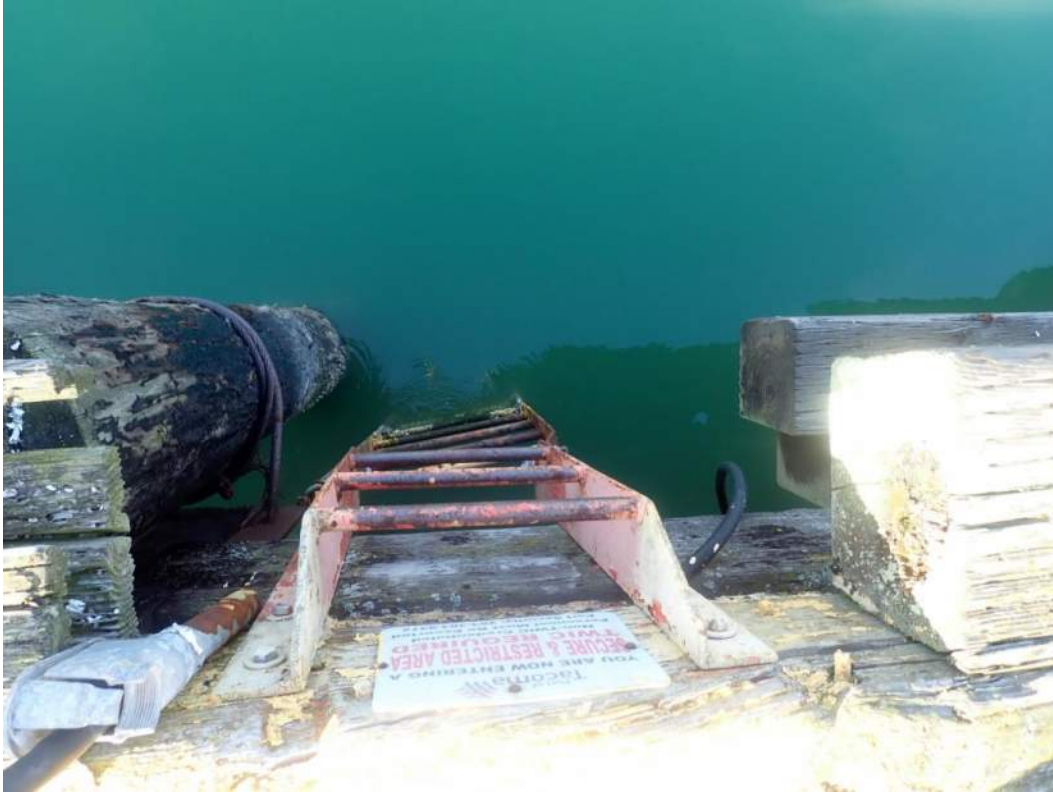
The ladders are in **poor** condition. 50-percent of the ladders have severe damage and are not useable. At bents 21 and 25, ladders are bent and/or missing critical components for use, see Photo 12. The remaining ladders have minor surface corrosion.

Photo 12: Typical Ladder with Impact Damage and Surface Corrosion

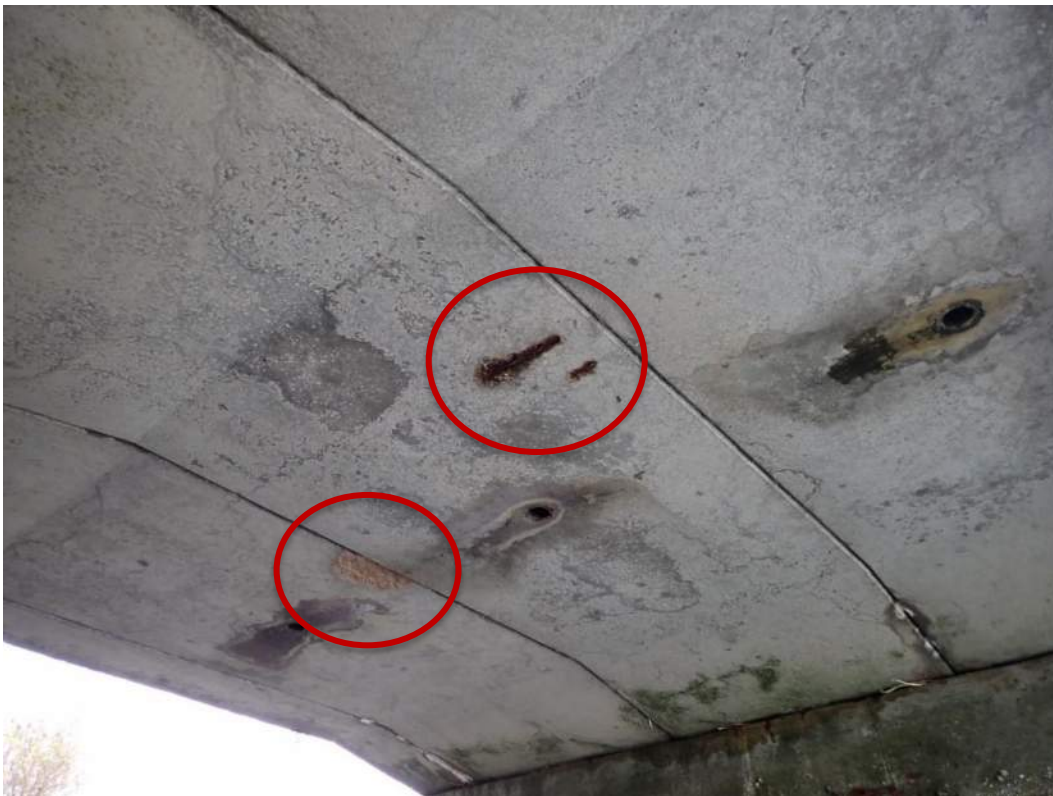
The concrete deck panels are in **satisfactory** condition. Minor cracks and/or spalls were observed at limited locations throughout the berth, shown in Photo 13.

Photo 13: Typical Minor Deck Panel Spalling and Corrosion Staining

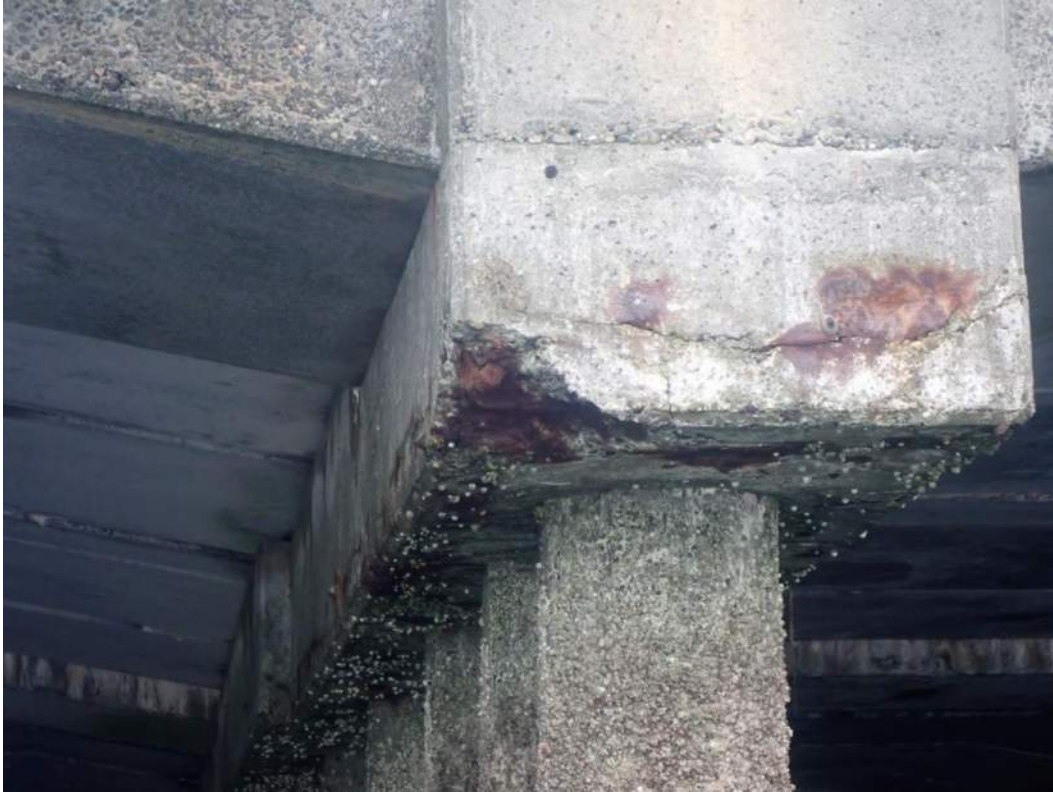
Concrete pile caps are in **fair** condition. Spalls and delaminated concrete were observed at several locations, primarily along the pile cap soffits, shown in Photo 14. Longitudinal cracks with rust staining along the lower edge of pile caps are present at multiple locations throughout the berth, as shown in Photo 15.

Photo 14: Typical Pile Cap Spalling with Exposed Rebar

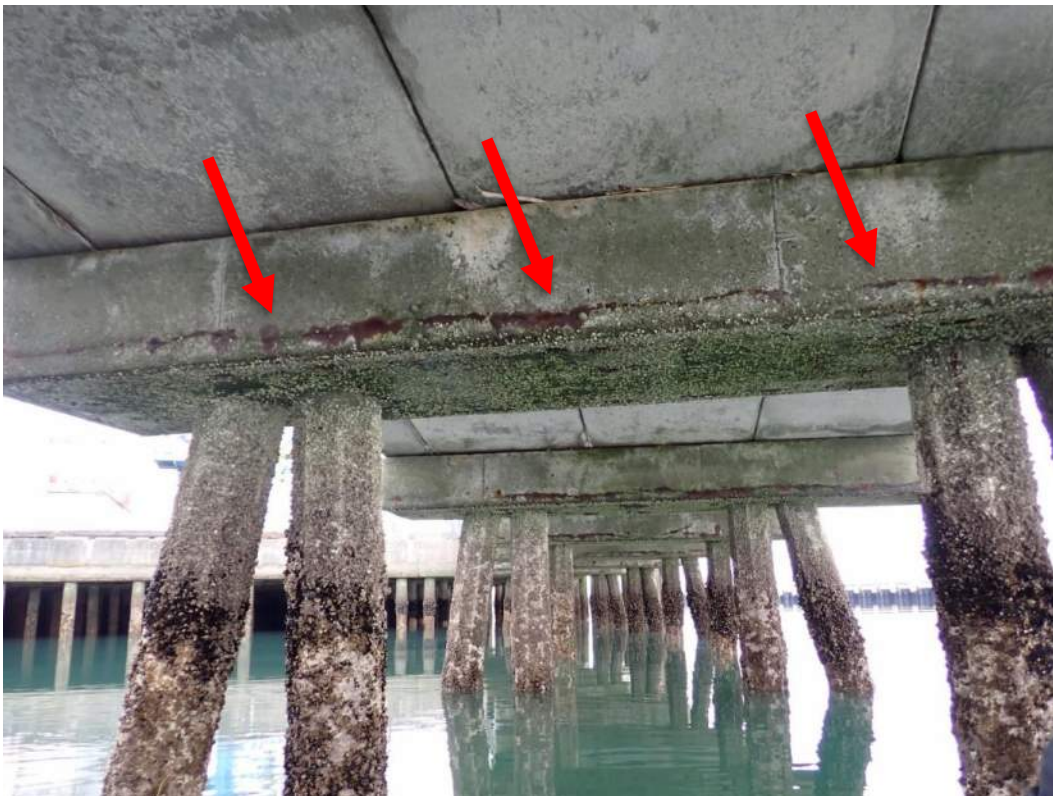
Photo 15: Typical Pile Cap with Corrosion Cracks

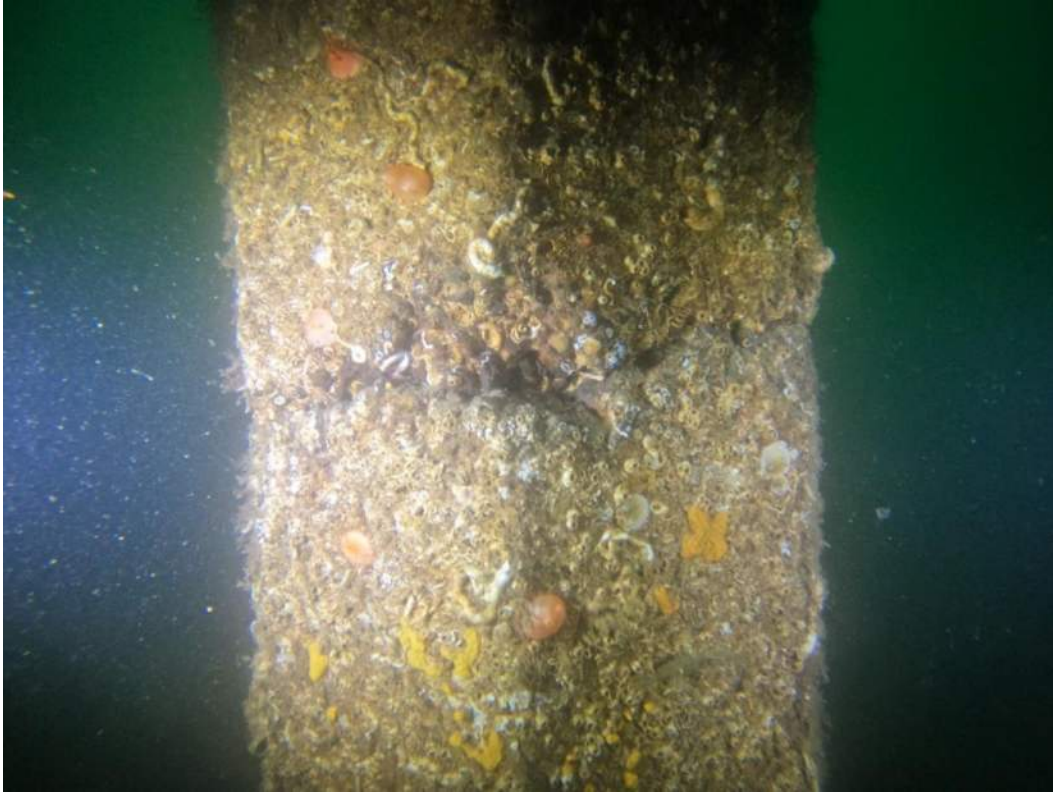
In general, concrete piles are in **fair** condition. The majority (93-percent) of the 240 piles inspected underwater have no noticeable defects or deterioration. Minor damage including hairline horizontal tension cracks with spalling of up to 1/2-inch deep was observed at 12 locations (5-percent). Moderate damage including horizontal tension cracks up to 1/32-inch wide and spalling up to 1-inch deep was observed at two piles (less than 1-percent). Major damage including spalling greater than 1-inch deep and horizontal tension cracks was observed at three piles (approximately 1-percent, see Photo 16). Severe damage consisting of softening of the concrete surface and rounding of the concrete edges was observed at one pile (Pile 26:A, see Photo 17), representing less than 1-percent of the total piles inspected.

Photo 16: Pile 26:G, Major Tension Crack with Spalling

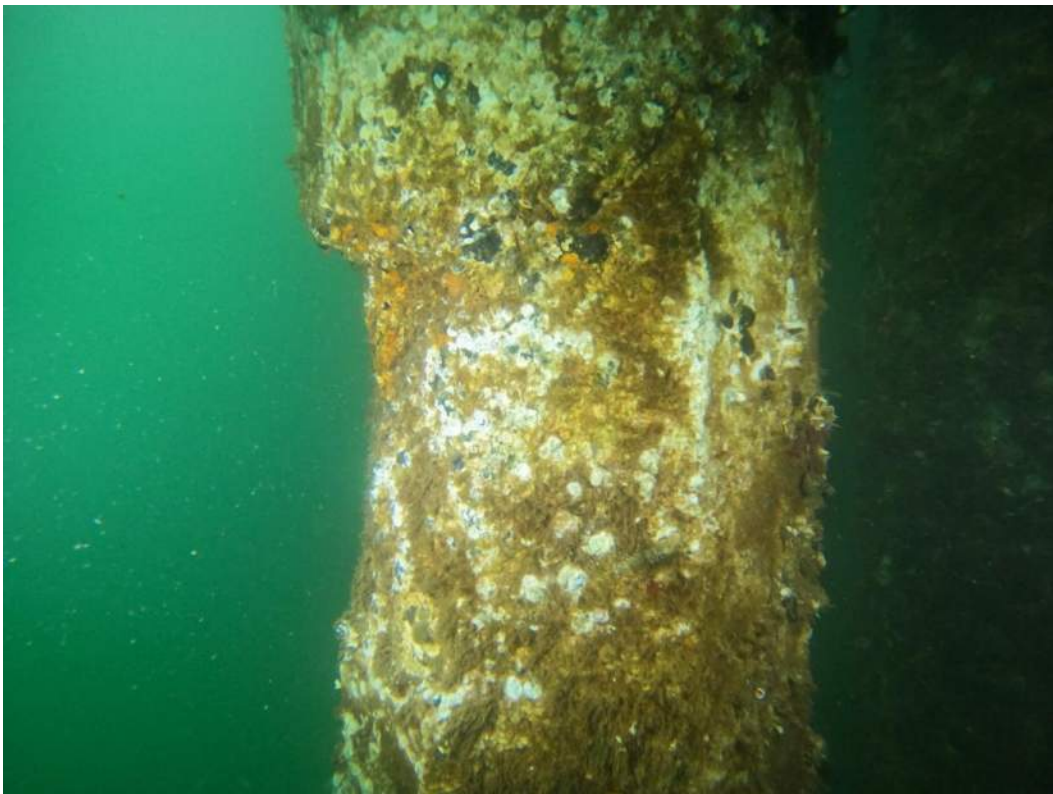
Photo 17: Pile 26:A, Severe Spalling with Section Loss

moffatt & nichol									
STRUCTURE ID:			TERMINAL 7 - BERTH D			DATE:			10/13/2023 - 10/14/2023			ABOVE WATER			X												
M&N JOB NO:			230763-01			RECORDERS:			M. PERRY / A. PATTERSON			UNDERWATER			X												
JOB NAME:			POT FCA 2023			INSPECTORS:			M. PERRY / A. PATTERSON / W. WISE			PILE TYPE:			BEARING AND FENDER												
PILE LOCATION (PILE ID)		PILE RATING	TIDE OR TIME	ML GAUGE	WRAPPED	INSP. LVL: II	OBSERVATION OF DEFECT / DAMAGE								DEFECT / DAMAGE RATING					COMMENTS	PHOTO NO.						
BENT NO.	PILE NO.						LOCATION ON PILE				CRACK (2)	SPALL (3)	CHEM (4)	# EXPOSED		DIMENSIONS (IN)			ND			MN	MD	MJ	SV		
		DEPTH (TOP)	DEPTH (BOT)	SIDE ⁽¹⁾	CORNER			STIRUP	STRAND/ BAR	HGT				WIDTH	DEPTH												
26	A						-7		SW, W							20"	15"	3"								CORROSION, EXP STEEL	77-83
24	A	ND		48															X								
24	B	ND		47															X
