# PORT OF TACOMA

### 2021 PIER REPAIRS (PILE CRACKS, SPALL REPAIRS AND MOORING COATING) - EB1, WUT, AND PIER 3

### PROJECT NO. 201130.01, 201130.02, AND 201130.03

### CONTRACT NO. 071569

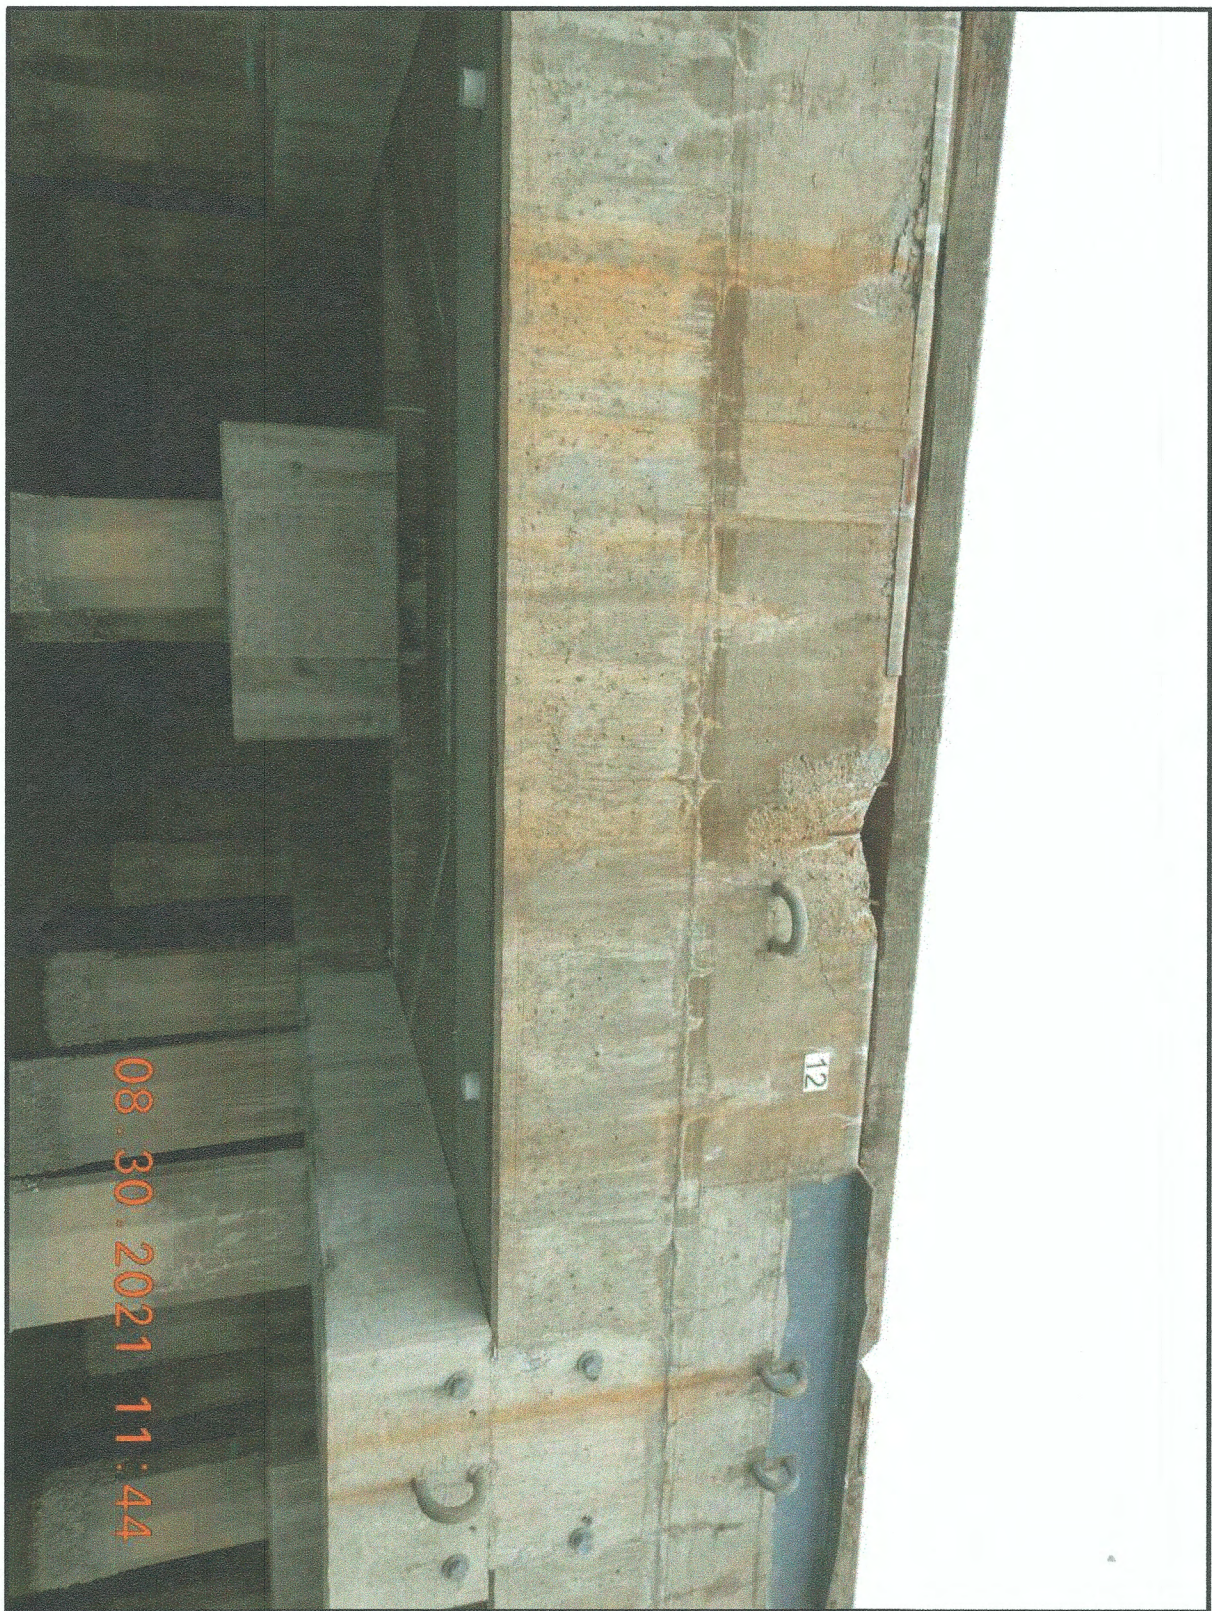
P1  
-  
EDGE BEAM SPALL - BENT 12.25  
LOOKING EAST

| CONCRETE SPALL REPAIR QUANTITIES | | | | | |
|---|---|---|---|---|---|
| EB1 | BENT 12.25 | EDGE BEAM | 1/S8.0 | 12 | CF |

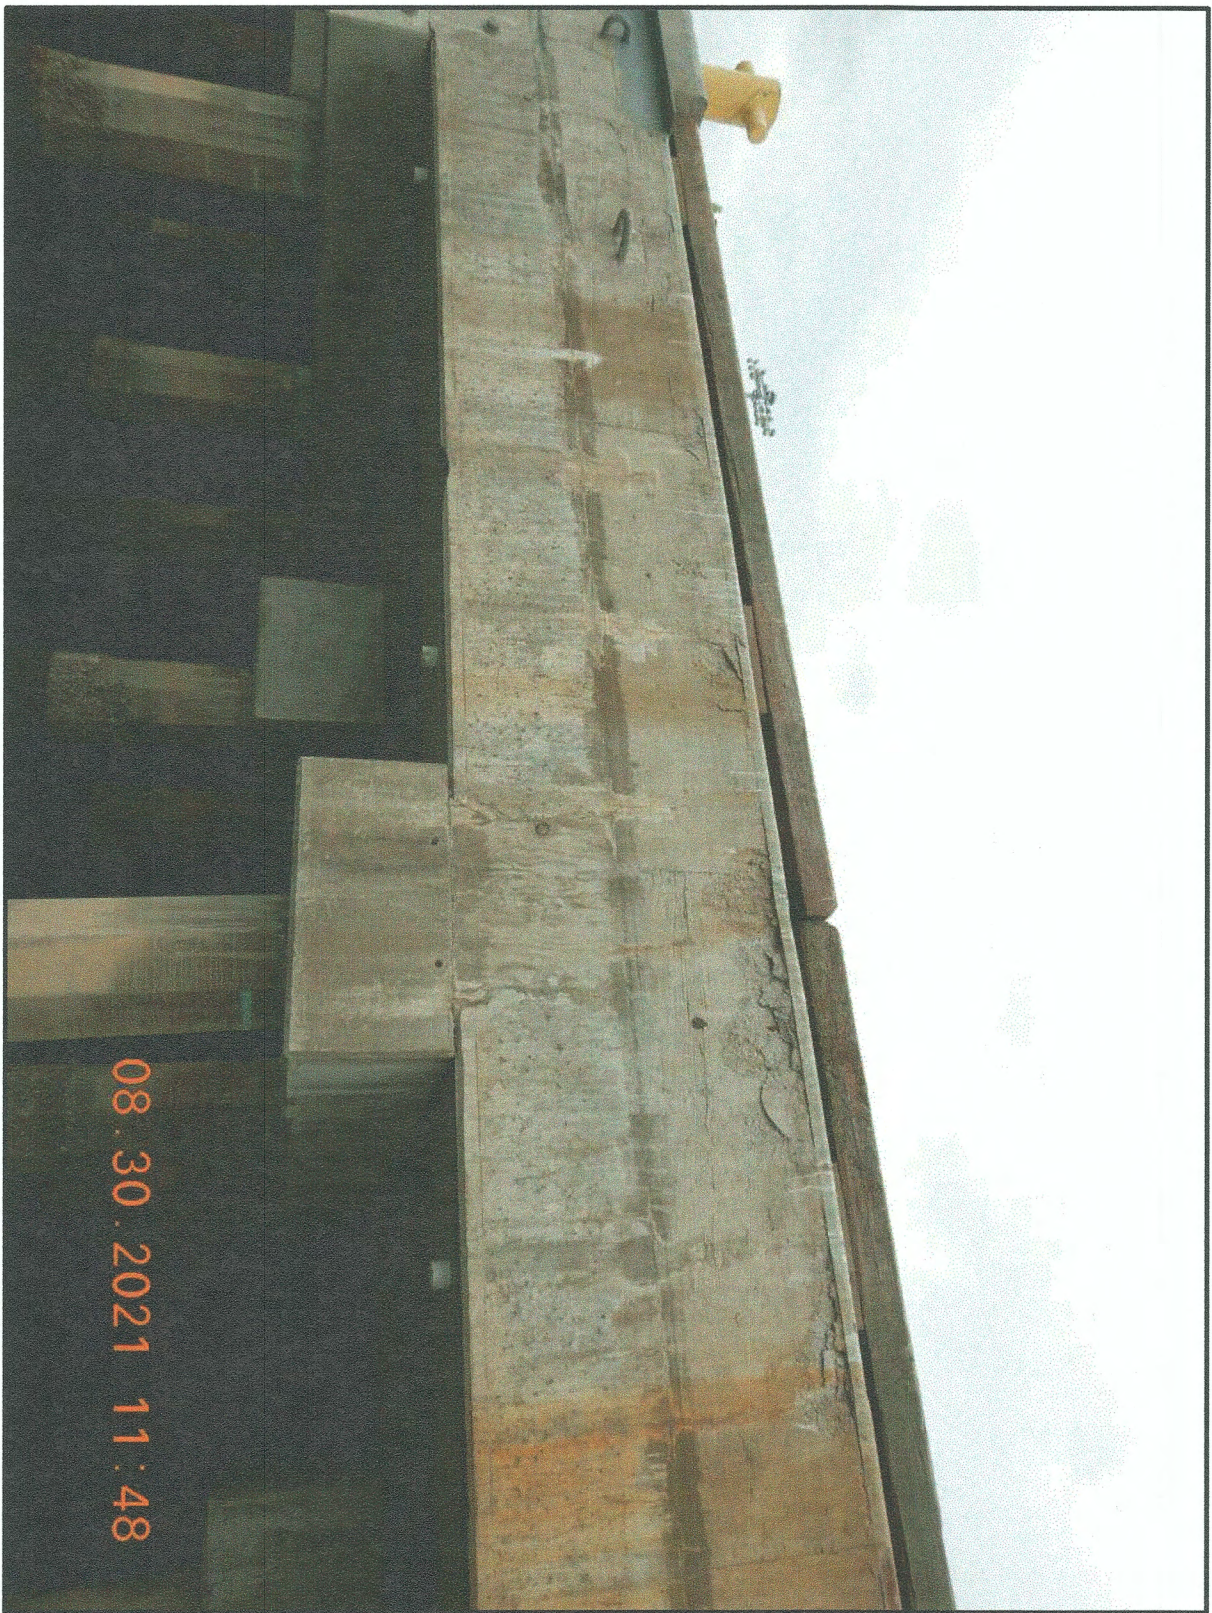
P2  
-  
EDGE BEAM SPALL - BENT 13  
LOOKING EAST

| CONCRETE SPALL REPAIR QUANTITIES | | | | | |
|---|---|---|---|---|---|
| EB1 | BENT 13 | EDGE BEAM | 1/S8.0 | 4 | CF |

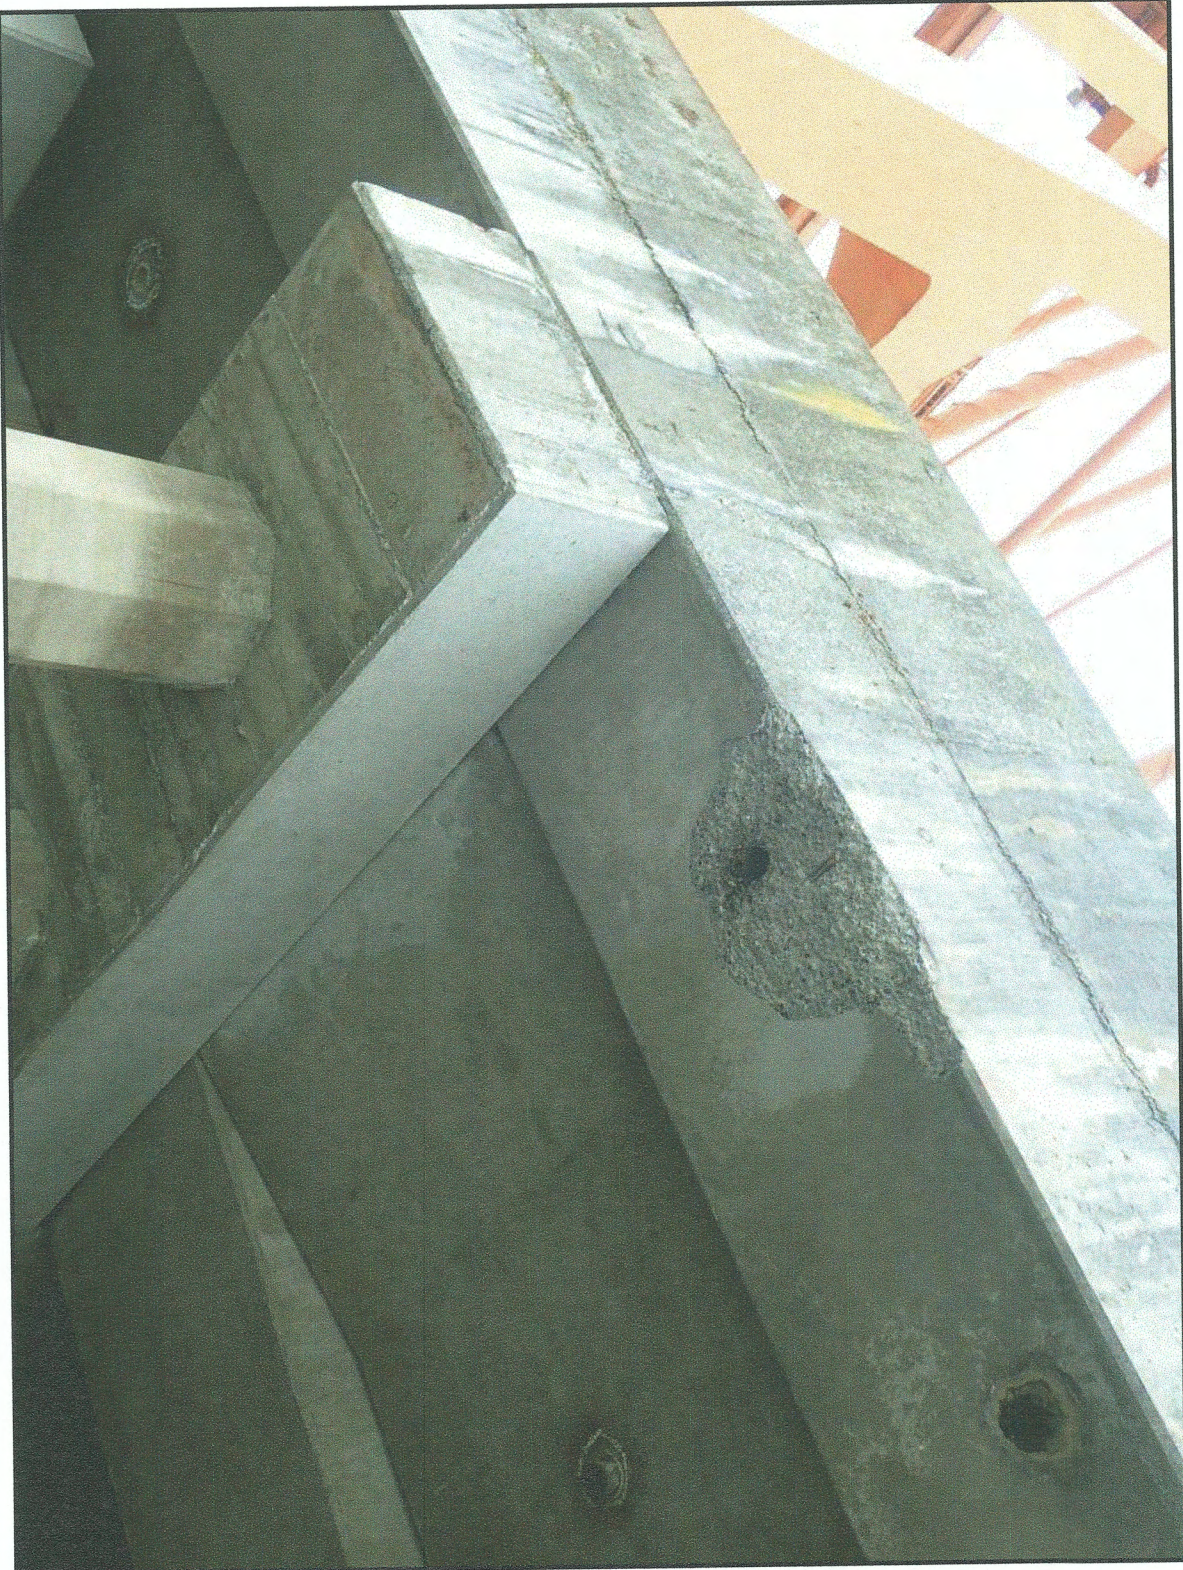
P1  
-  
EDGE BEAM SPALL - BENT 19  
LOOKING SOUTH

| CONCRETE SPALL REPAIR QUANTITIES | | | | | |
|---|---|---|---|---|---|
| WUT | BENT 19 | EDGE BEAM | 1/S7.0 (SIM) | 2 | CF |

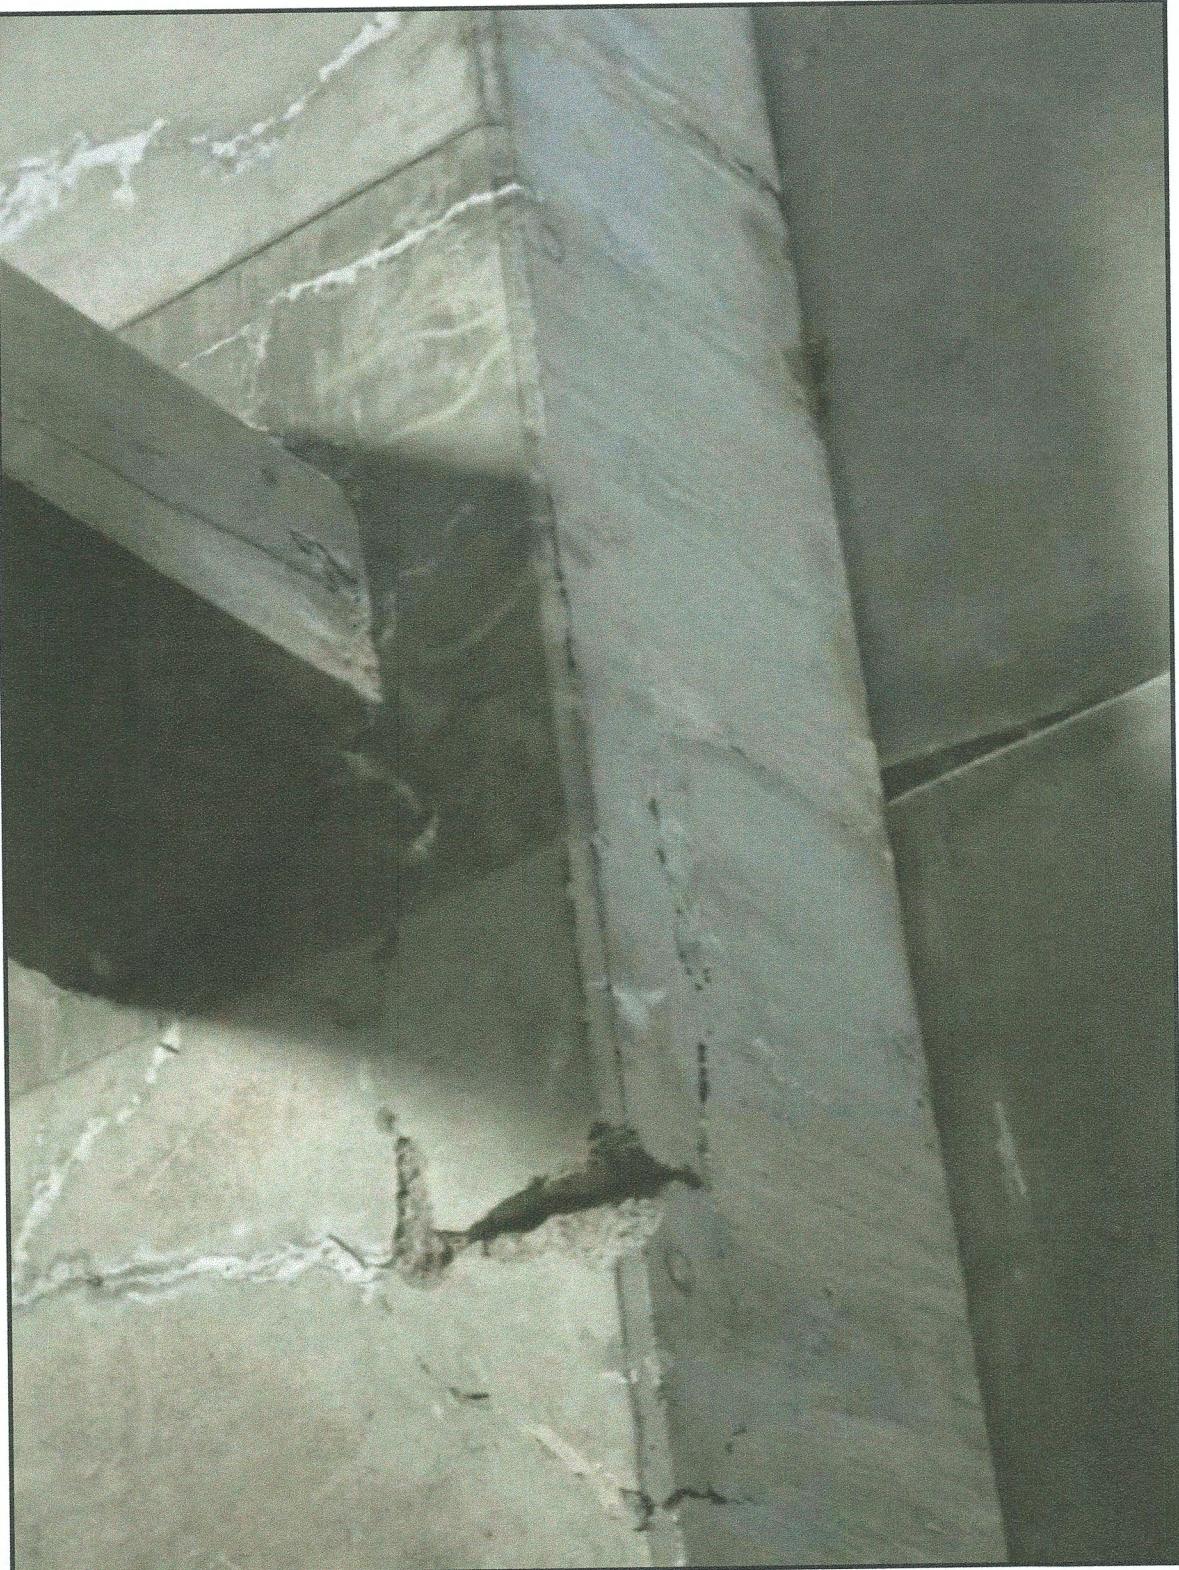
P2  
-  
PILE CAP SPALL - BENT 82:B  
LOOKING SOUTH

| CONCRETE SPALL REPAIR QUANTITIES | | | | | |
|---|---|---|---|---|---|
| WUT | BENT 82:B | PILE CAP | 1/S7.0 | 1.5 | CF |

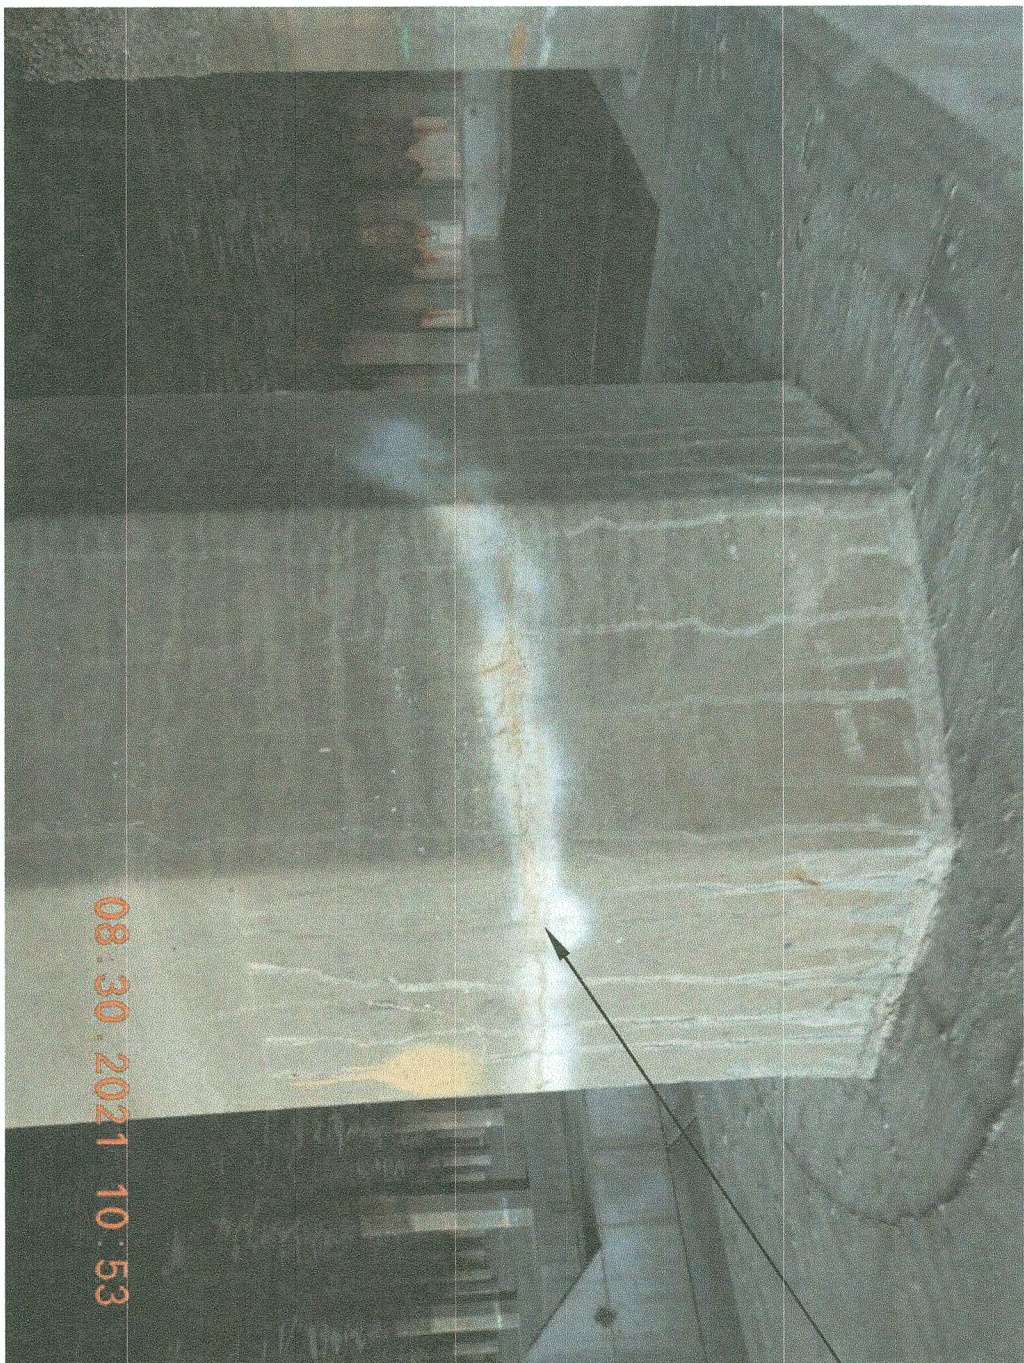
EXISTING CRACK, MARKED WITH WHITE PAINT

P1  
TYPICAL PILE CRACK

2  
DETAIL - SURFACE APPLIED EPOXY CRACK REPAIR
