**REGULATED BUILDING MATERIALS
SUPPLEMENTAL SAMPLING AND PROJECT SUMMARY
TO SUPPORT DEMOLITION**

**PORT OF TACOMA
1940 EAST 11TH STREET
TACOMA, WASHINGTON**

April 8, 2014

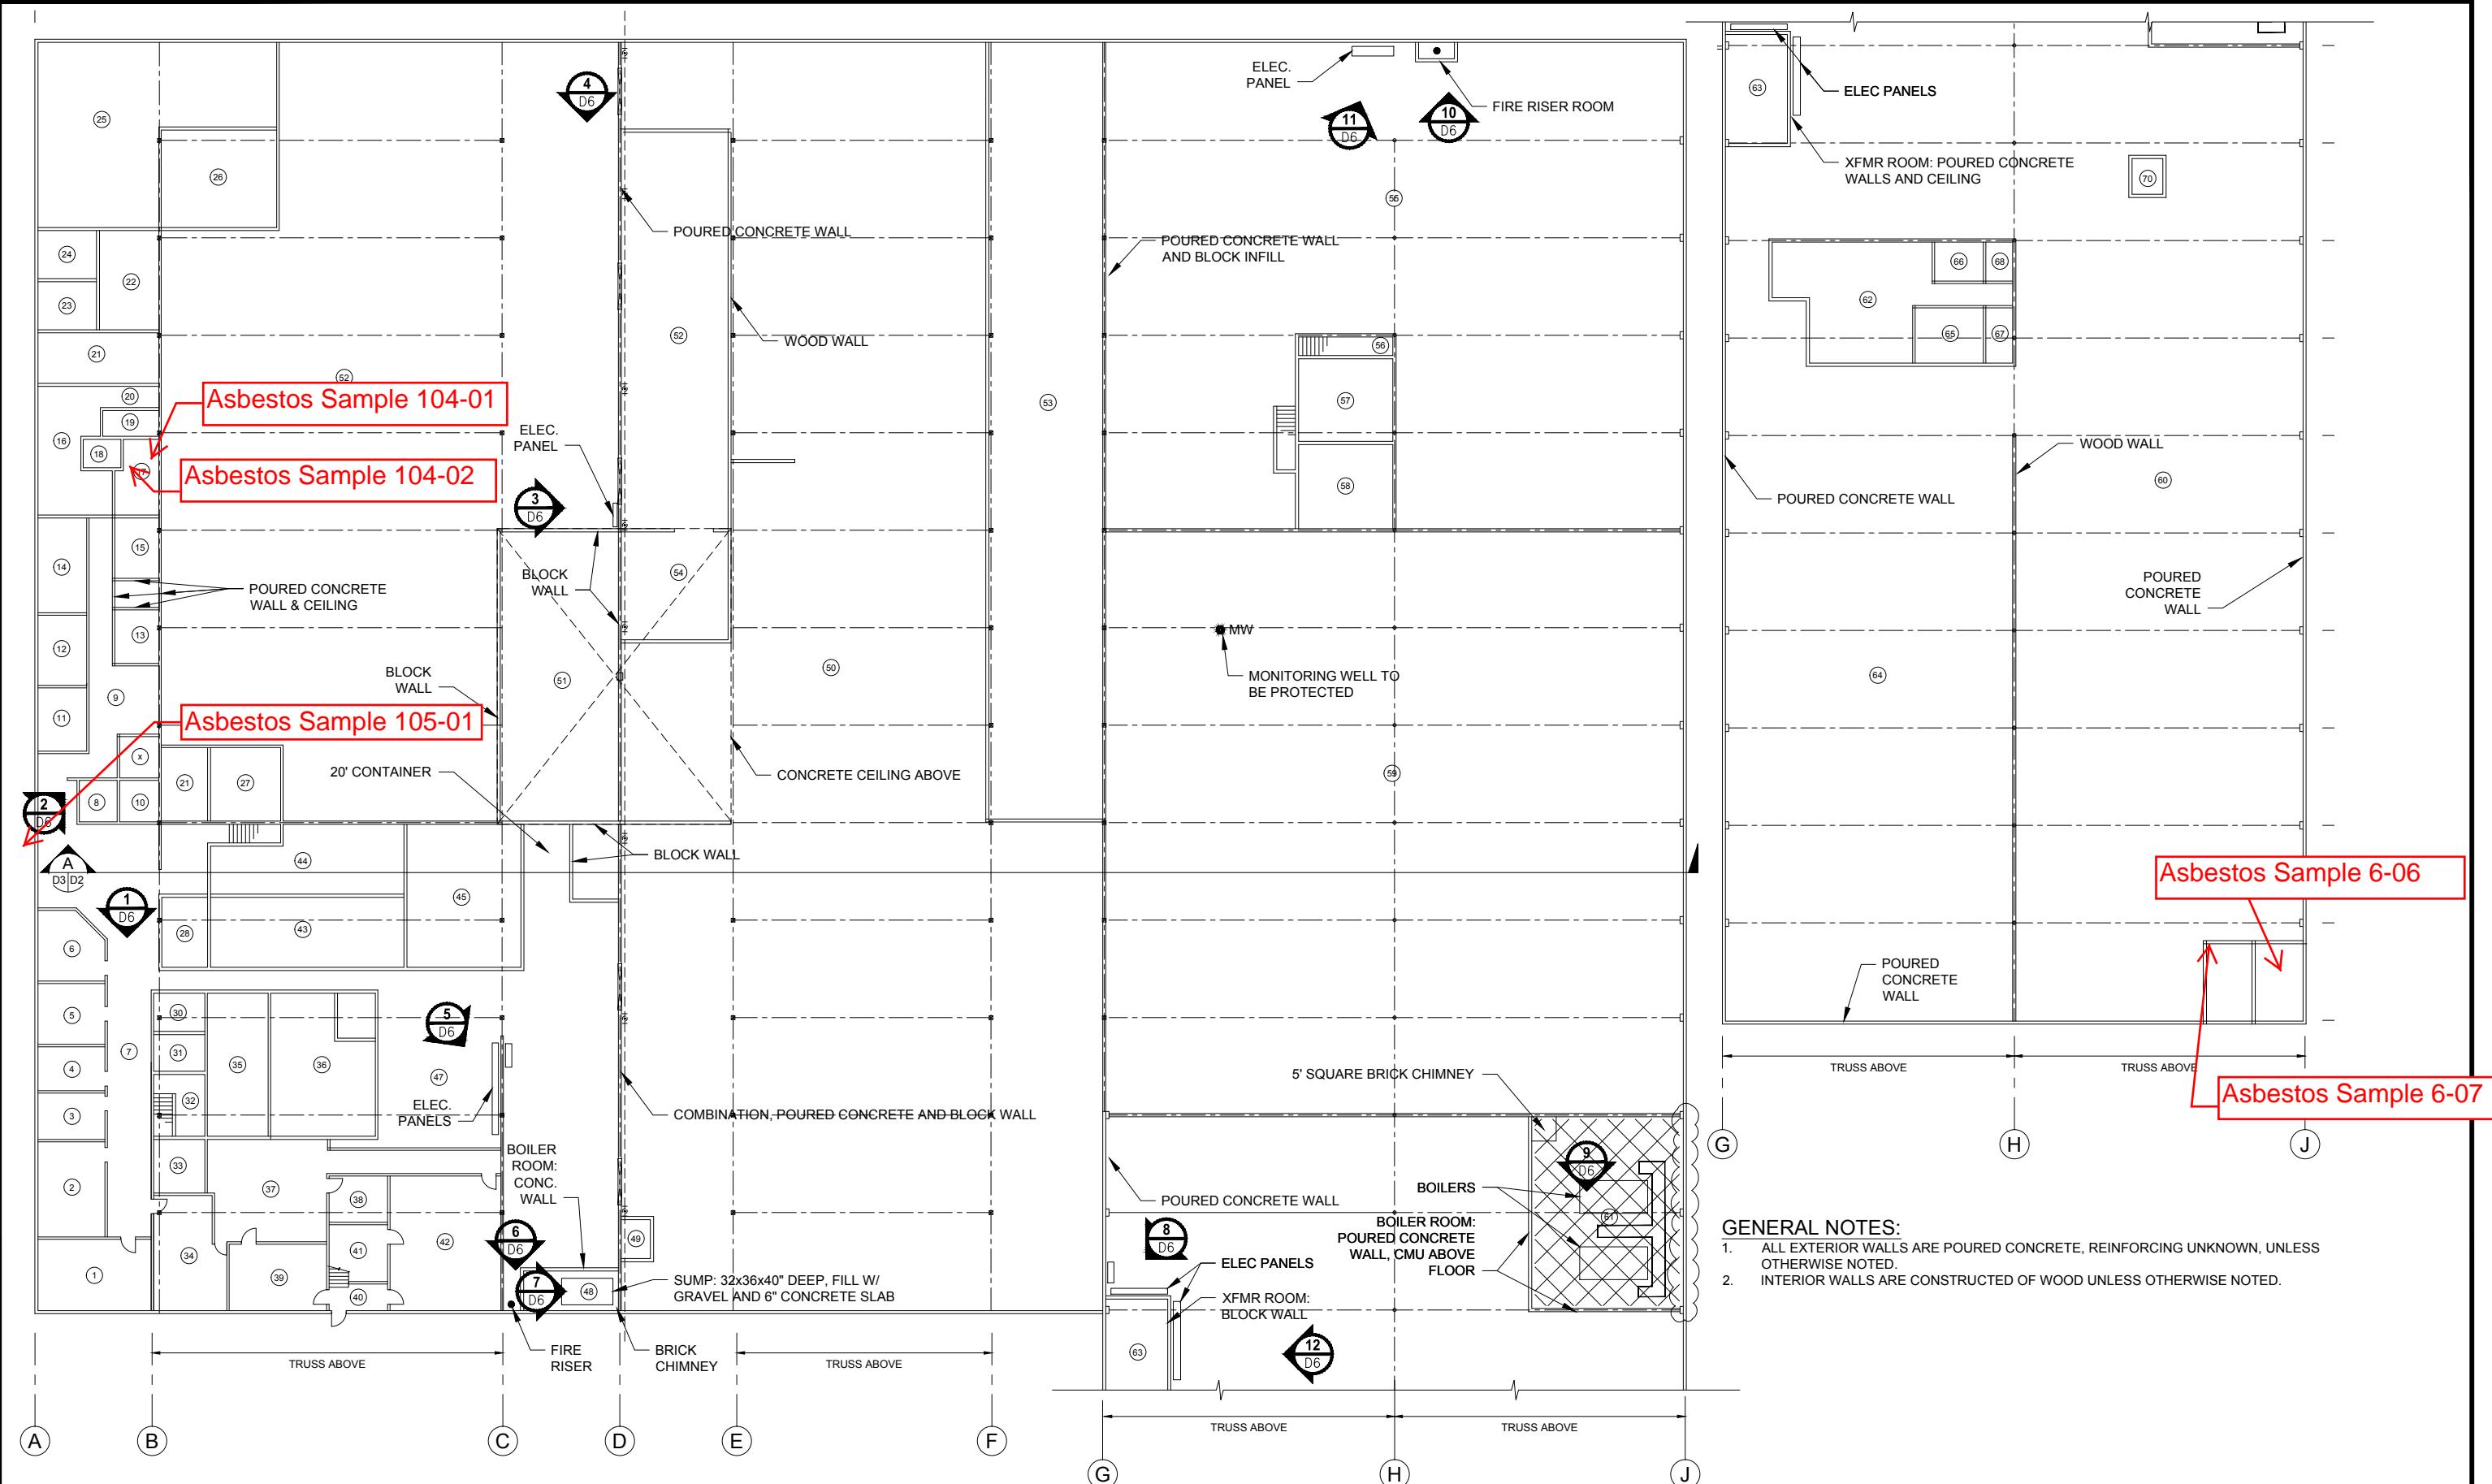
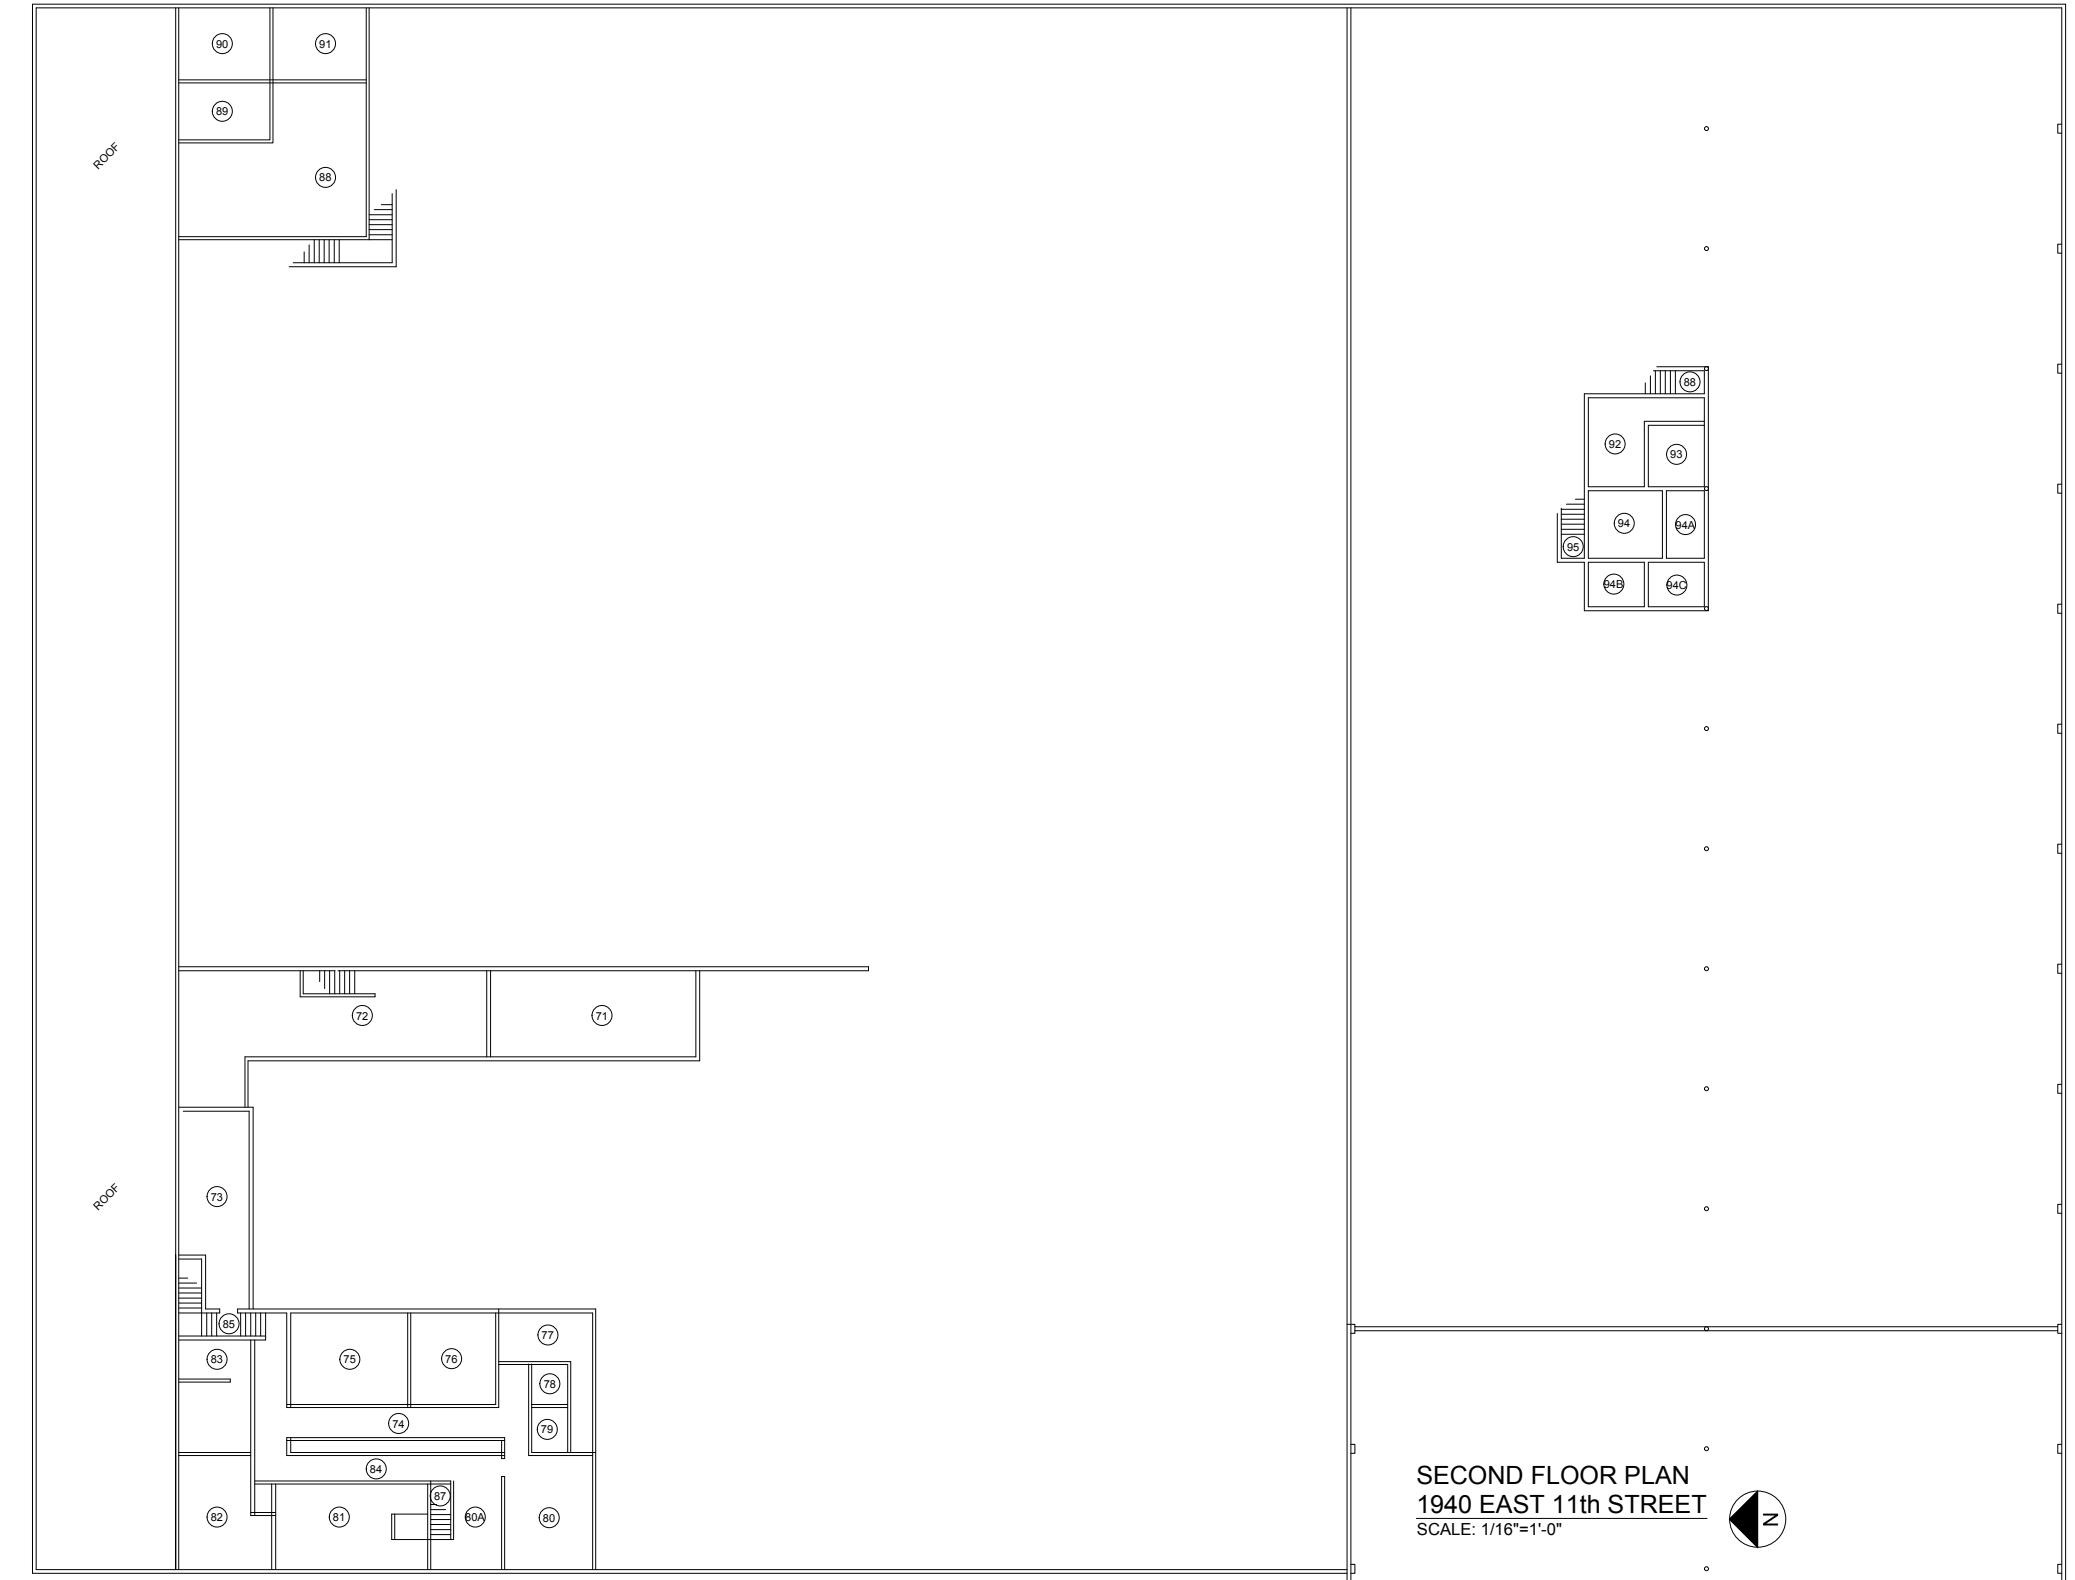
Figure 1 – EMB Consulting, Supplemental Sampling Locations

The results of the supplemental bulk asbestos samples collected by EMB Consulting are presented in Table 2. Sample locations are indicated on Figure 1.
