**PORT OF TACOMA  
TACOMA, WASHINGTON  
W. SITCUM BLDGS. 900, 700, 975, 575 AND 75 ROOF  
REPLACEMENTS**

**PROJECT NO. 201062.04  
CONTRACT NO. 071126**

**Appendices A Part 1**

Subject: Port of Tacoma 8-Building Roof Replacement  
Building 700 Domestic Equipment Control Building  
Hazardous Building Materials Investigation  
Tacoma, Washington  
Med-Tox Northwest Project No. A-8772.4

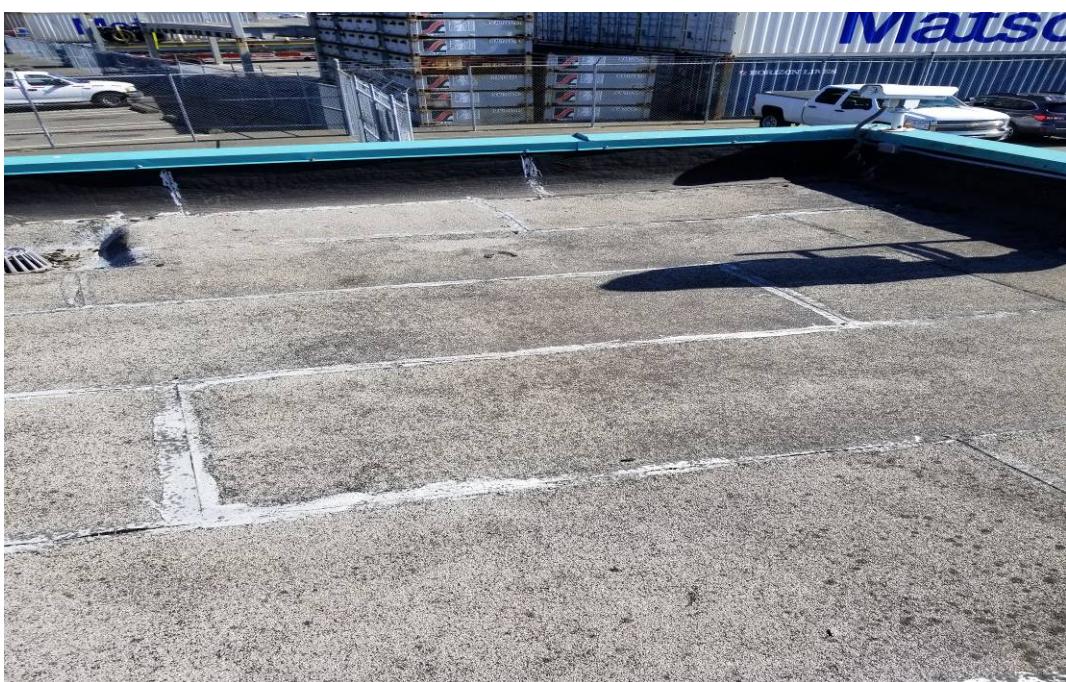
There were no asbestos-containing materials identified in the roofing samples collected from building 700.

Photograph 2: Built-up roof system. All suspect materials were determined to be negative for asbestos.

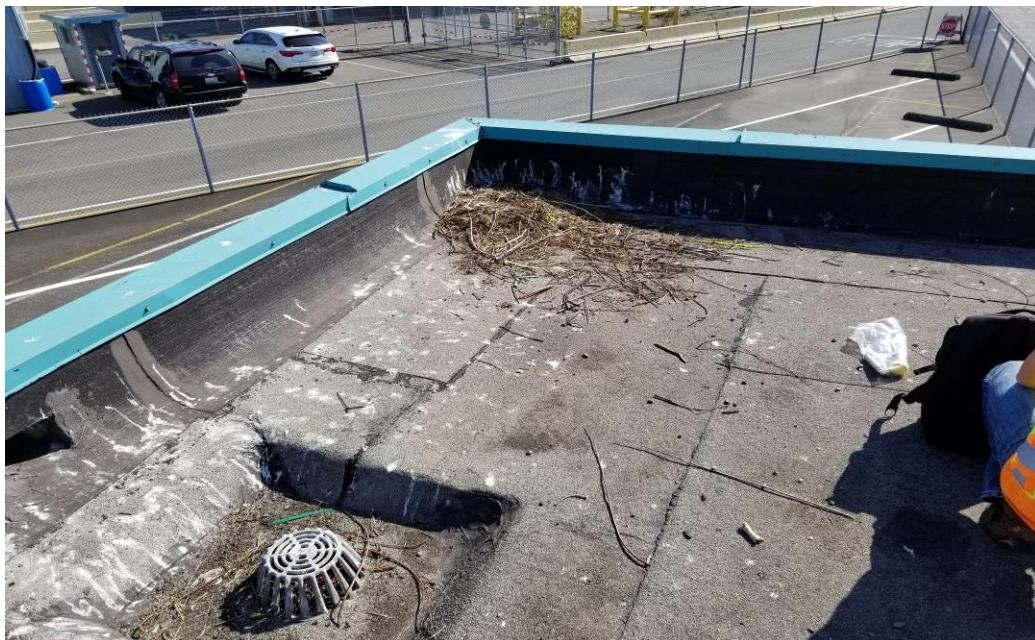
Photograph 2: Built-up roof system. All suspect materials were determined to be negative for asbestos.

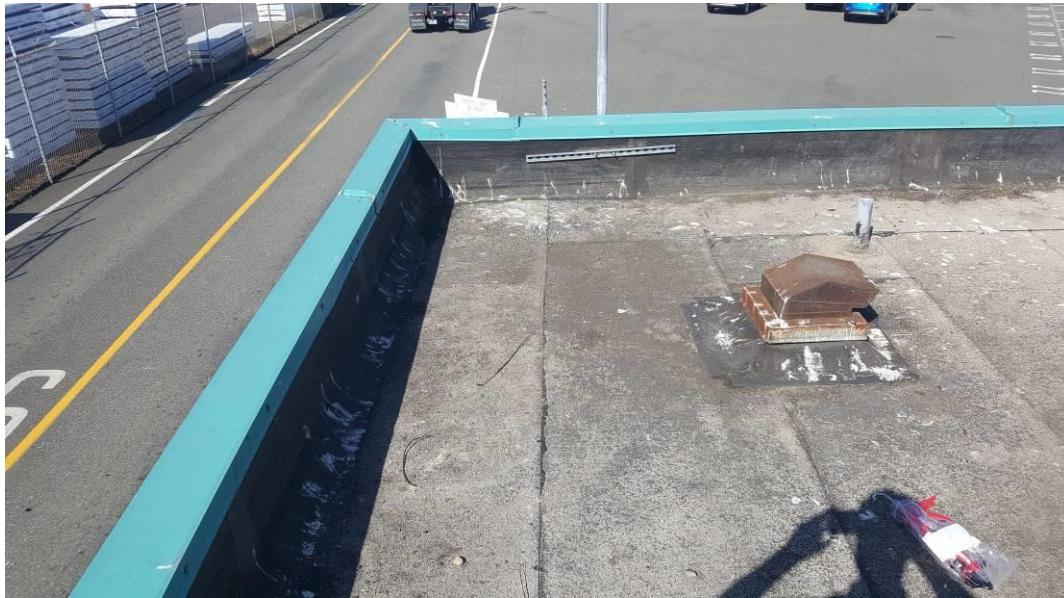
Photograph 3: Built-up roof system

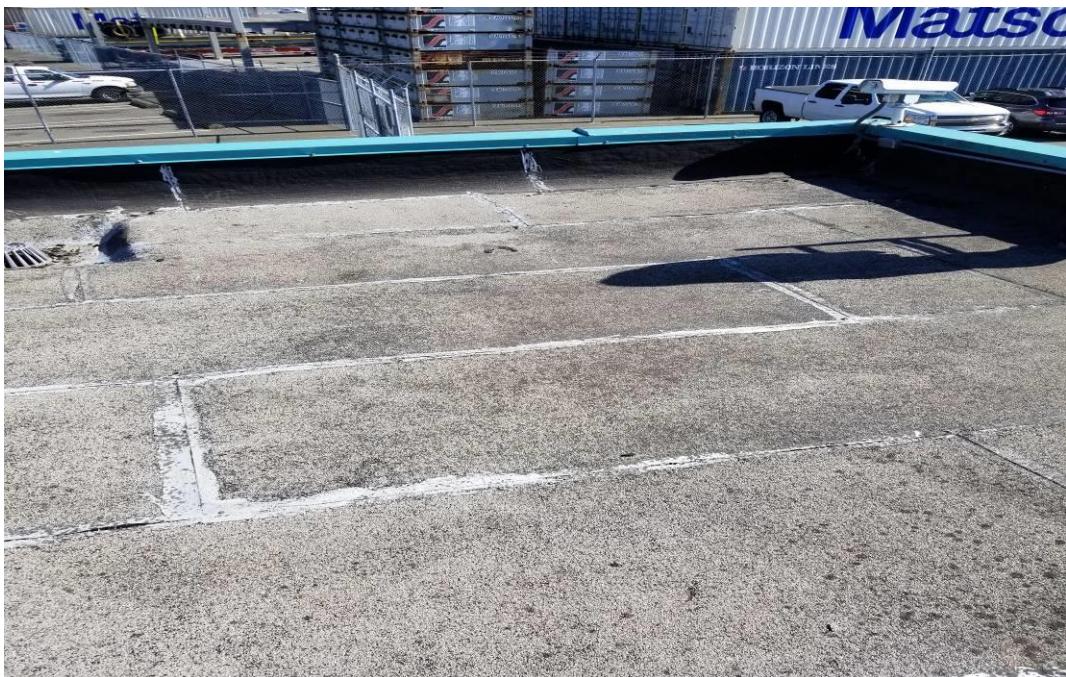
Photograph 2: Built-up roof system. All suspect materials were determined to be negative for asbestos.
