HAZARDOUS BUILDING MATERIALS SURVEY

Demolition

Commercial Structure
2306 11th Street
Tacoma, Washington

Med-Tox Northwest
Post Office Box 1446
Auburn, WA
MTNW Project A-8842.1

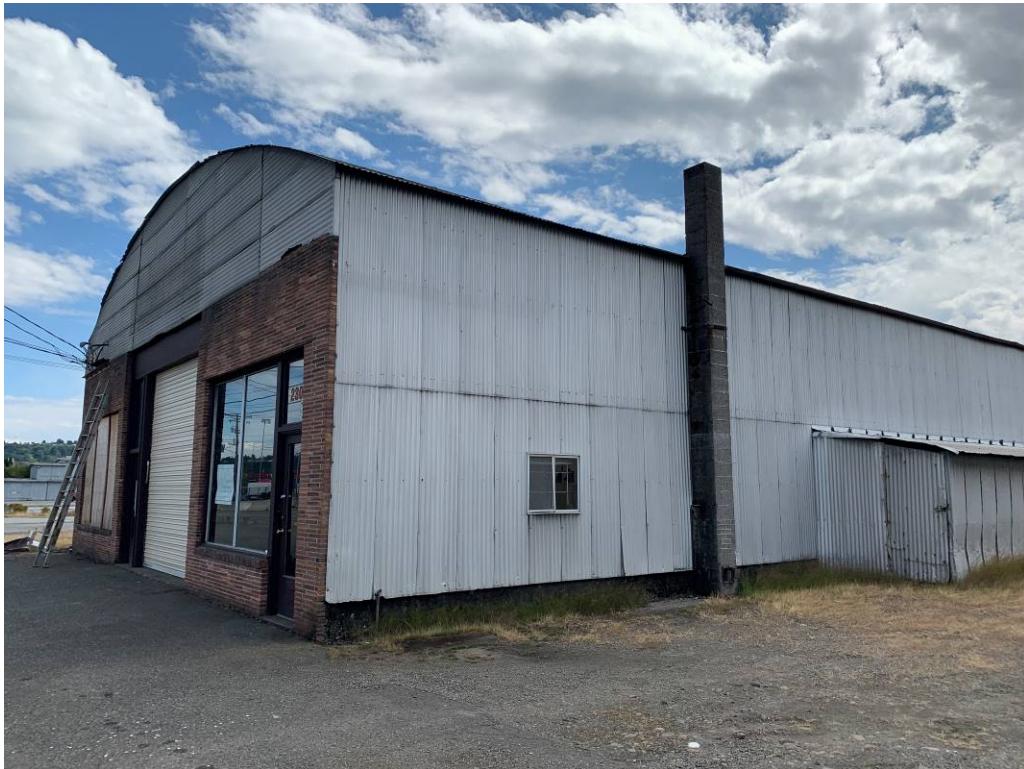
Photo 1: South and west sides of the building facing northeast.

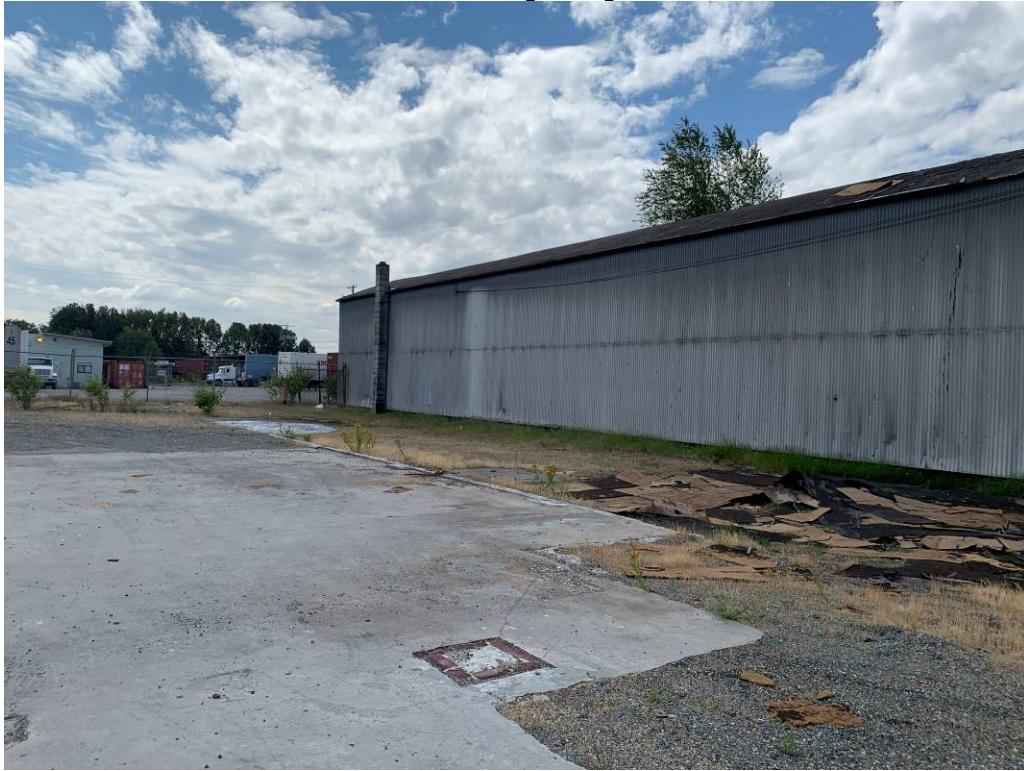
Photo 2: North side of the building facing southeast.

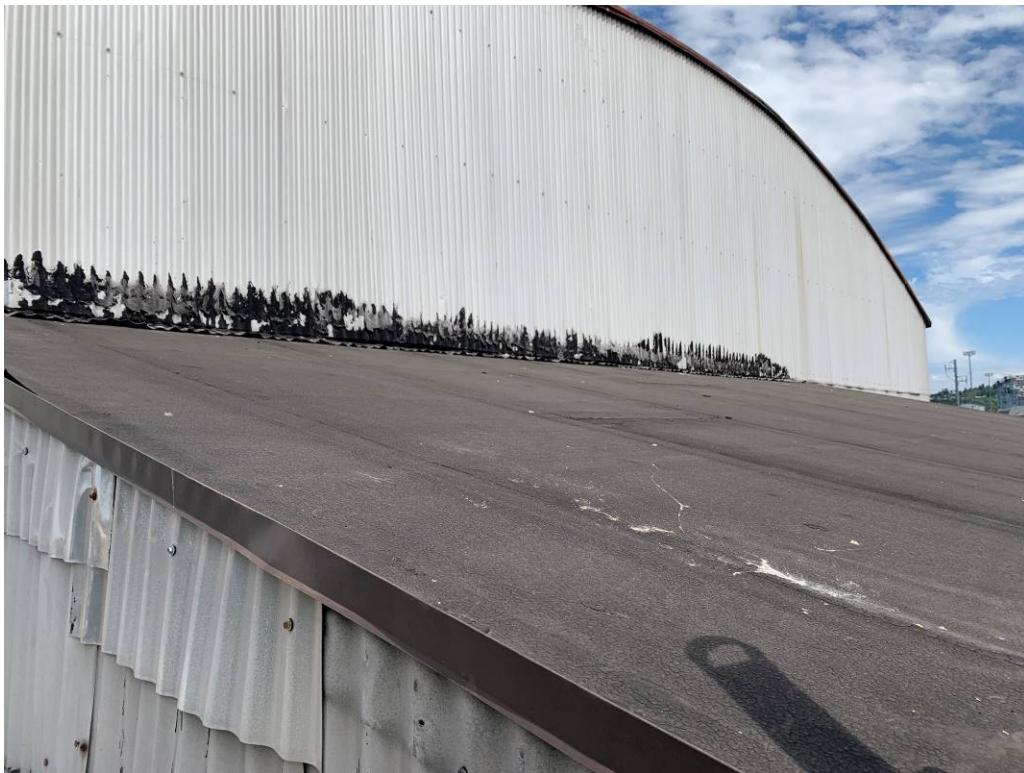
- Torch down tar sheeting over plywood (HM-15). The roof of the shed is finished with torch down tar sheeting over plywood sheeting. Two samples were collected and analyzed for asbestos content; this material was determined to be negative for asbestos.

Photo 3: Roof of shed. The roofing is non asbestos containing.

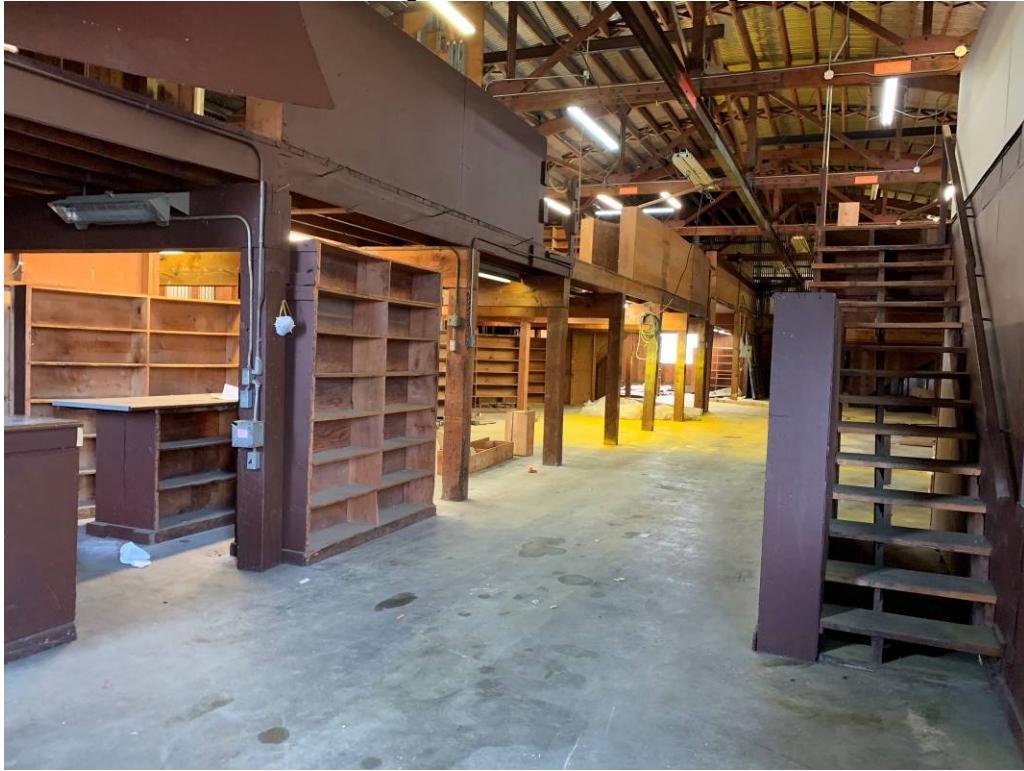
Photo 4: Interior of building facing east.

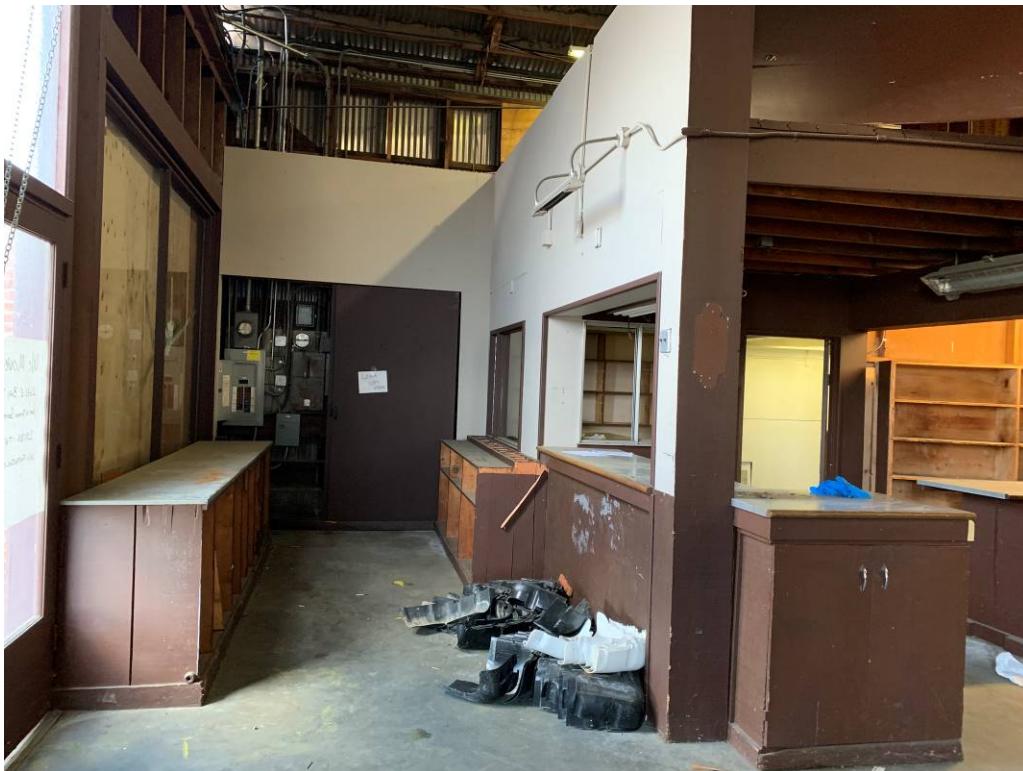
Photo 5: Front end sales area facing north.

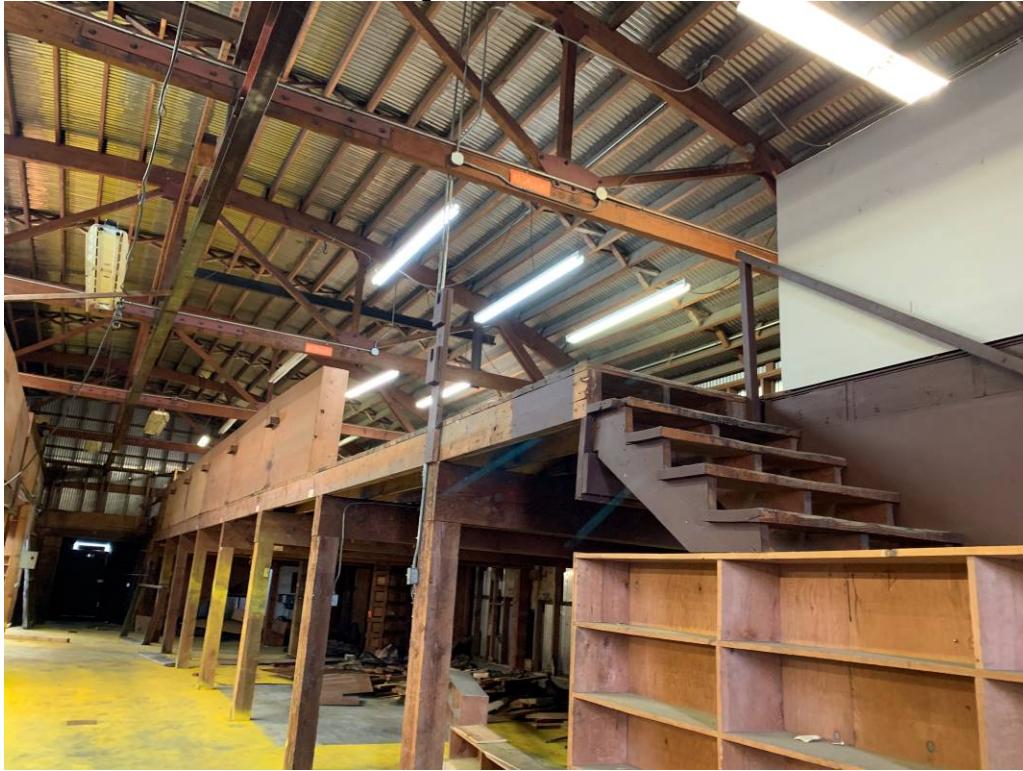
Photo 6: 2nd floor mezzanine storage area facing southeast.

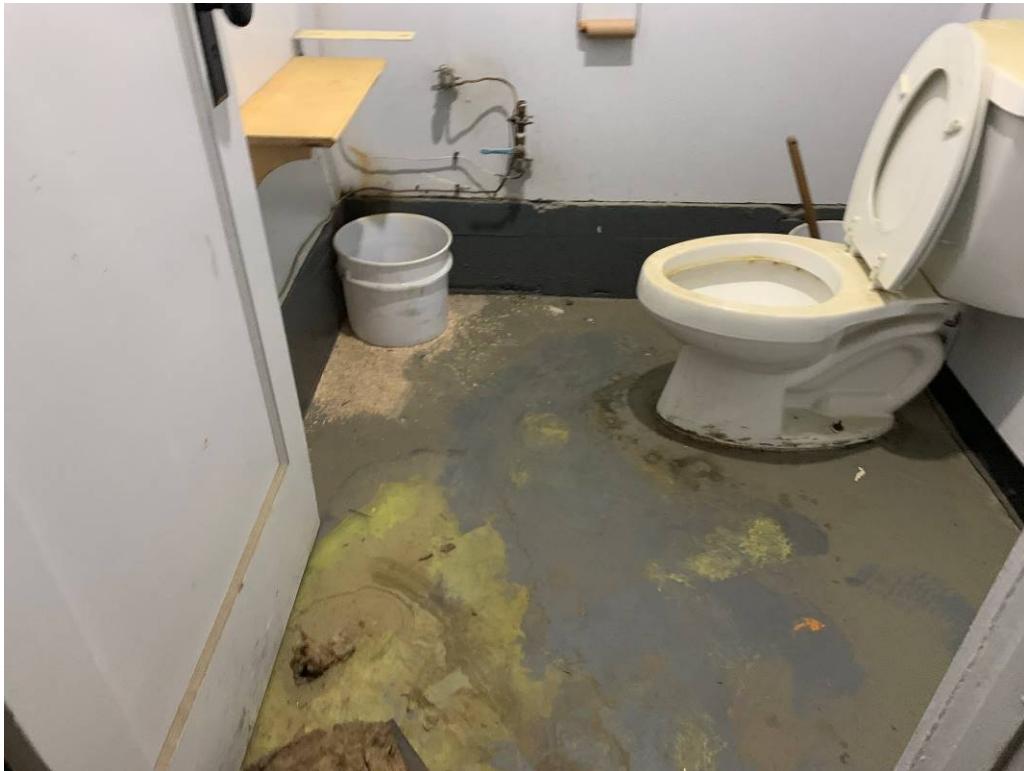
Photo 7: Typical finishes observed in the bathroom.

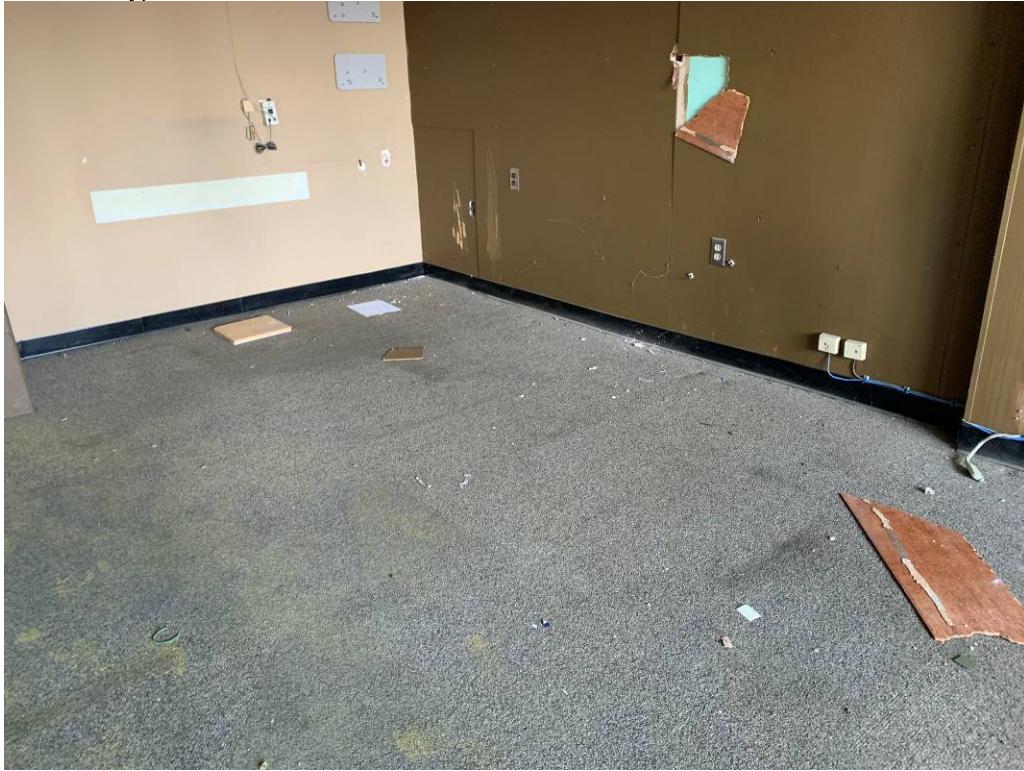
- Brown mastic (HM-07). This material was identified behind the wood paneling in the office area. Two samples were collected and analyzed for asbestos content; **this material was determined to contain 3% Chrysotile asbestos.**

Photo 8: Typical finishes observed in the office area. The paneling mastic is ACM.

MTNW recommends, and state law requires, that all asbestos materials identified in **Table 1** be removed prior to demolition.

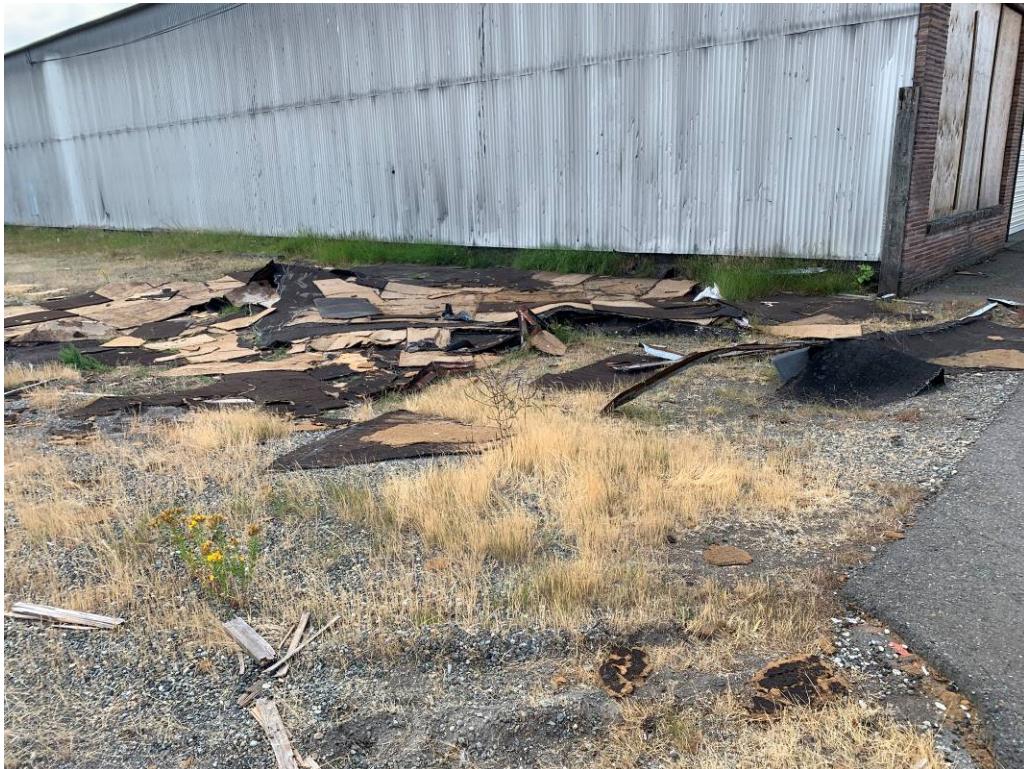
Photo 9: Non asbestos roofing debris on the north side exterior.
