HAZARDOUS BUILDING MATERIALS SURVEY

Demolition

Commercial Structure
2338 11th Street
Tacoma, Washington

Med-Tox Northwest
Post Office Box 1446
Auburn, WA
MTNW Project A-8842.1

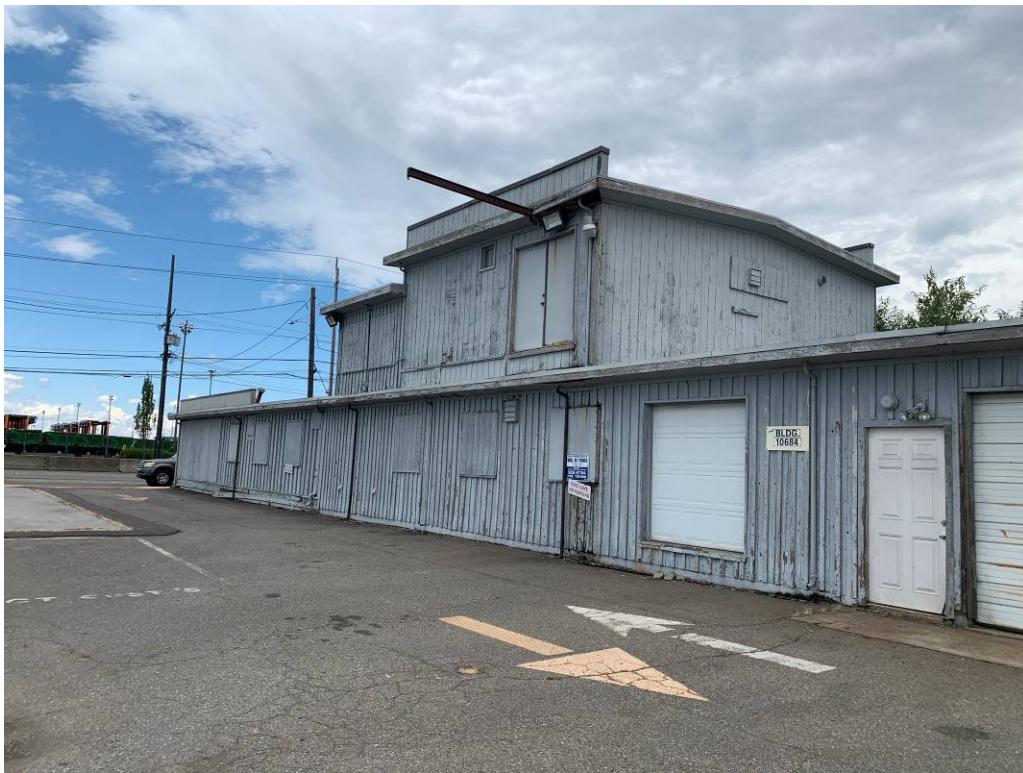
Photo 1: South side of the building facing northwest. This is the south section with 2nd floor storage and office area.

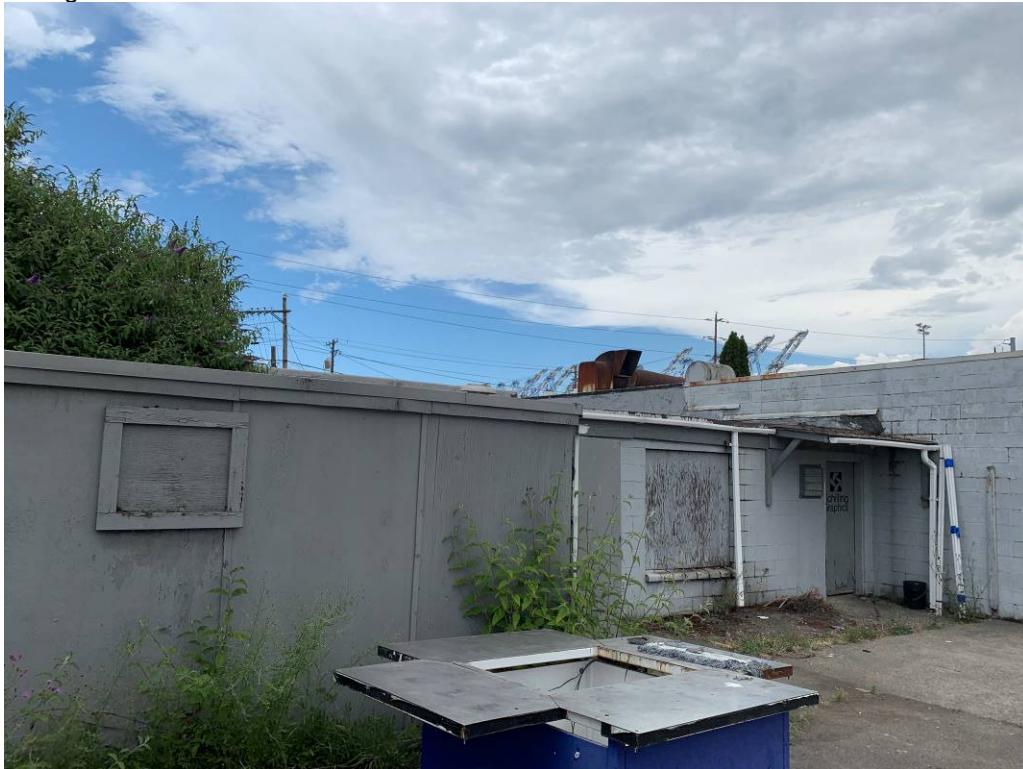
Photo 2: East side of the building facing northwest.

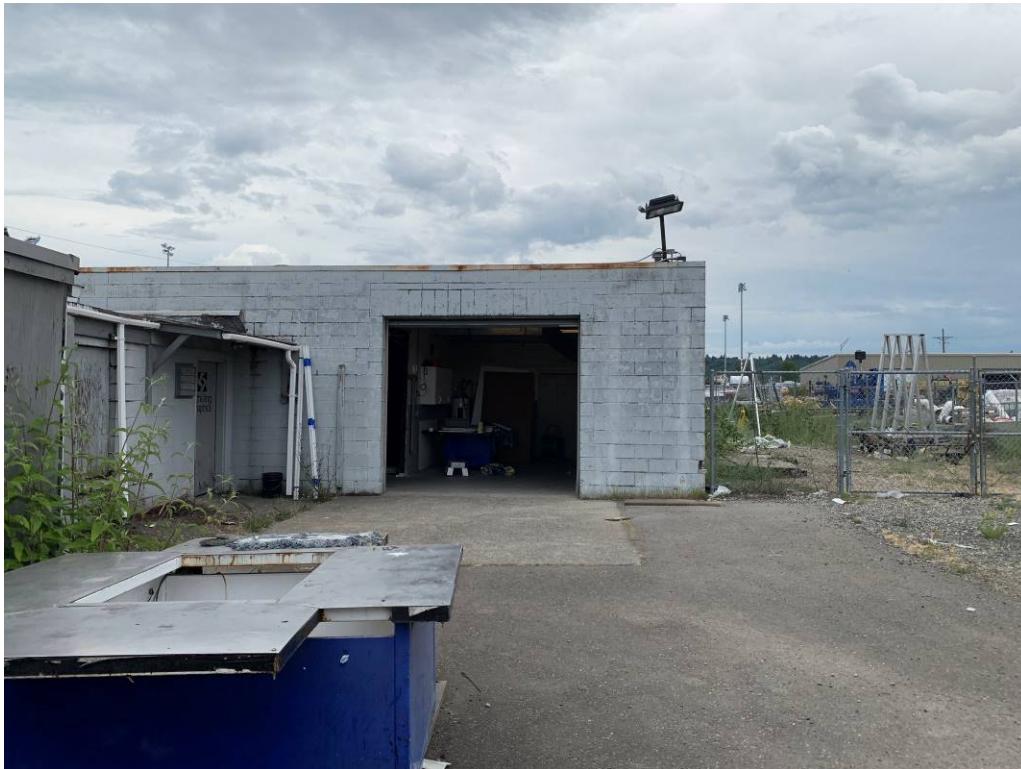
Photo 3: East side of the building facing north.

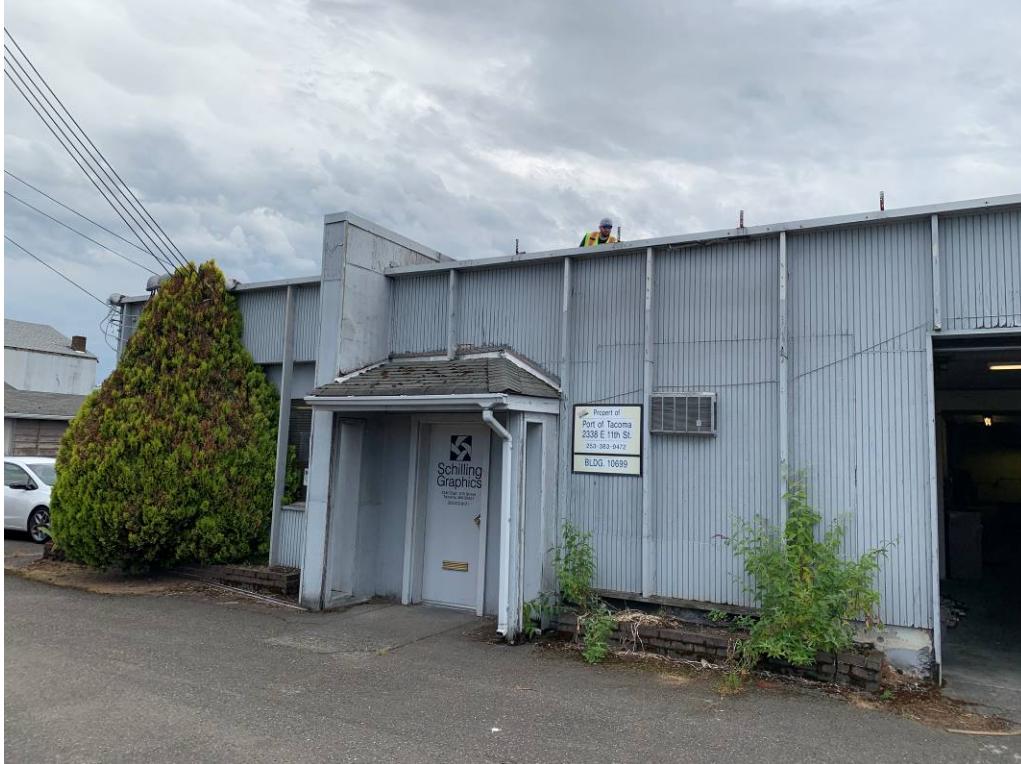
Photo 4: Main entrance to the north section.

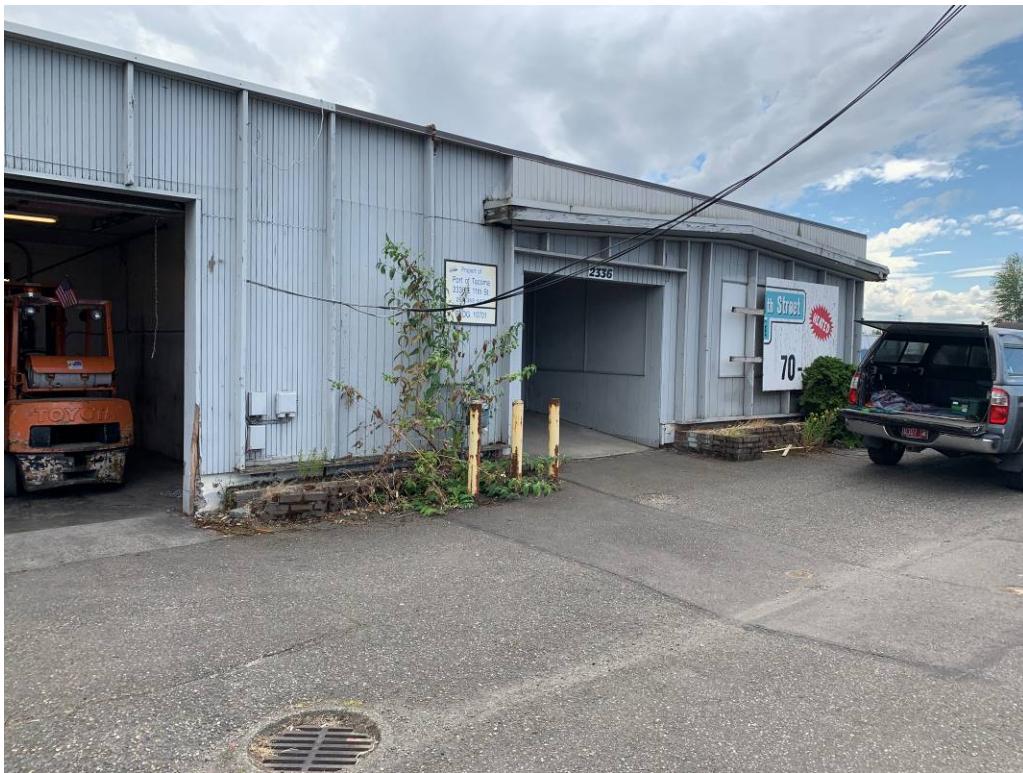
Photo 5: West side of the building facing southeast. This is the front entry to the south section.

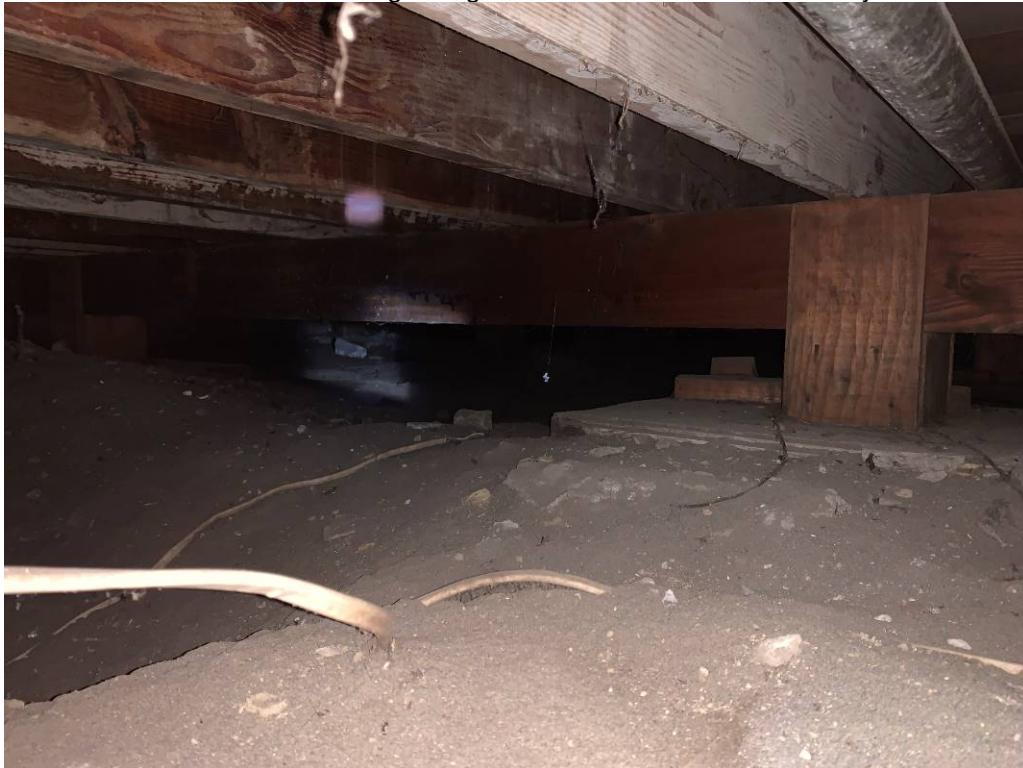
Photo 6: Typical finishes observed in the crawlspace under the south section.

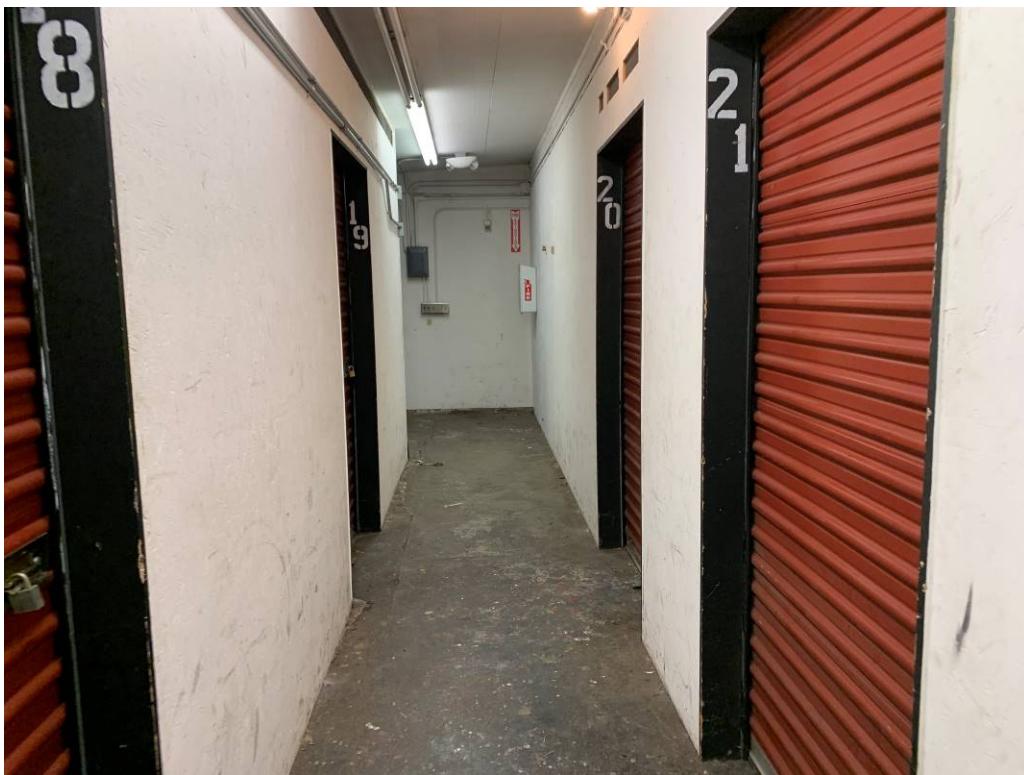
- 9-inch tan VFT and black mastic (HM-06). This material was observed on the main floor throughout most of the space. Two samples were collected and analyzed for asbestos content; this material was determined to contain 2% Chrysotile asbestos in both the tile and mastic by PLM analysis. The samples were re-analyzed by the more stringent 400 Point Count method to contain 0.50% in the floor tile and 0.25% Chrysotile in the mastic or less than 1% asbestos.

Photo 7: Typical finishes observed in the storage units. The floor tile and mastic are less than 1% asbestos.

The materials identified in **Table 3** were found to contain less than 1% Chrysotile asbestos. Materials in this report with asbestos content less than 1% will require special handling during removal and/or demolition as detailed in WRD 23.10, *Occupational Exposure to Asbestos*. A copy of this directive is available at:

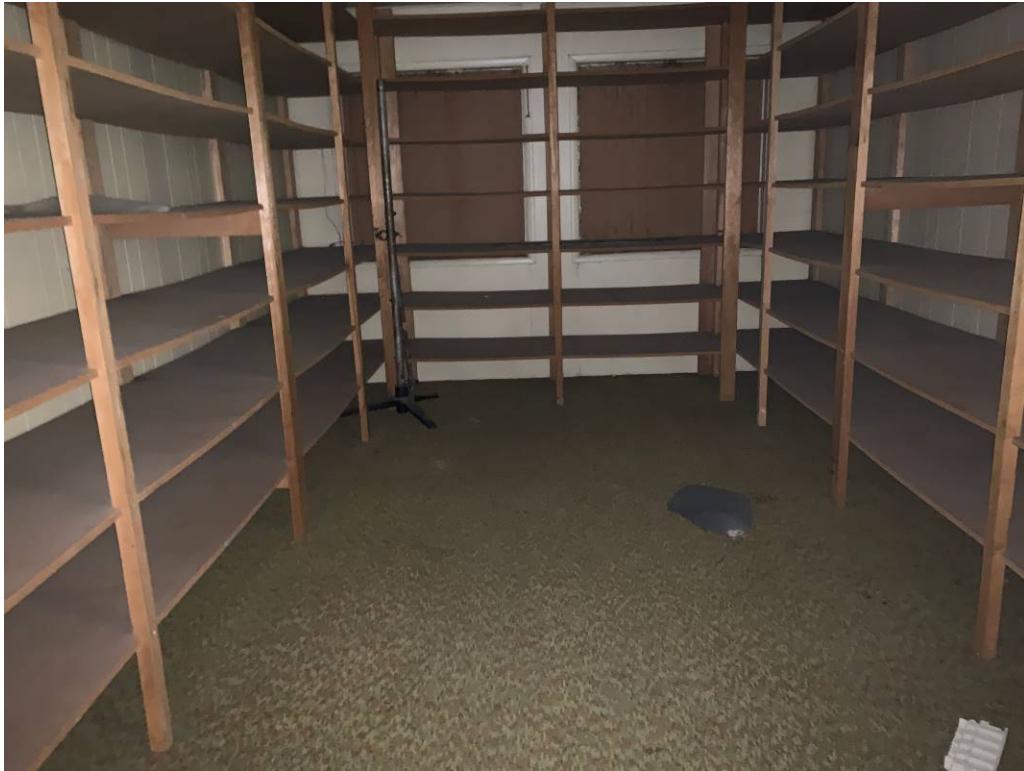
Photo 8: Typical finishes observed in the 2nd floor storage area in the south section.

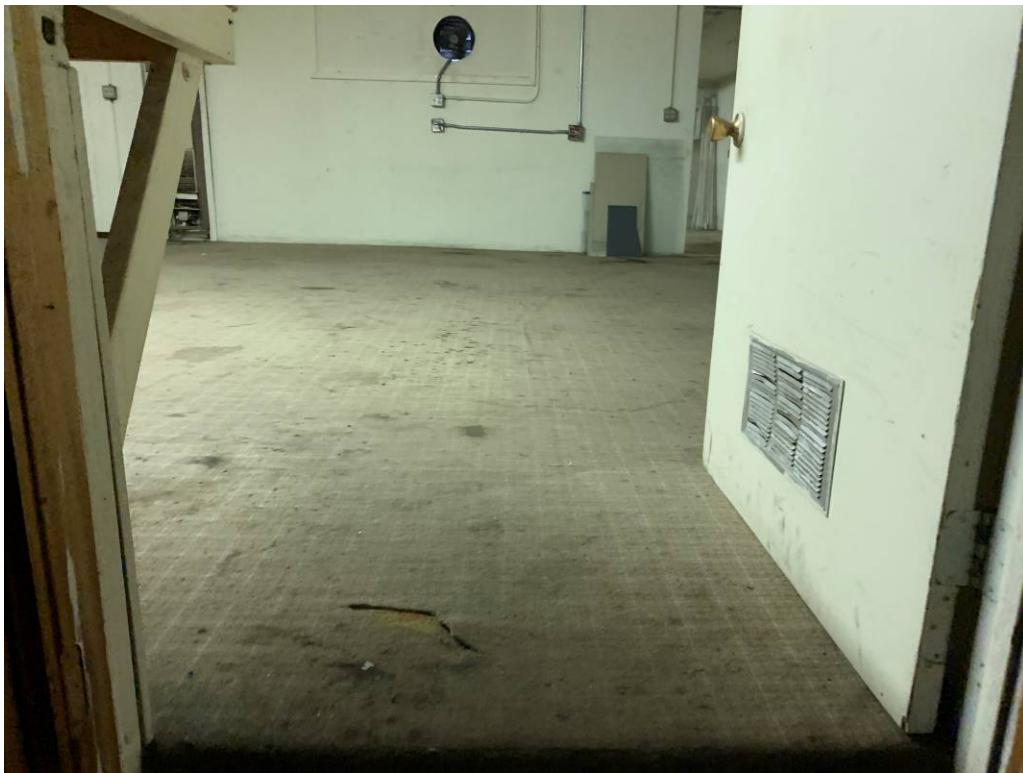
Photo 9: Typical finishes observed in the 2nd floor office area of the south section.

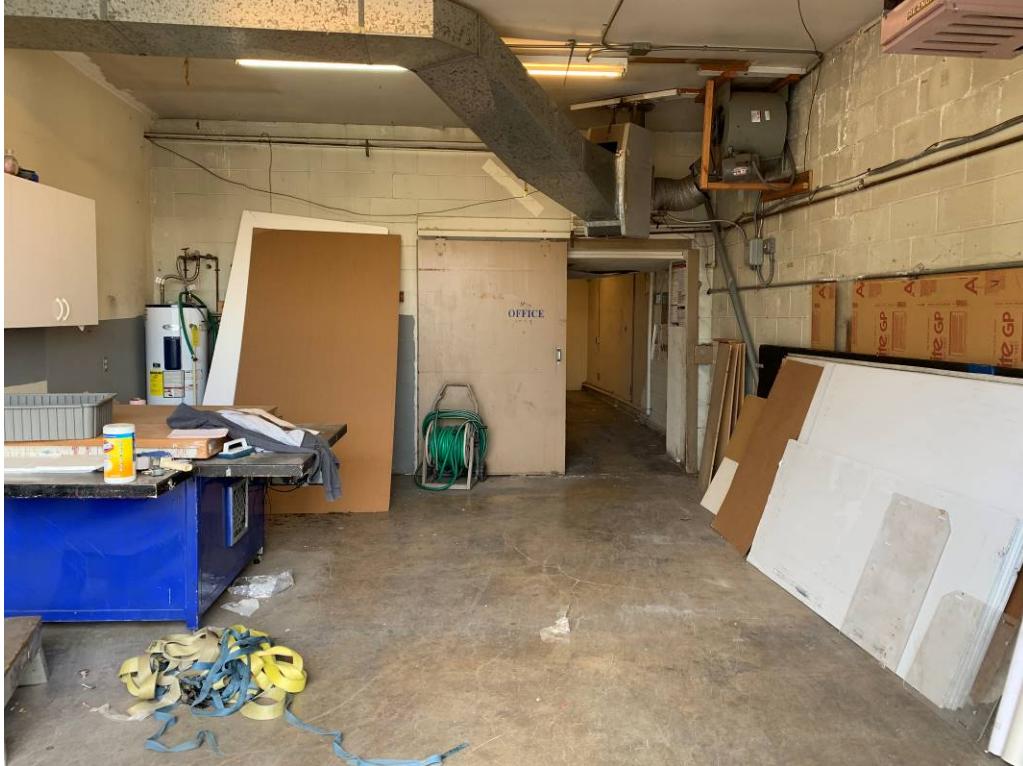
Photo 10: Shipping area in the north section.

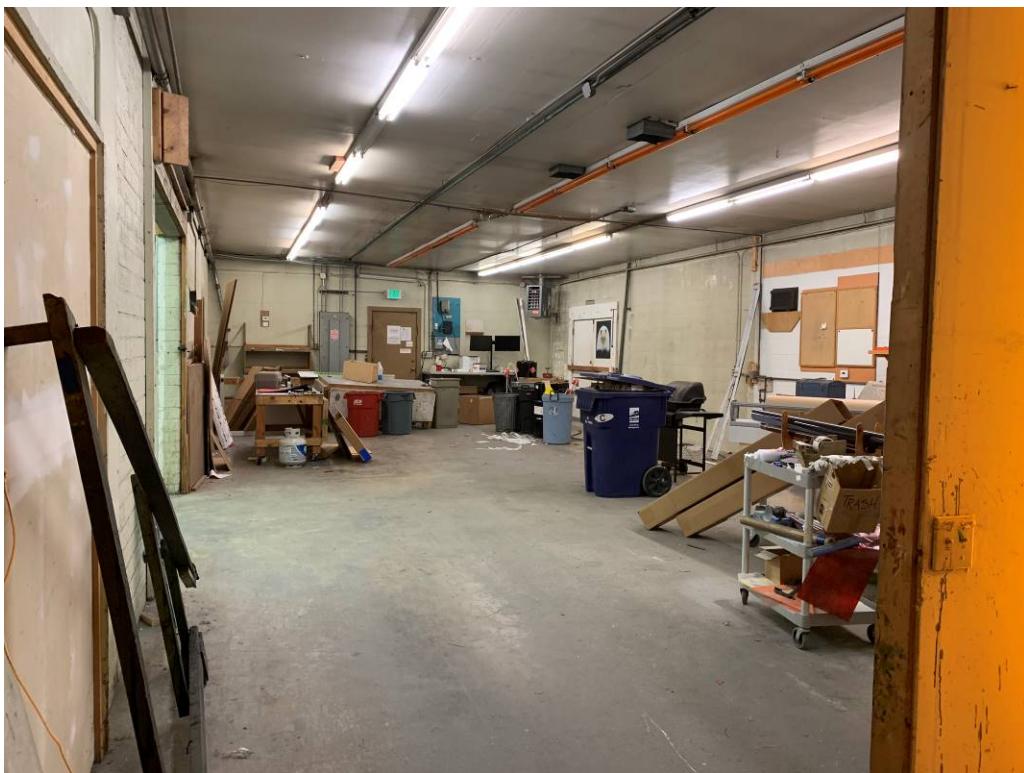
Photo 11: Typical finishes observed in the warehouse area of the north section.

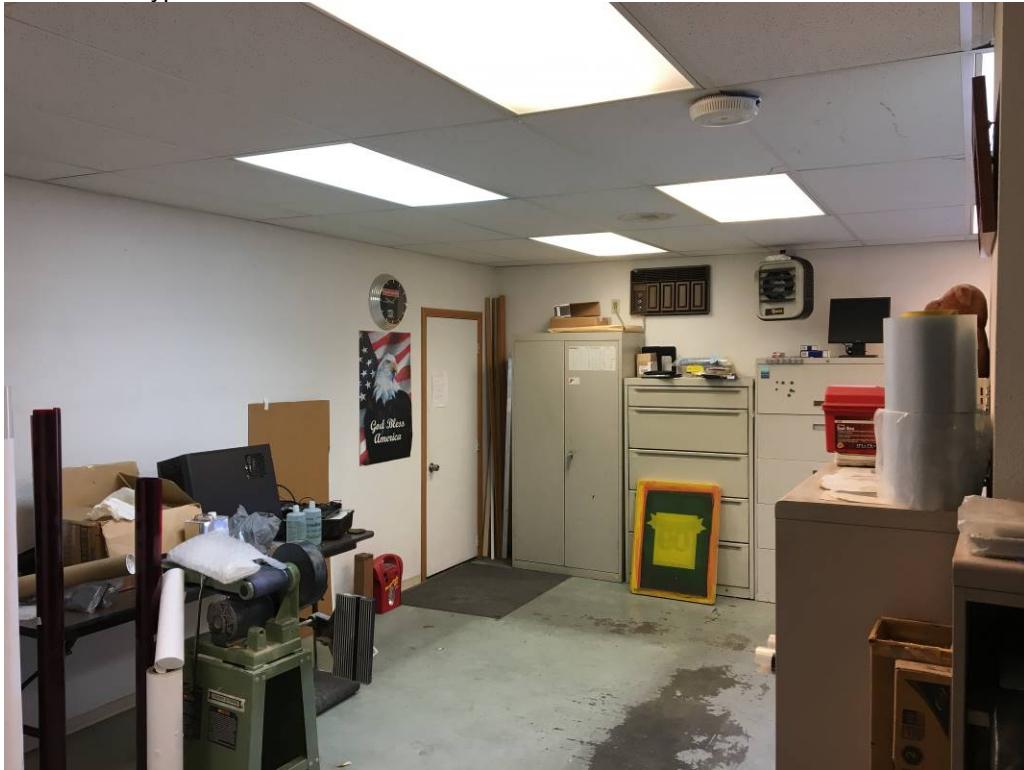
Photo 12: Typical finishes observed in the north section front office area.

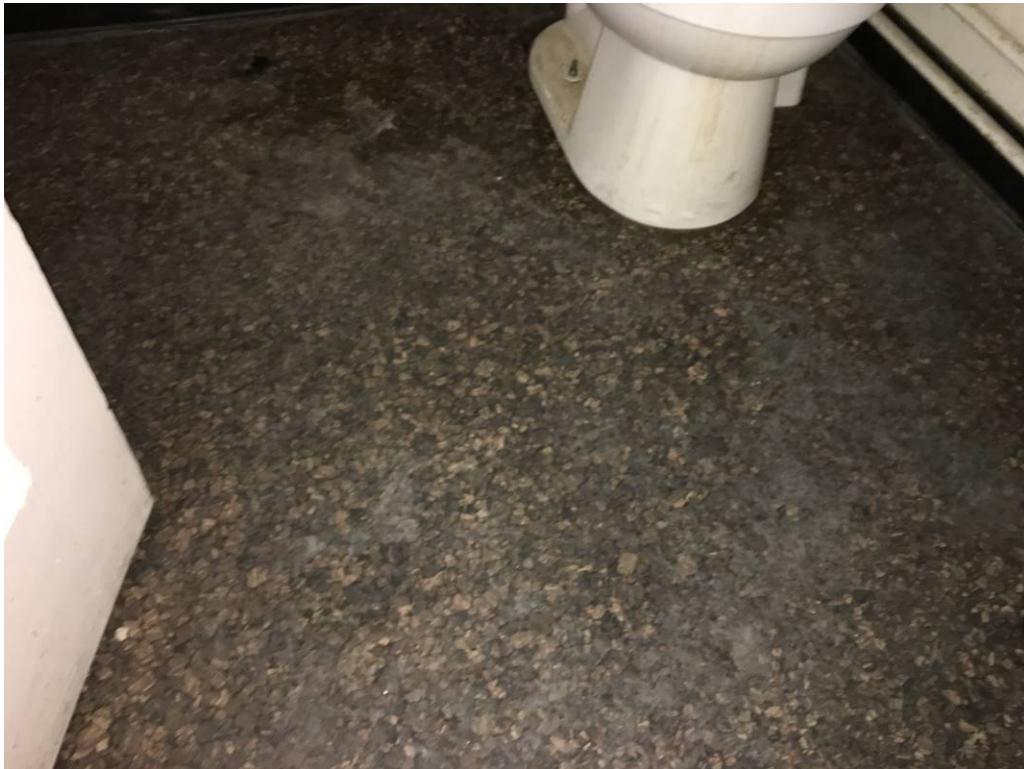
- Brown/ yellow terrazzo pattern SVF (HM-18) over off-white floor tile and mastic (HM-19). This material was identified in the office restroom and back storage area. Four samples were collected (HM-18), three were cores that included the bottom layer of off-white floor tile and mastic (HM-19). The samples were analyzed for asbestos content; **the brown/ yellow terrazzo pattern SVF (HM-18) was determined to contain 46% to 50% Chrysotile asbestos and the off-white floor tile (HM-19) was determined to contain 2% Chrysotile asbestos**. The associated floor tile mastic is negative for asbestos.

Photo 13: ACM flooring in the office restroom and storage area.

MTNW recommends, and state law requires, that all asbestos materials identified in **Table 1** be removed prior to demolition.

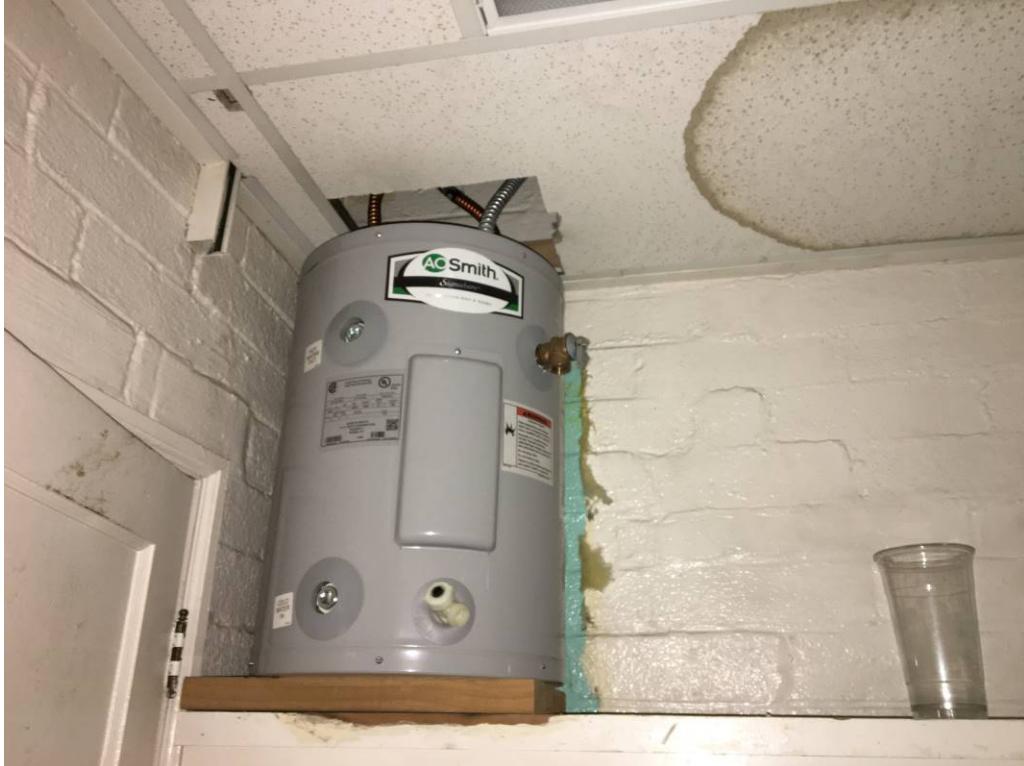
Photo 14: Hot water heater located in the office restroom.

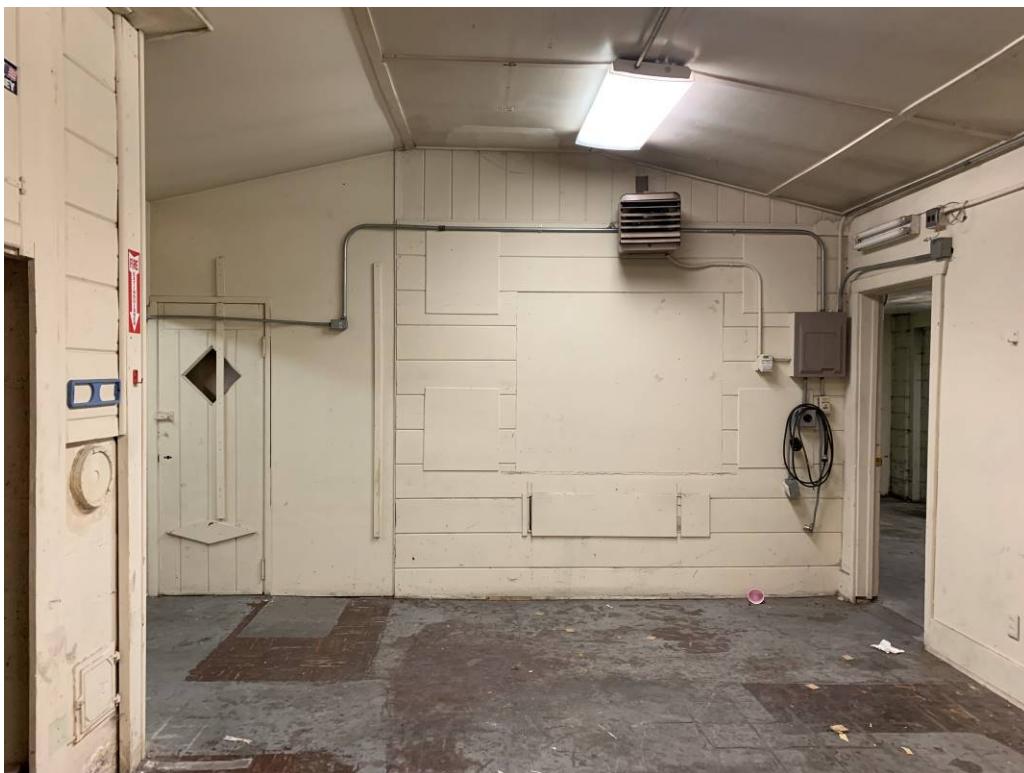
- 9-inch brown VFT and black mastic (HM-20). This material was identified in the NE section of the building. Two samples were collected and analyzed for asbestos content; **the tile was determined to contain 2% Chrysotile asbestos and the black mastic 3% Chrysotile asbestos**.

Photo 15: NE corner of the north section of the building the floor tile and mastic is ACM.

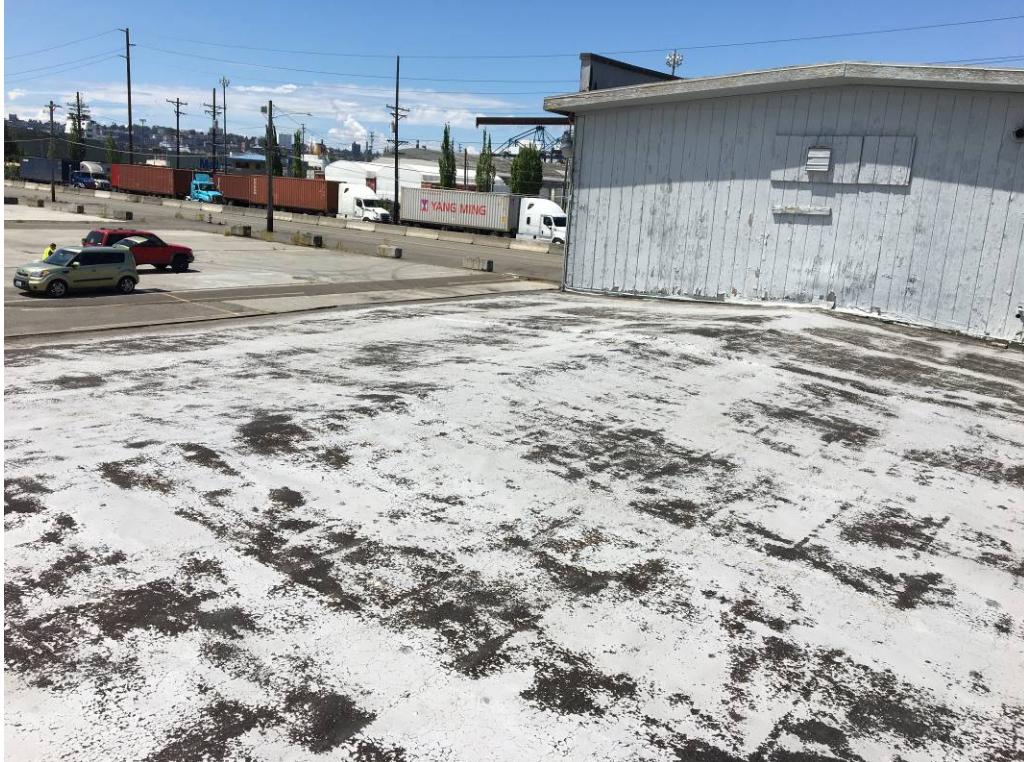
- Silver coat paint (HM-28) and built-up roofing (HM-29) cores. This material was observed on all roofs of the building. Three core samples (one from the south section, one from the center and one from the north section) and an additional 3 samples (total of 6) of just the silver coat paint were collected and analyzed for asbestos content; these materials were determined to be negative for asbestos.
- Black roof sealant (HM-30). This material was observed on the roof. Three samples were collected and analyzed for asbestos content; this material was determined to be negative for asbestos.

Photo 16: Typical finishes observed in the roofs
