# HAZARDOUS BUILDING MATERIALS SURVEY

## Demolition

Commercial Structure  
3502 Lincoln Avenue  
Tacoma, Washington

Med-Tox Northwest  
Post Office Box 1446  
Auburn, WA  
MTNW Project A-8842.1

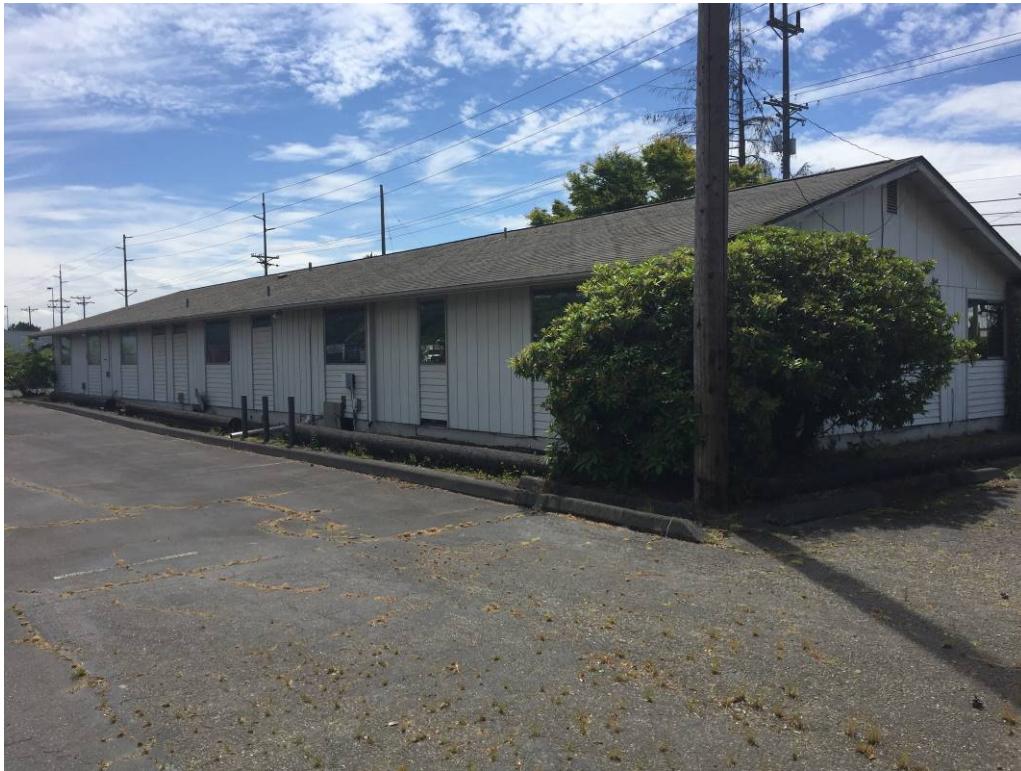
- **Cement board skirting (HM-01)**. CAB was observed around the exterior of the building and in the courtyard. Two samples were collected and analyzed for asbestos content; **this material was determined to contain 13% to 15% Chrysotile asbestos**.

Photo 3: North side of the building facing southeast. The skirting around the perimeter is CAB.

MTNW recommends, and state law requires, that all asbestos materials identified in **Table 1** be removed prior to demolition.

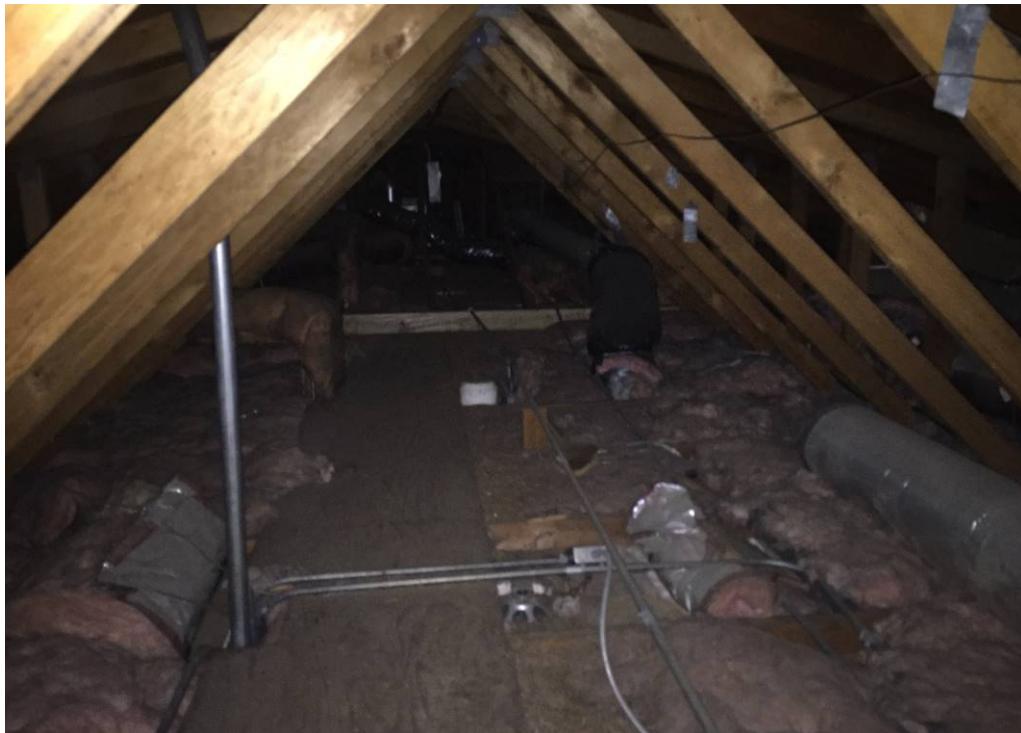
Photo 5: Attic space over the west side of the office. There were no ACM's identified in the attic spaces.

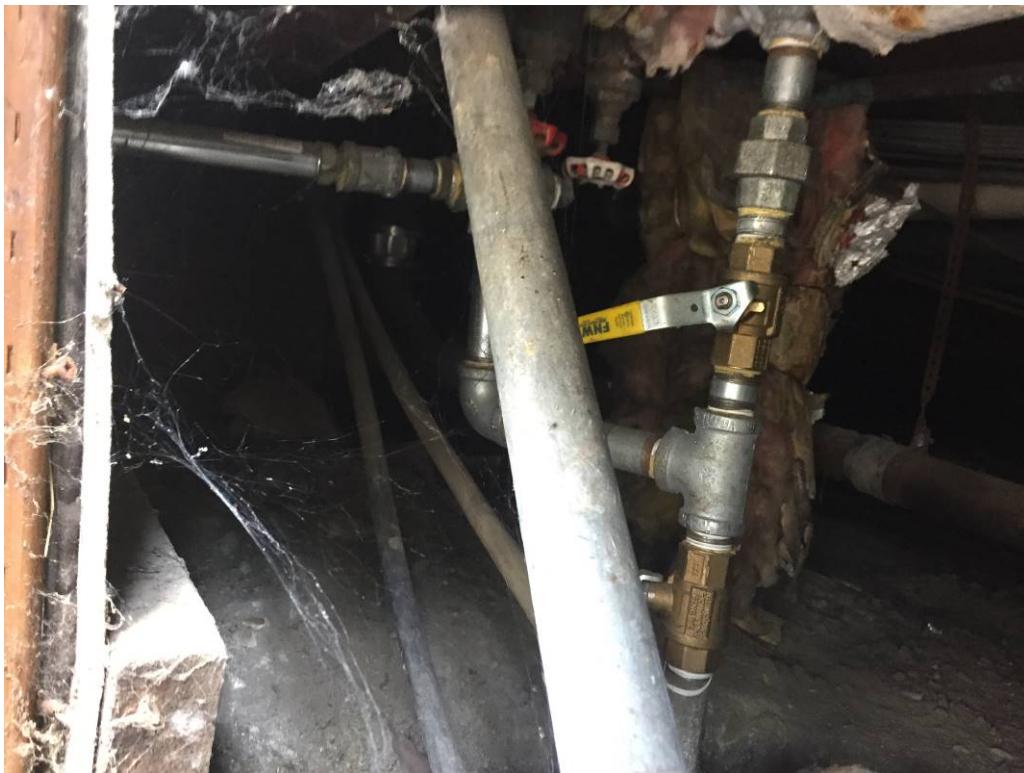
There were pipes observed in the crawlspace of the building that are insulated with fiberglass lagging and polyvinyl chlorinate (PCV) fittings over fiberglass. Visible pipes inside the building were un-insulated.

Photo 7: Pipes observed in the crawlspace. Some were insulated with fiberglass lagging.

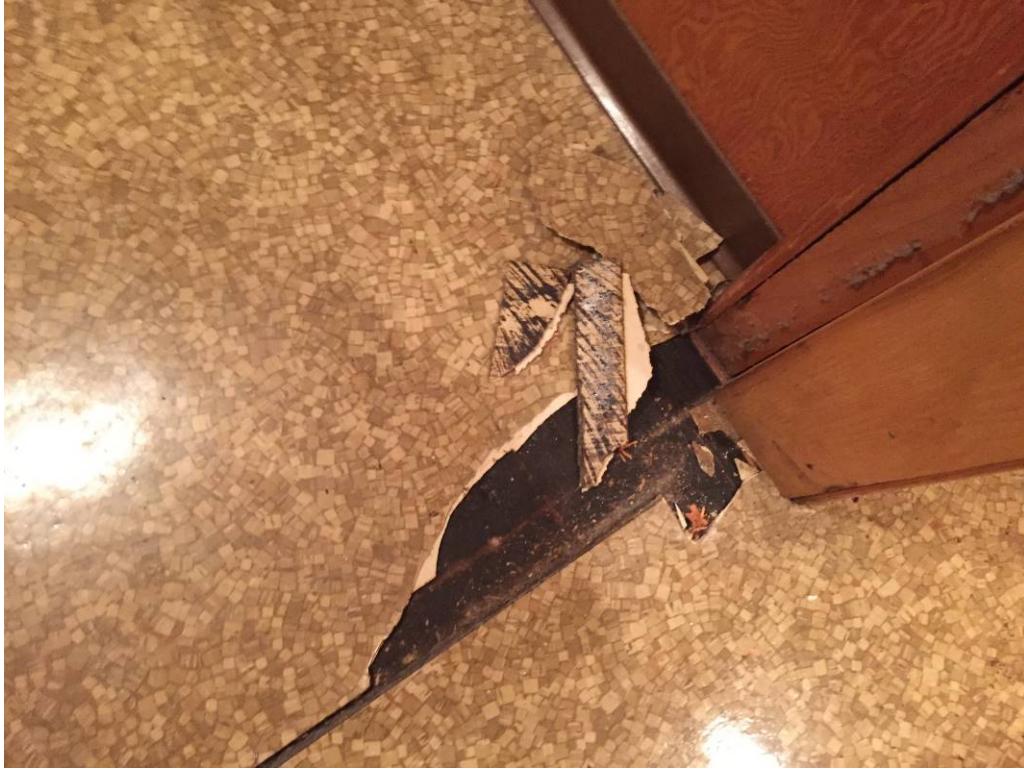
- **Brown terrazzo pattern SVF (HM-23)**. This material was identified in the restrooms (rooms 5, 6, 16, 17, 19, 20, 24 and 25). Two samples were collected and analyzed for asbestos content; **this material was determined to contain 50% to 53% Chrysotile asbestos**.

- **Brown terrazzo pattern SVF over beige floor tile and black mastic (HM-23 and HM-24)**. These two flooring materials were identified in two of the restrooms (rooms 5 and 6). Two core samples that include two additional samples of HM-23 and the bottom layer of floor tile and mastic. These cores were analyzed for asbestos content; **the layers of HM-23 were determined to contain 50% Chrysotile asbestos and the beige floor tile (HM-24) was determined to contain 2% Chrysotile asbestos**. The black mastic is negative for asbestos.

Photo 10: ACM AVF flooring and floor tile in the restrooms and closet. Rooms 16, 17, 19, 20, 24 and 25 only have ACM SVF.

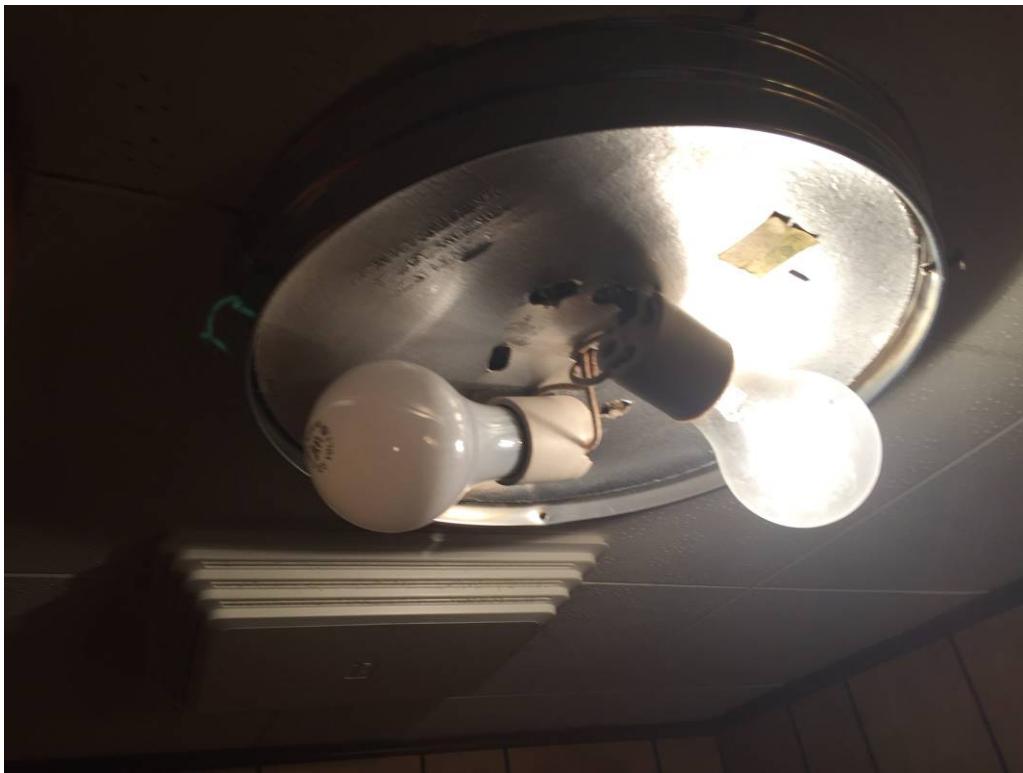
- Light heat shield (HM-13). This material was observed inside several light fixtures in the south side of the building (rooms 5 and 6). Three samples from each HM were collected and analyzed for asbestos content; **this material contain 3% to 65% Chrysotile asbestos**.

Photo 11: ACM light heat shields in restroom 5 and 6.

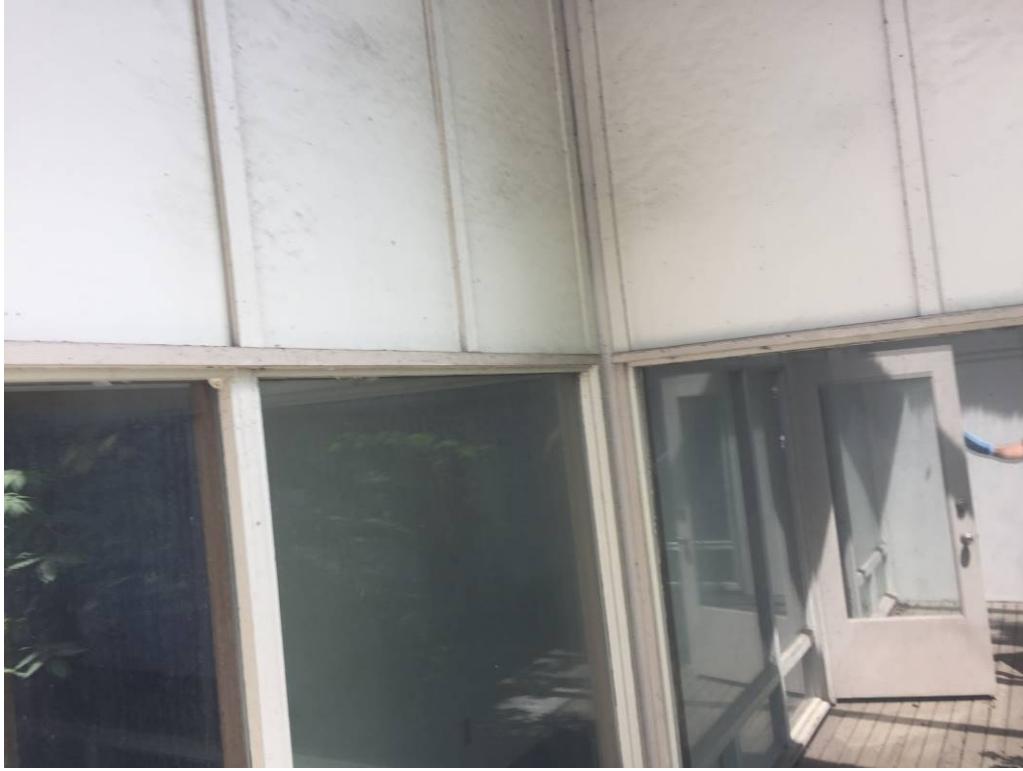
Photo 12: CAB panels in the courtyard.

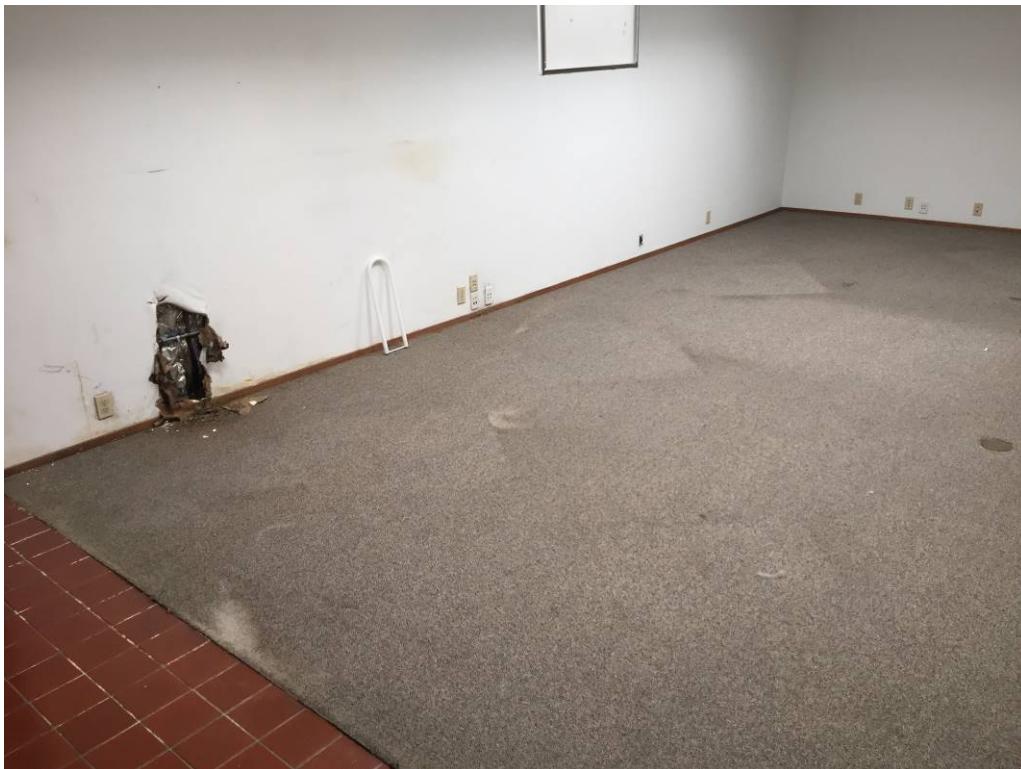
- Orange peel textured GWB system (HM-12). This material was observed throughout most of the building on the walls and ceilings. Nine samples were collected and analyzed for asbestos content; this material was determined to contain 2% Chrysotile asbestos in three samples by polarize light microscopy (PLM) analysis. The samples were re-analyzed by the more stringent 400 Point Count method to contain 0.25% to 0.50% Chrysotile or less than 1% asbestos.

Photo 13: Typical finishes observed in the office spaces. The orange peel textured GWB system was determined to contain <1% asbestos. This material is located throughout the building.

The materials identified in **Table 3** were found to contain less than 1% Chrysotile asbestos. Materials in this report with asbestos content less than 1% will require special handling during removal and/or demolition as detailed in WRD 23.10, *Occupational Exposure to Asbestos*. A copy of this directive is available at:
