October 2020
Parcel 86 Shoreline Repair Project

Conceptual Design Options Evaluation

Prepared for Port of Tacoma

Prepared by
Anchor QEA, LLC
1119 Pacific Avenue, Suite 1600
Tacoma, Washington 98402

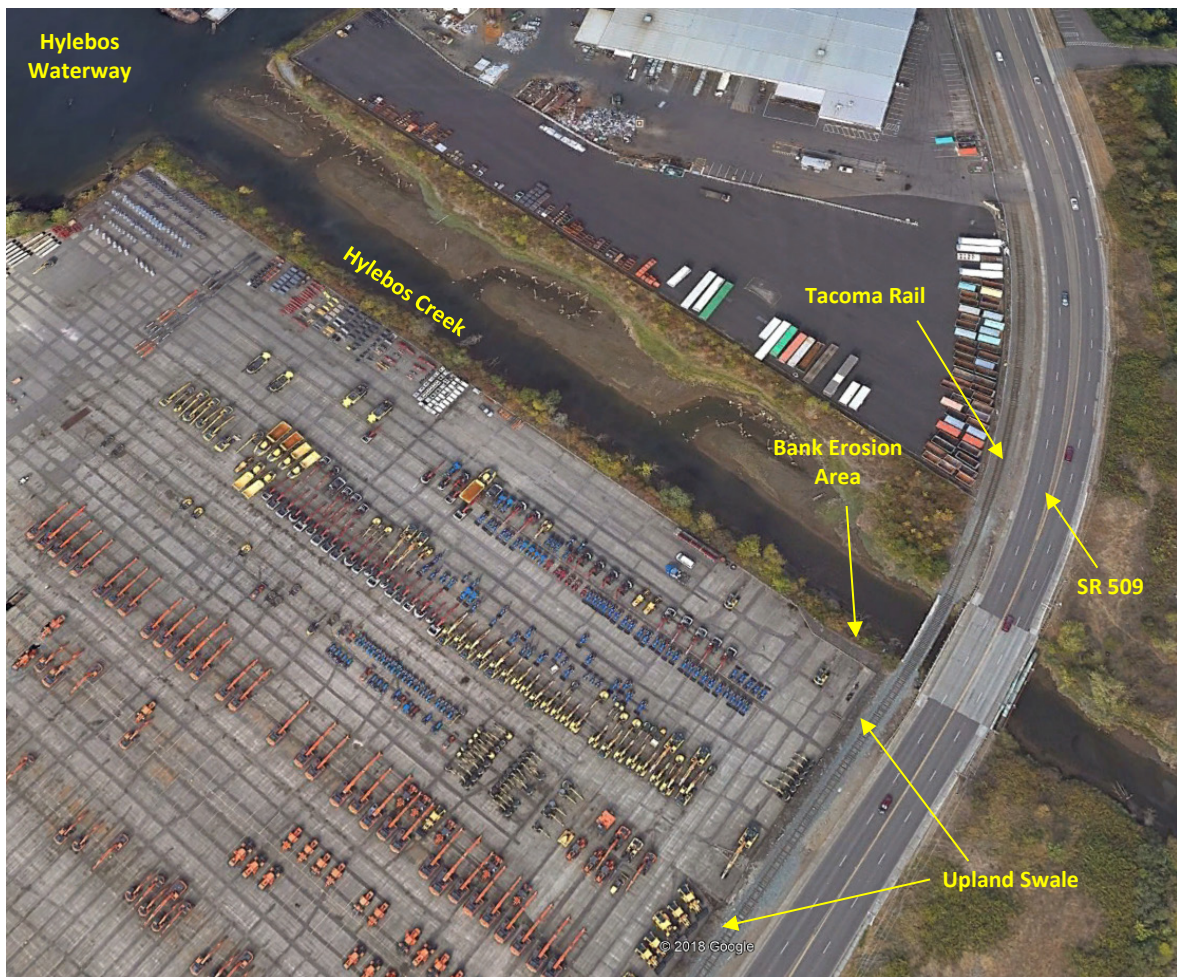
Figure 1
Overview of Parcel 86

Erosion of the shoreline bank in the southeast corner of Port of Tacoma (Port) Parcel 86, located at 3701 Taylor Way, was previously identified by the Port. This erosion has progressed landward and has exposed a manhole that is part of the Parcel 86 stormwater management system. It also threatens the integrity of the environmental cap constructed on the property. The Port contracted with Anchor QEA, LLC, to investigate the cause of the erosion and develop potential options for restoring the eroded bank. An overview of the site is provided in Figure 1.

Anchor QEA previously conducted a site visit in June 2019 to perform a visual inspection of the bank erosion and potential seep location. From the site visit, it was concluded that gravel material observed on the slope was most likely crushed bedding rock placed around the stormwater vault exposed in the upper portions of the eroded bank. It was not apparent if the bank erosion occurred due to a leak from the adjacent stormwater vaults, a groundwater seep channeled along the bedding gravel for the vault, high creek flows, or some combination of causes. There was no flow or seep visible at the time of the site visit.

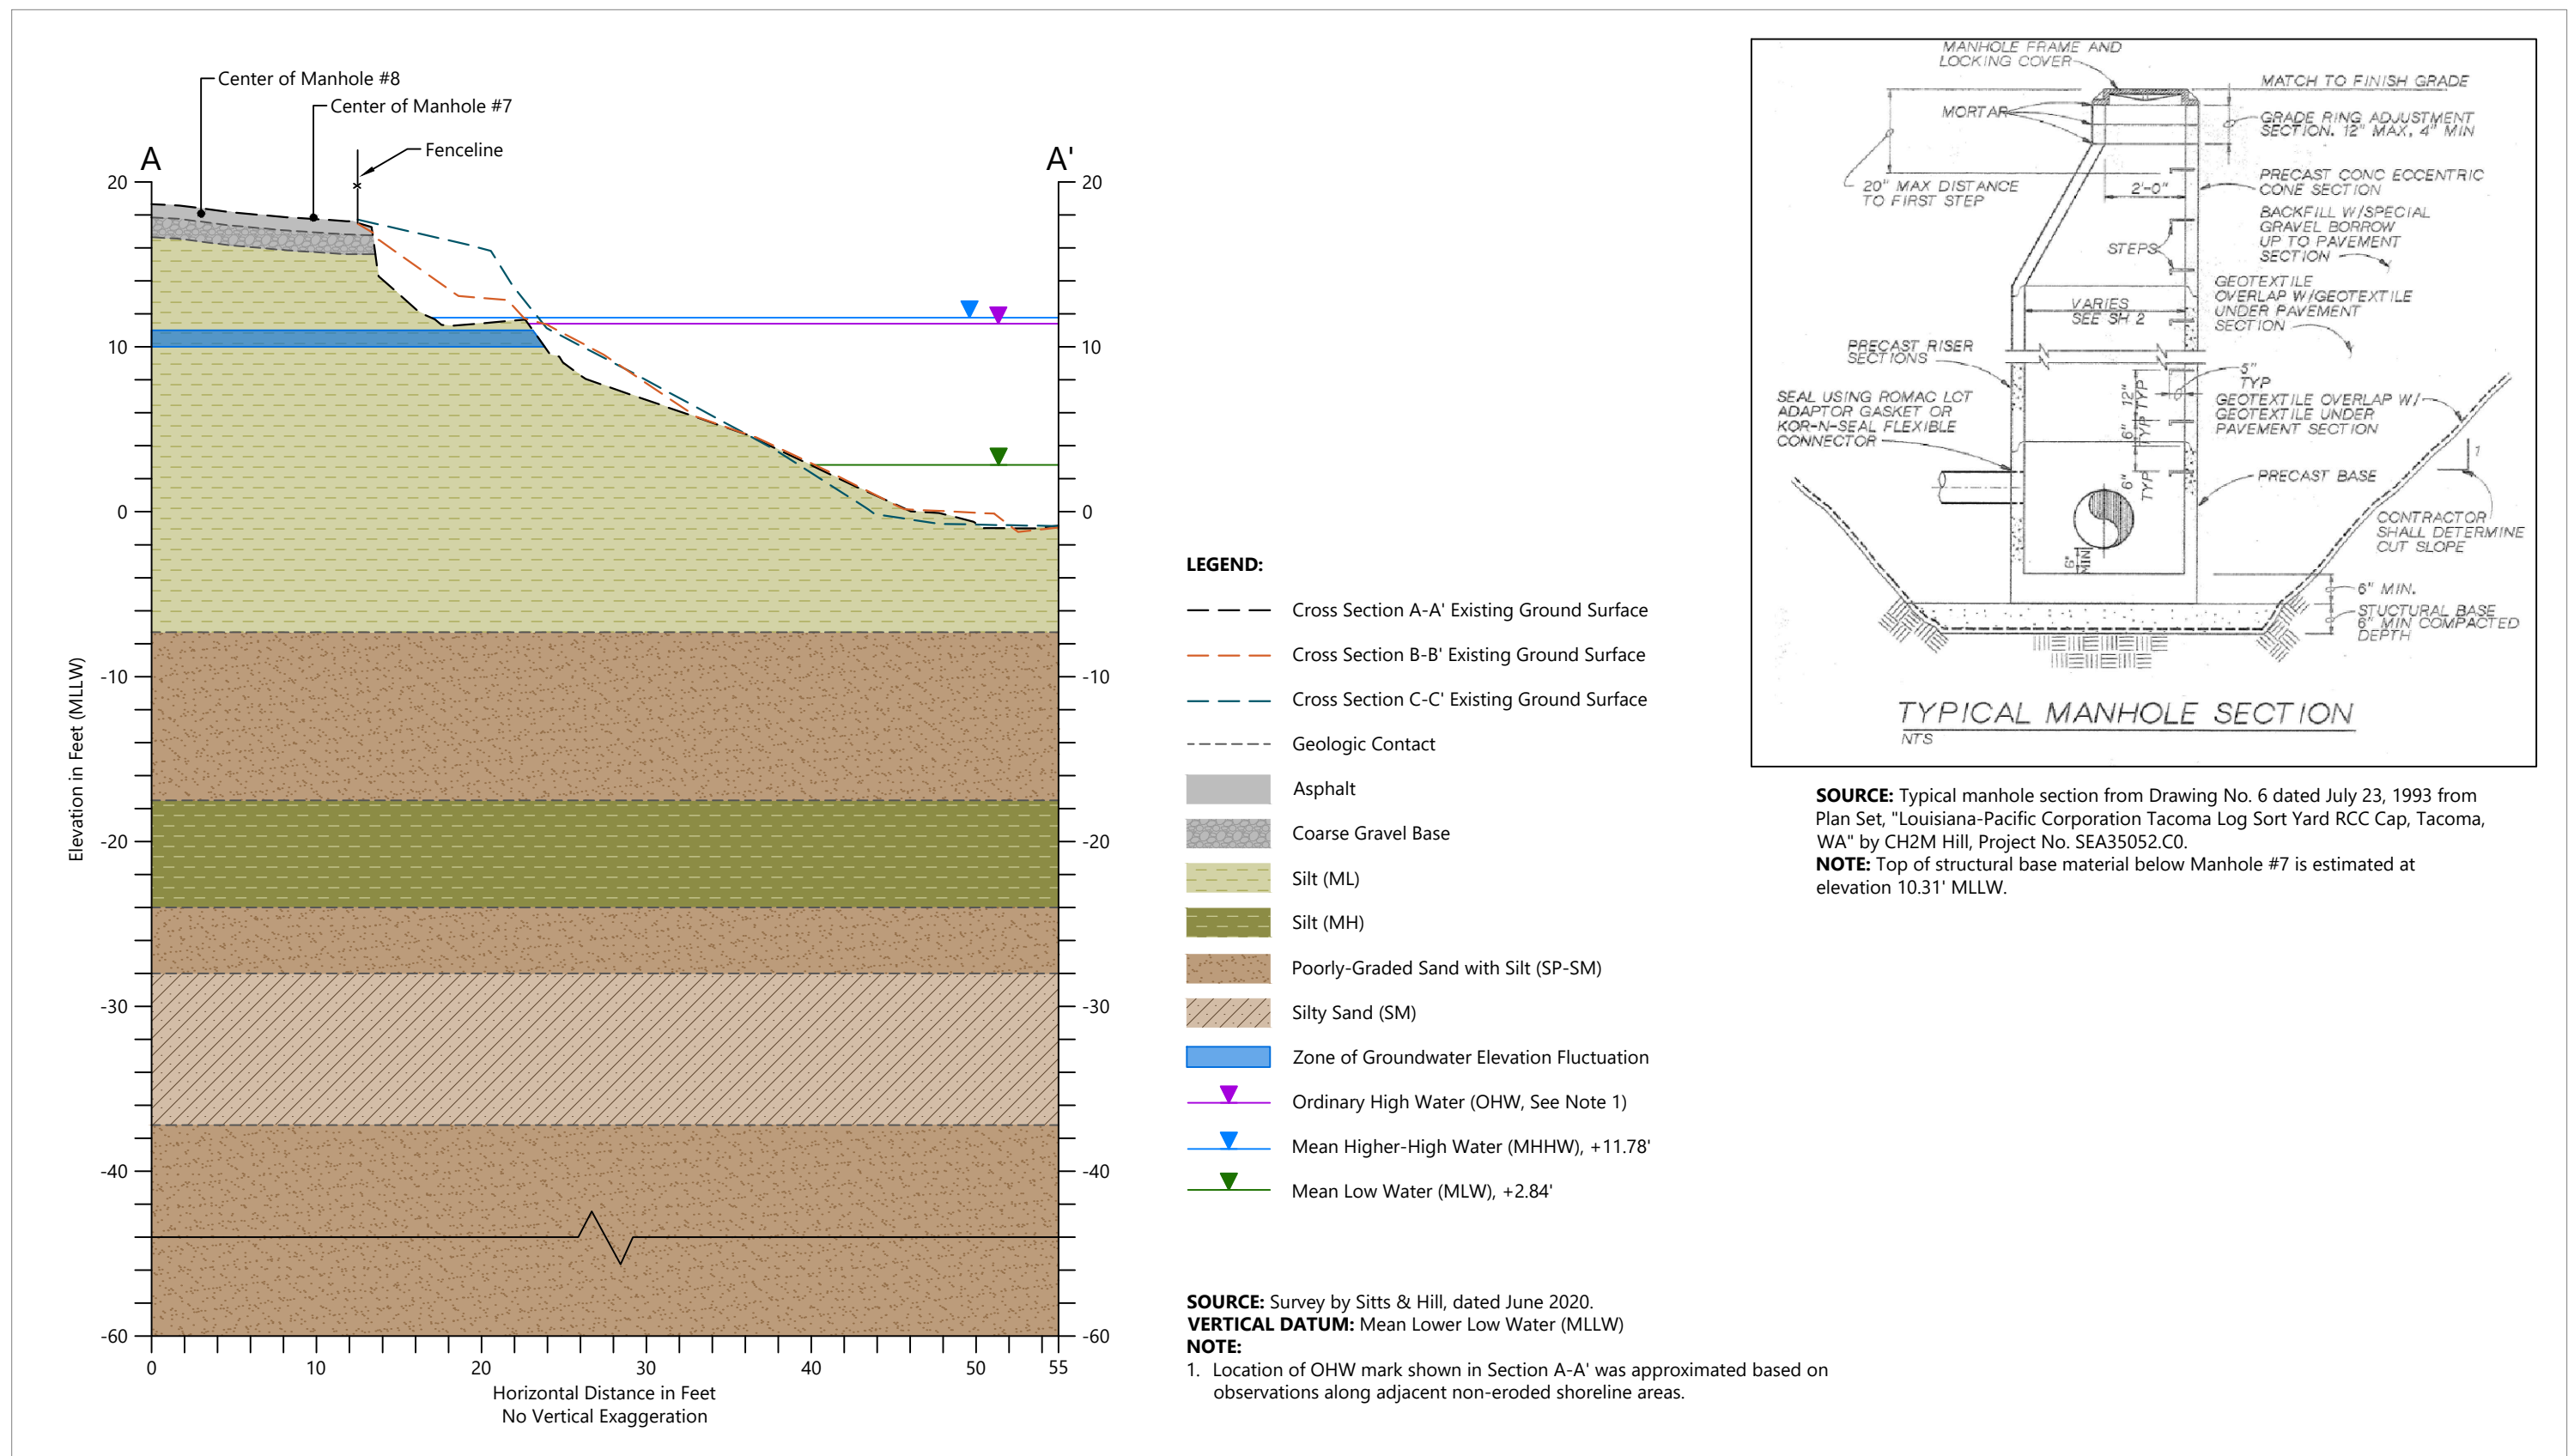
Publish Date: 2020/10/23 1:40 PM | User: tgriga
Filepath: K:\Projects\0092-Port of Tacoma\Parcel 86 Shoreline Repair Project\0092-RP-001 (Section).dwg Figure 3

Gravel Base. The asphalt is underlain by a subbase layer consisting of gravel up to 2 inches in diameter. The gravel also underlies the foundations of the manholes and other components of the stormwater system. Adjacent to the bank of the Hylebos Waterway, this material extends approximately to elevation 10.1 feet MLLW at MH7 and is exposed along the creek bank (refer to typical detail in Figure 3).

Based on our assessment of the bank slope (Figure 3), we do not believe that hydrodynamic forces that act on the bank during tidal exchange are a significant source of the observed erosion. The topography of the slopes west of the main erosion area (i.e., represented by Section A-A') is fairly consistent below the mean higher high water elevation and continues westward along the creek. This indicates that the creek bank is stable outside of the influence of the concentrated groundwater seep.

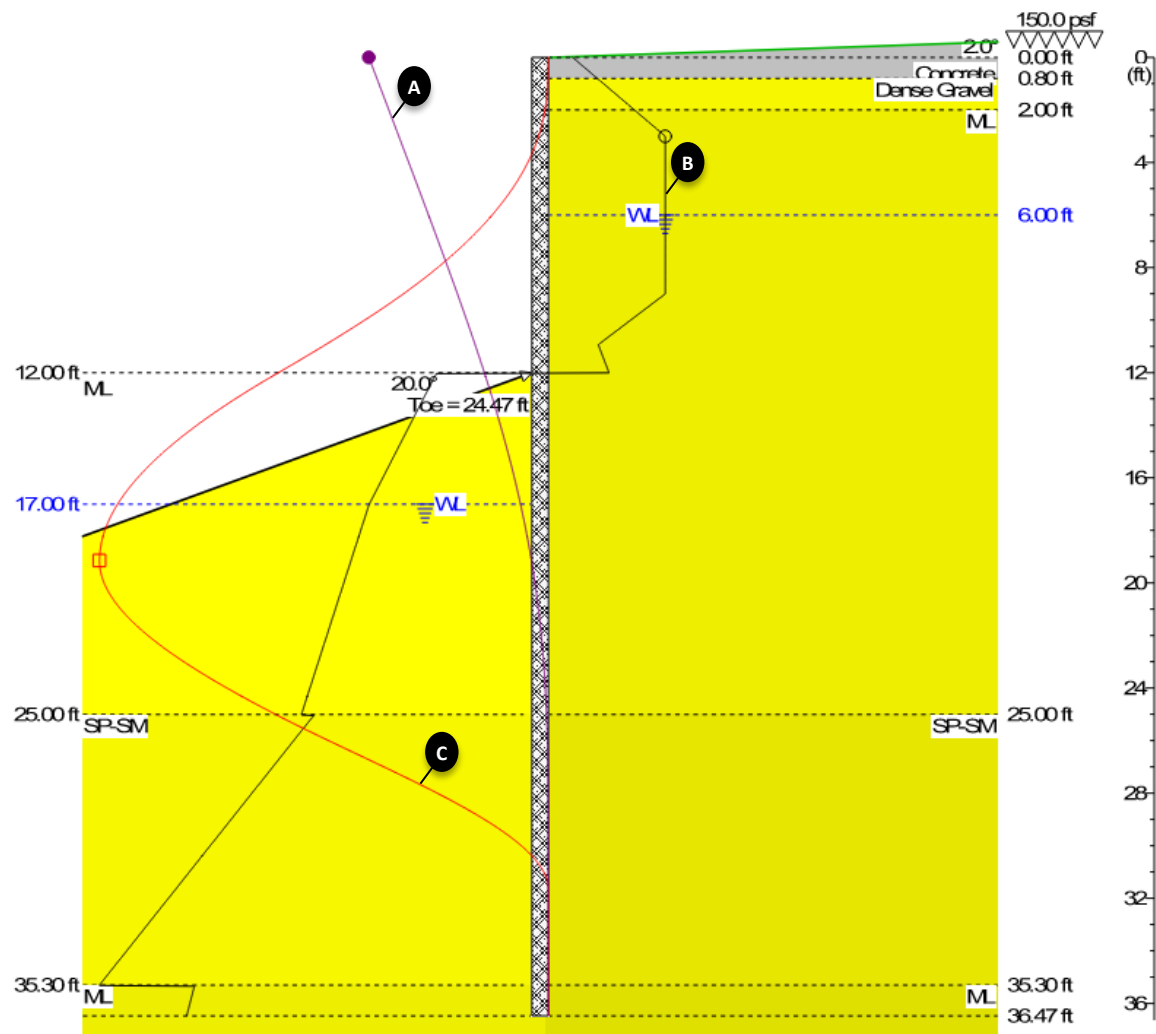
Figure 4
Conceptual Design Section for Sheet Pile Wall at Section A-A'

| Evaluated Section | Approximate Length of Segment along Alignment | Preliminary Sheet Depth (bgs) | Notes about Slope Condition at Cross-Section |
|--|---|---|--|
| Section A-A' | 10 feet | 35–40 feet | Shoreline is not stable and significant erosion has occurred. Multiple groundwater seeps are observed and gravel base layer around and below the stormwater system provides continuous flow path. Erosion will continue until remedy is constructed. |

structural solutions (e.g., the use of a thicker gauge sheet pile section) to mitigate the deflection along Section A-A' will be evaluated during intermediate design to confirm there are no other cost-effective options that maybe used in lieu of a box pile configuration.

1. The graphic depicts the conceptual design section for a box configuration sheet pile wall segment that would be installed along Section A-A' to a depth of approximately 35 to 40 feet bgs. The section was modeled using SupportIT retaining wall design software developed by GTSOFT Limited.
2. The three lines (labeled A, B, and C) represent the following model output (not to scale):
 - A. The shape deflection (horizontal displacement) of the sheet pile) that will occur over time.
 - B. The active/driving (the right) and passive/resisting (the left) earth pressures that are exerted on the wall.
 - C. The bending moment diagram.
