Pacific Accessory Corporation

## Radio Replacement Interface for Select Mazda Vehicles with Bose Sound Systems

### Tech Brief

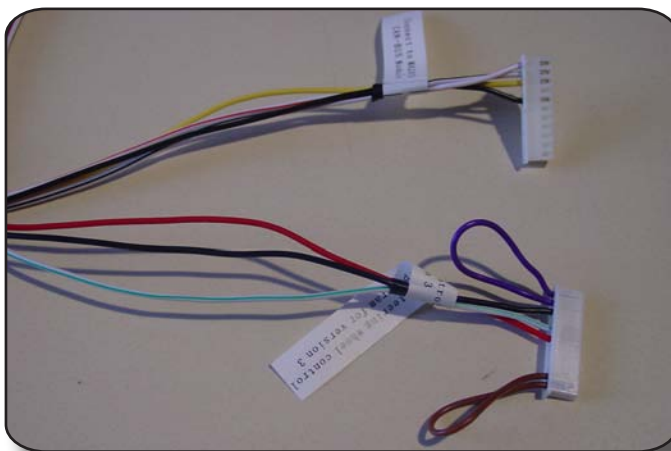
There may be an occasion where a wire is missing in the harness. This wire being missing will cause the amplifier in the vehicle to not turn on. This can be easily fixed, in field, by the installer. The first picture below is of an affected harness. There should be a blue/white wire connecting pin 1 of the top connector to the red wire on the second connector.
