**THURSTON COUNTY**  
**FACILITY CONDITION ASSESSMENT**  
**FINAL REPORT**  
**MAY 27, 2016**

## I. EXECUTIVE SUMMARY

Thurston County engaged MENG Analysis to conduct Facility Condition Assessments (FCAs) of 21 County owned, operated, and managed facilities. This report includes both summary and detailed results of that assessment.

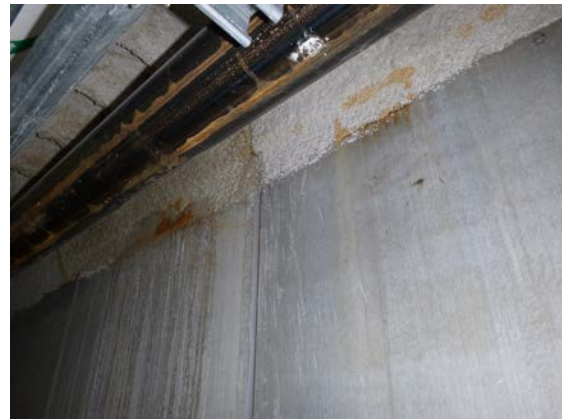
Surveyors identified substandard roofing detailing for flashing systems and downspouts shows signs of additional water leaks at the exterior. Although the report scores these problems in overall scores of subsystems, we recommend additional review by building envelop specialist to make recommendations for long-lasting, corrective action to lengthen the subsystems life expectancy. In isolated locations, the water leaks are prematurely affecting the building structural elements.

*\*Photo from midpoint of ARC Mezzanine showing rusting near repaired leak area.*

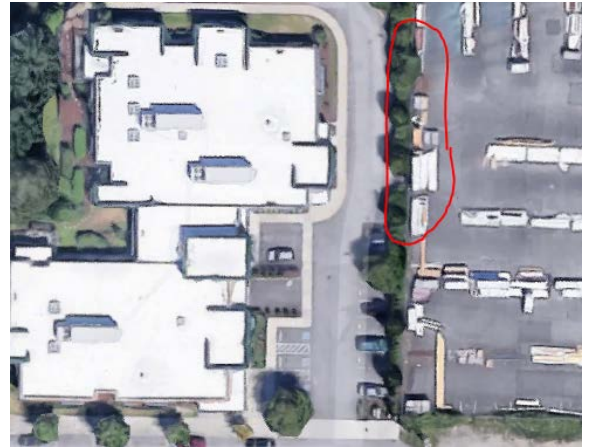
**Evaluation and Treatment Building** At the site parking adjacent to the neighboring lumber yard, it appears that storm water drains runs off that property and onto Thurston County property. We recommend code review for treatment of water runoff for additional considerations and mitigation.

*\*Area circled in red shows approximate location where water runoff is coming from adjacent property at the Evaluation and Treatment Building.*

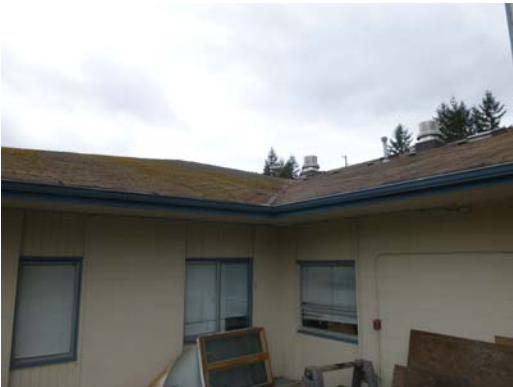
Roofing composition shingles aged and deteriorated. Remove and replace with new roofing.

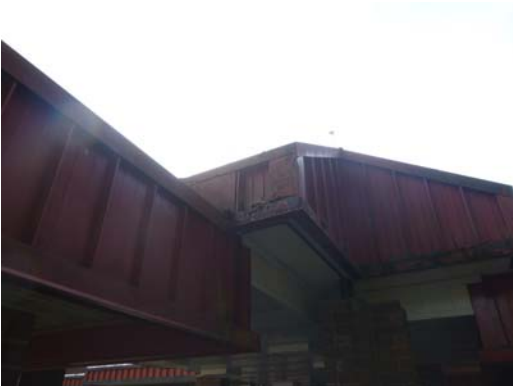
Material	Cond.	Material Useful Life	Survey Year	Condition Notes	Qty	Unit Cost	Unit	Direct Constr. Cost	Marked Up Cost
Deficiency				Action					
Facility: Thurston County Courthouse Building #1					Total System Deficiency Repair Cost (Undiscounted/Unescalated):				\$140,250
System: Roofing					Total System Deficiency Repair Cost (Marked Up):				\$341,859
Projections									
Covered walks	4	3	2016		70	\$375.00	LF	\$26,250	\$63,984
Covered walks wood framing exposed, metal roofing poor condition, soffits cracked.				Replace roofing, replace damaged soffit, paint exposed wood.
