1 FIRST FLOOR REFERENCE PLAN
1/16" = 1'-0"

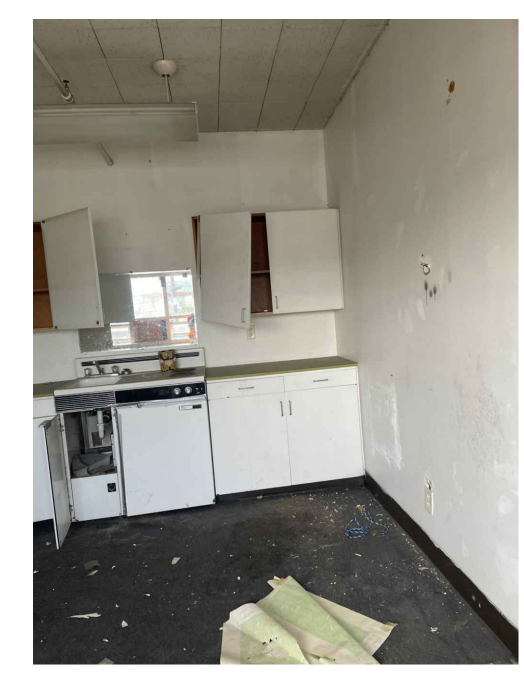
PHOTO 1

ASBESTOS-CONTAINING BLACK MASTIC UNDER CARPET (SEE PHOTO 1)
-

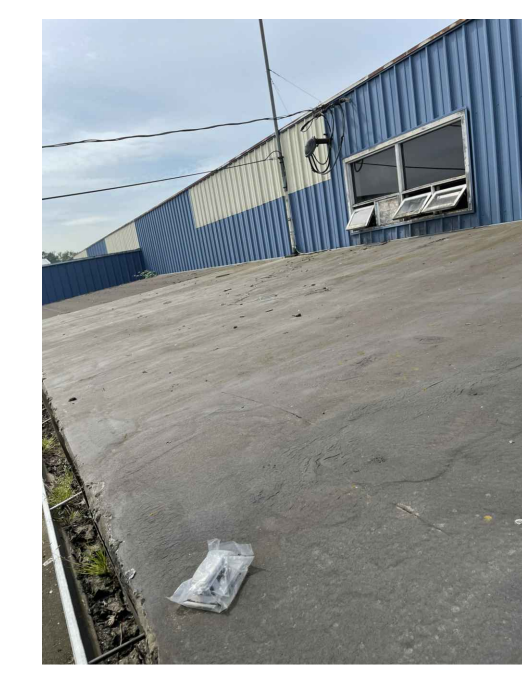
PHOTO 2

ASBESTOS-CONTAINING BLACK SEALANT (SEE NOTE 6)* (SEE PHOTO 2)
-

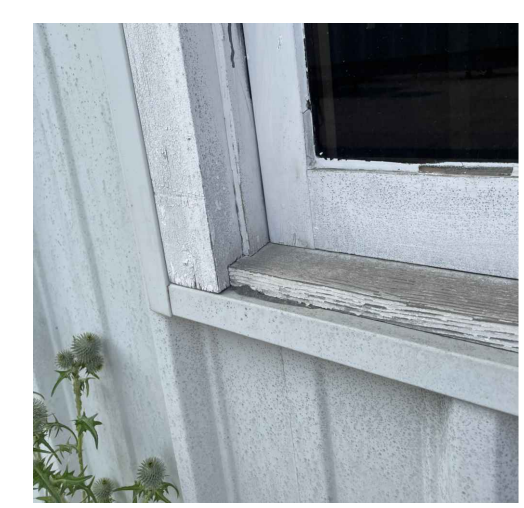
PHOTO 3

ASBESTOS-CONTAINING WINDOW PUTTY (SEE PHOTO 3)

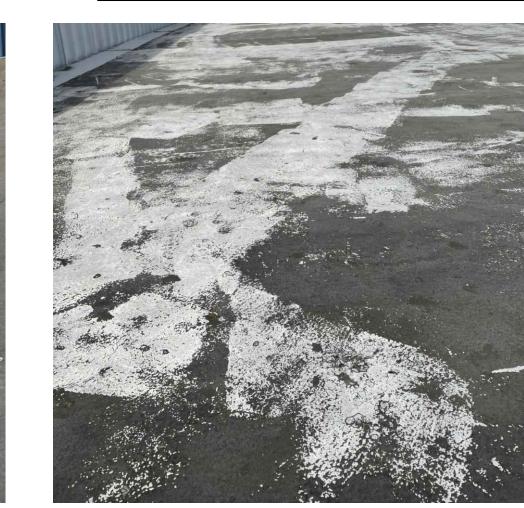
PHOTO 5

ASBESTOS-CONTAINING BUILT-UP ROOFING (SEE PHOTO 5)
-

ASBESTOS-CONTAINING SILVER COAT (SEE PHOTO 5)
-
