# Highway 17 Laurel Wildlife Crossing Study 2023-2024

Prepared by Tanya Diamond & Ahíga Sandoval  
Pathways for Wildlife

For the Land Trust of Santa Cruz County,  
the California Department of Transportation, and the  
Wildlife Conservation Network

April 2024

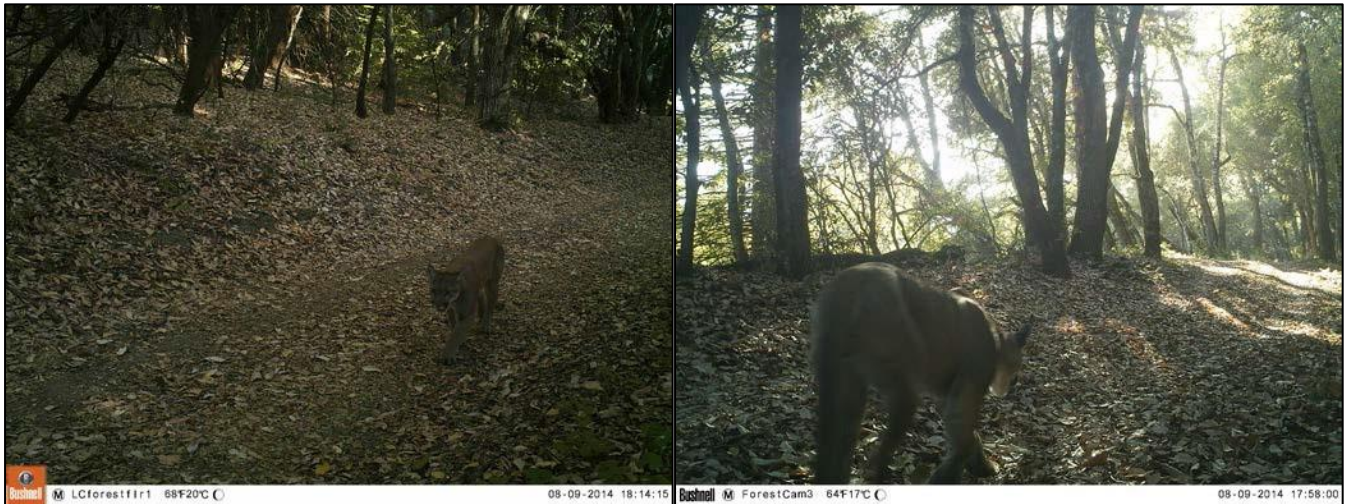
Figures 2 and 3. Male mountain lion traveling toward the east side of the highway on 8/9/2014.

Extensive camera arrays were set up on both the west and east sides of the highway to document wildlife traveling through the properties and locations approaching the highway. Over ten individual mountain lions, including females with kittens and males, were recorded on both sides of the highway. From June 2014 to October 2014, an adult male mountain lion was consistently recorded traveling from Soquel Creek on the southeastern end of the property up to Highway 17 and then back down to Soquel Creek. This mountain lion was recorded along the array of camera stations leading up to Highway 17 (Figures 2 and 3).

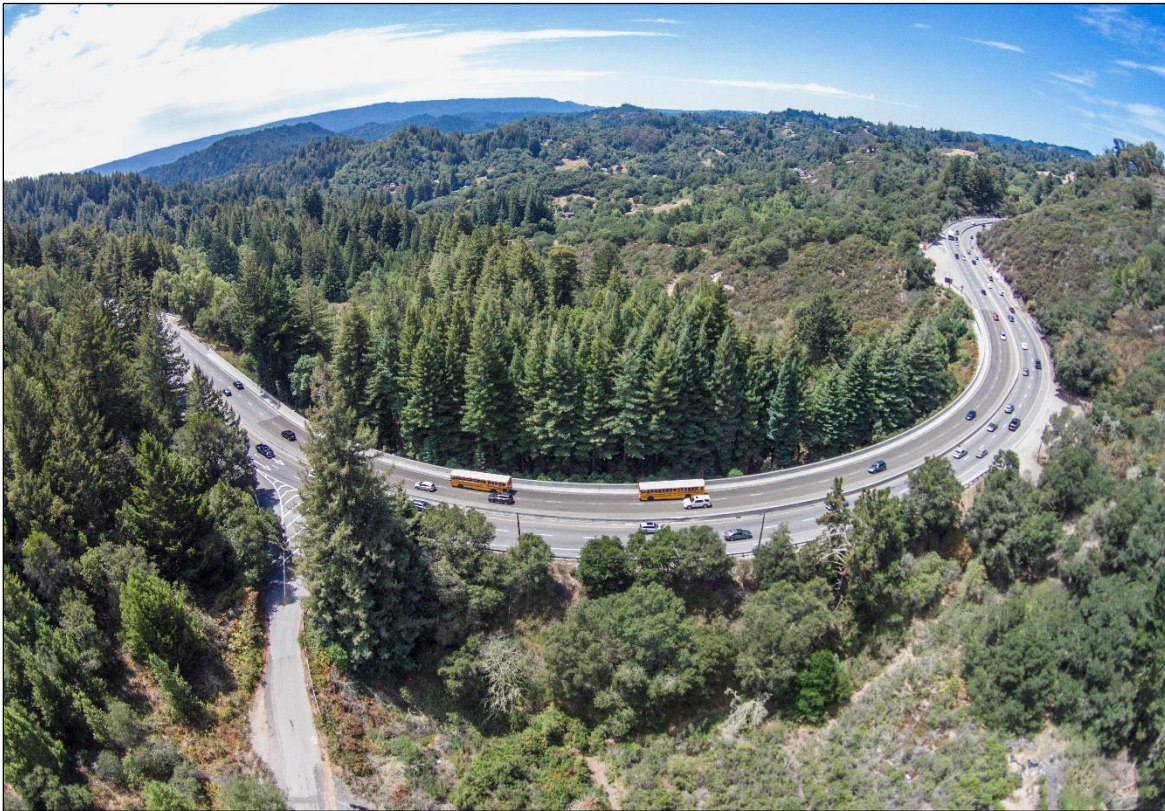
Figure 5. Laurel Curve on Highway 17. Photo credit Steve Mandel.

Laurel Curve at Highway 17 consists of a 4-lane highway, with two southbound lanes and two northbound lanes (Figure 5). Laurel Curve is 3.25 miles north of Scotts Valley (Figure 6). In 2012, Caltrans installed median barriers at this particularly treacherous piece of the road. This effort to increase safety for people, unfortunately, made it even more difficult for local wildlife, such as bobcats, gray foxes, mountain lions, and black-tailed deer to cross the highway. Extensive roadkill data collection identified Laurel Curve on Highway 17 as one of the deadliest sections of the highway for wildlife (Figure 6; Diamond & Snyder 2016).

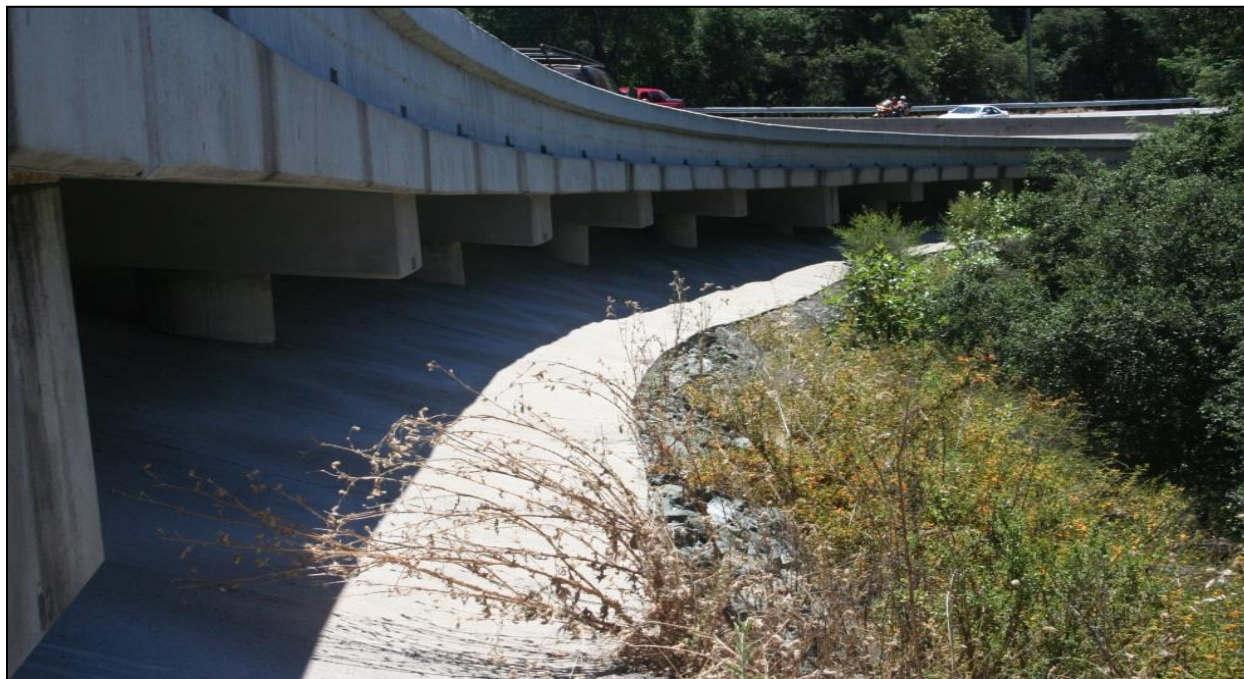
Figure 7. Cement wall viaduct at the Highway 17 Laurel Curve.

Laurel Curve on Highway 17 consisted of a large cement viaduct, which was completely impermeable to wildlife movement and a barrier (Figure 7). The viaduct was built on fill dirt (Figure 8).

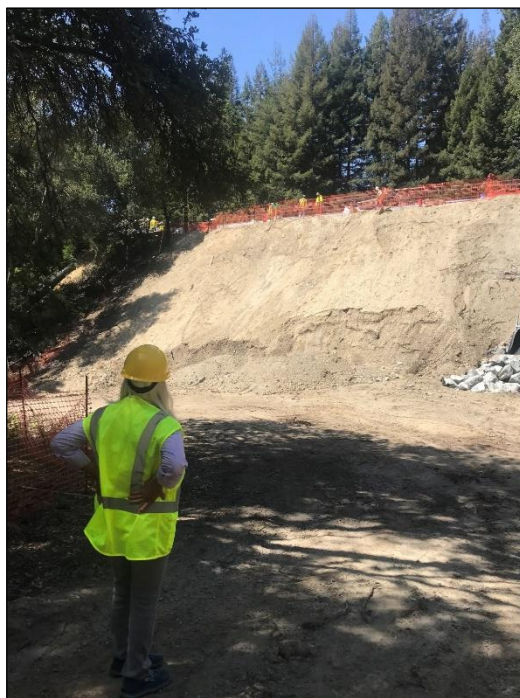
Figure 8. The fill dirt of the viaduct at the Highway 17 Laurel Curve.

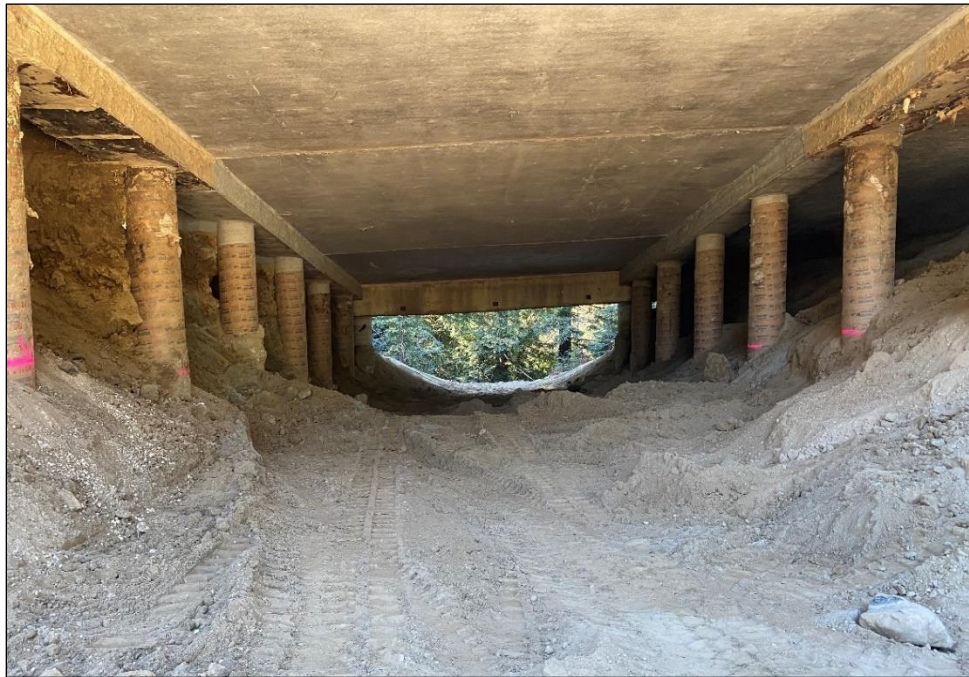
Figure 9. Post excavation of the Highway 17 Wildlife Crossing.

To create the wildlife crossing structure, Caltrans excavated the existing fill dirt. The excavation resulted in a 13.5 ft high, 71 ft wide, and 85 ft long crossing structure (Figures 9 and 10).

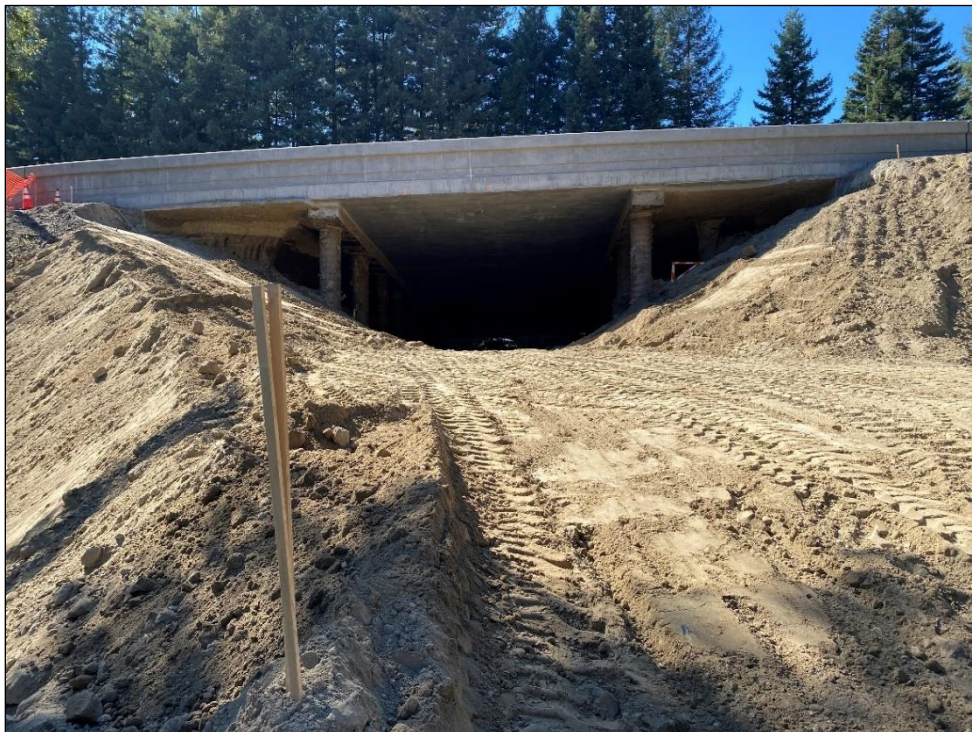
Figure 10. Post excavation of the Highway 17 Wildlife Crossing, east view.

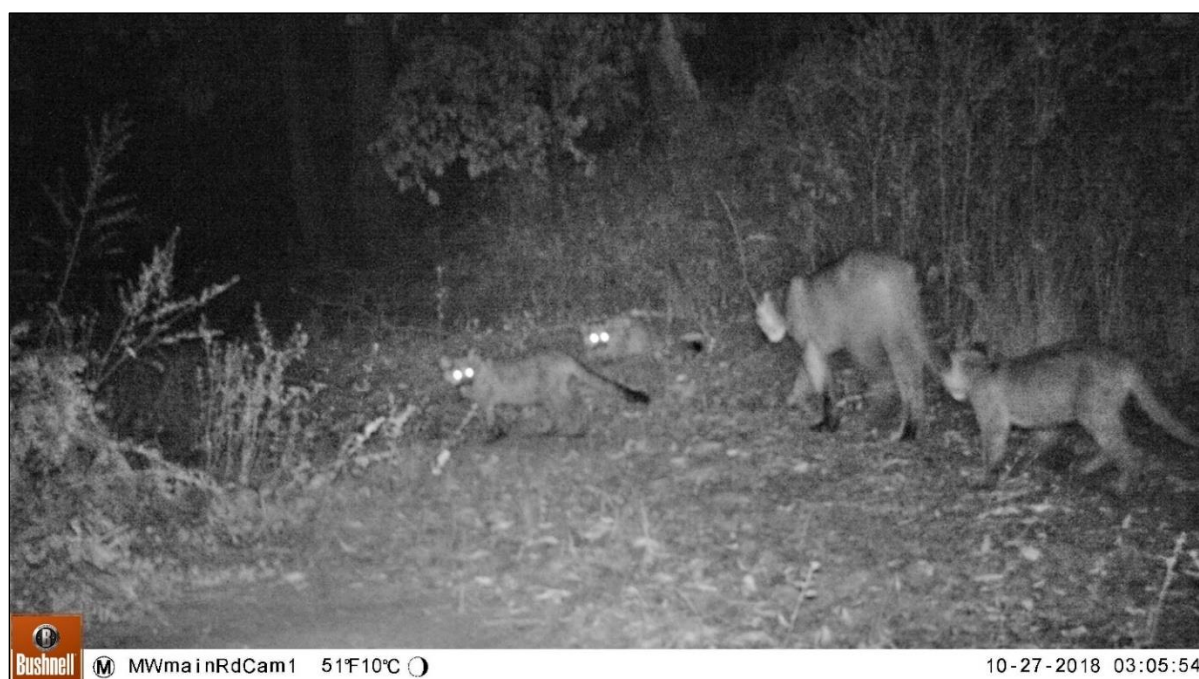
Figure 12. Marywood mountain lion traveling with three of four kittens on 10/27/2018.

During the 2013-2016 study, we recorded female mountain lions with kittens on the Marywood property (Figure 12). Recording the radio-collared female with kittens on 11/7/2023 was a great finding in documenting that there is the continuing use of the property by a female mountain lion with kittens. We did not document the female traveling through the wildlife crossing with the kittens to date.

Until that date, no mountain lions had been recorded using the wildlife crossing or traveling along the fire road. However, before the crossing was built we recorded multiple individuals, including a female mountain lion with three kittens, traveling along the fire road during the 2013–2016 study (Figure 12). In December 2023, the LTSCC organized a volunteer event, where 20 volunteers removed the invasive vegetation, which included large patches of dense French broom (*Genista monspessulana*).

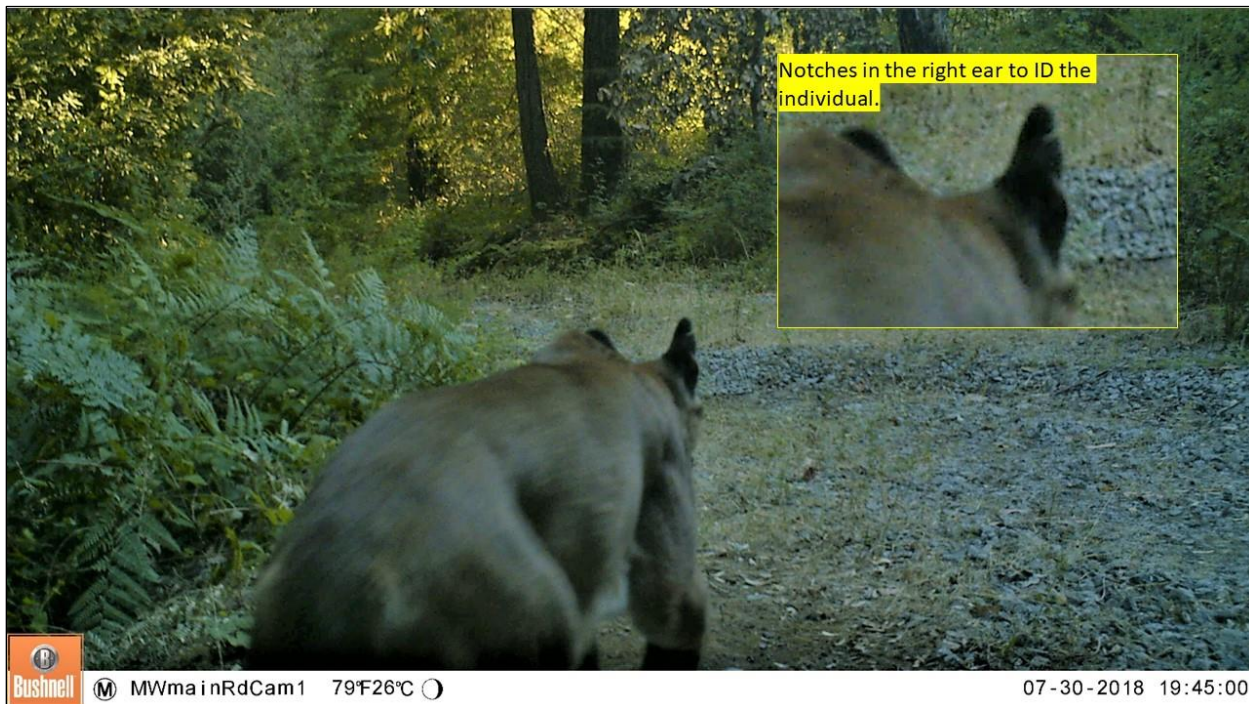
Figure 13. Male mountain lion recorded traveling at Lions Gate on 7/30/2018, which was found as a roadkill on the Highway 17 Laurel Curve on 12/4/2018, four months later.

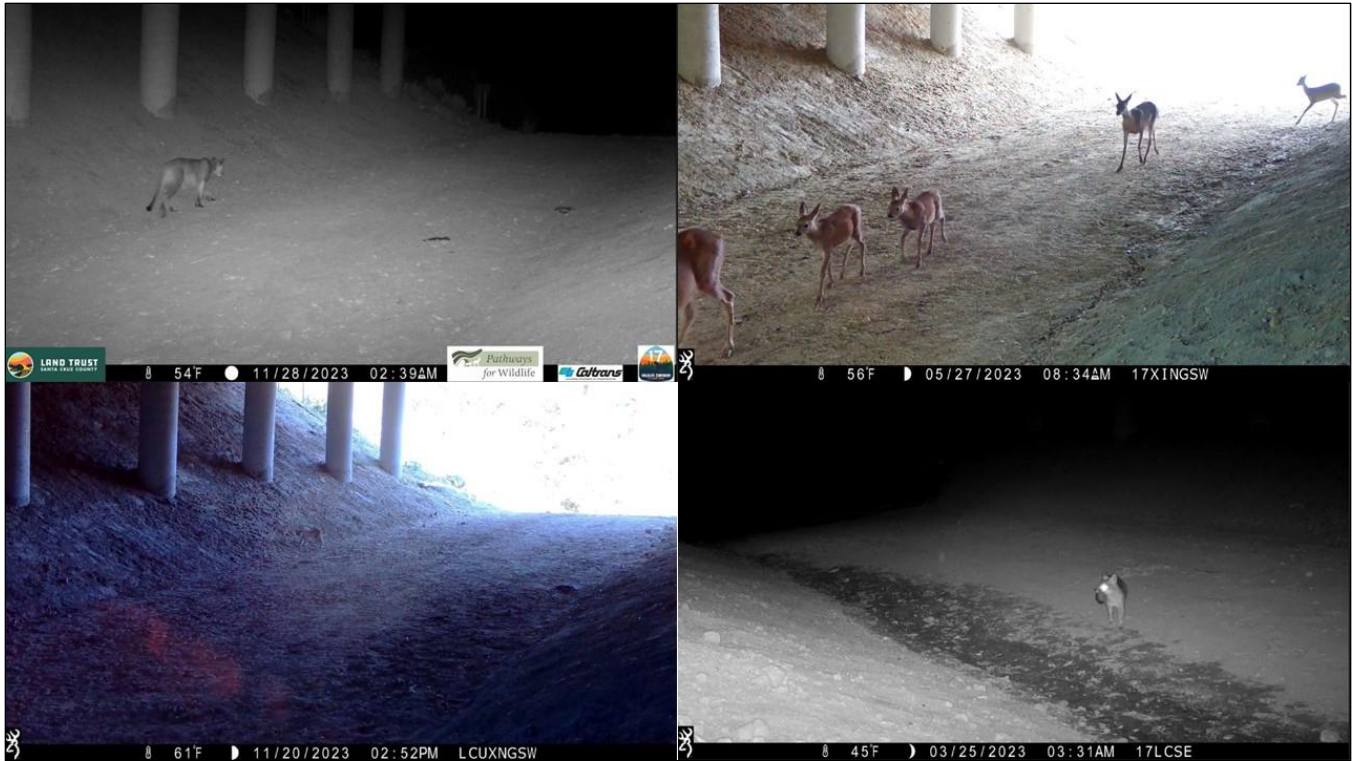
Figure 14. Species use of the Highway 17 Laurel Curve Wildlife Crossing: mountain lion (upper left), black-tailed deer (upper right), bobcat (lower left), and gray fox (lower right).

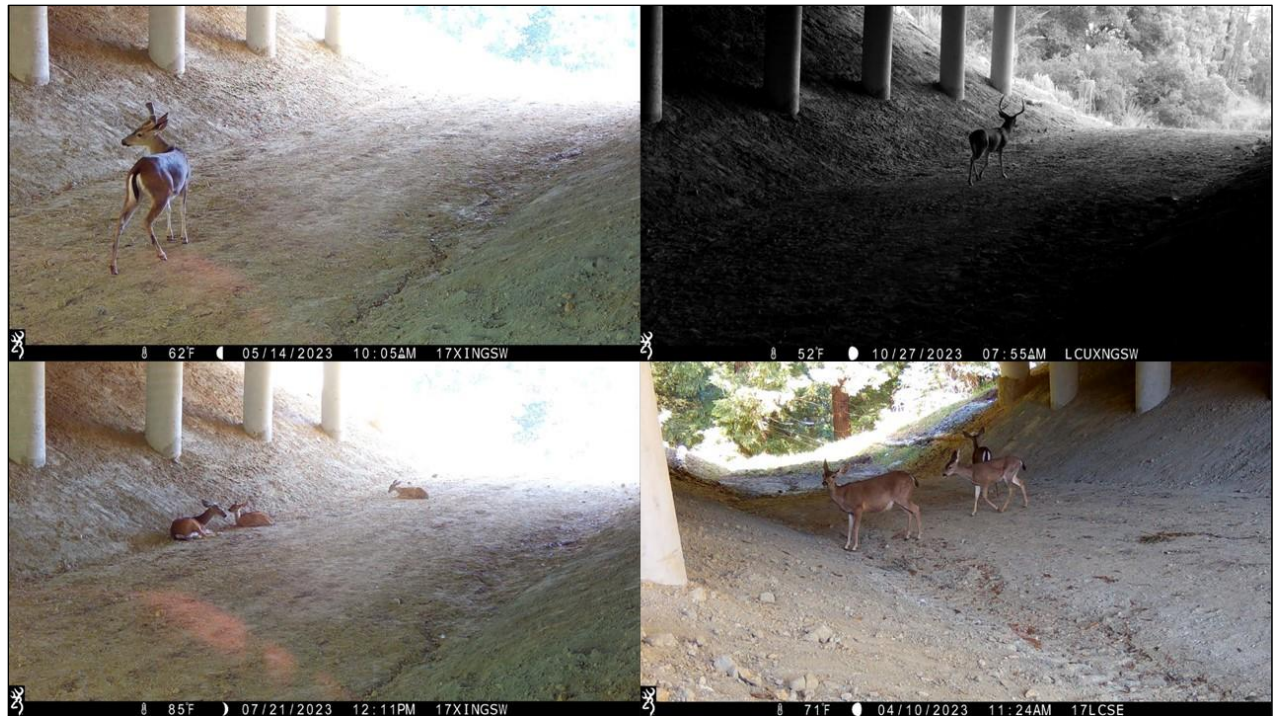
Figure 15. Male and female deer at the wildlife crossing.

identified by counting the number of tines within their antler system and based on the tine sizes. There was an increase in the male deer passage rates in November. This could be because of the rutting season when the male deer travel together in the Fall. An increase in the number of individual male deer traveling through the wildlife crossing and male deer traveling together was recorded from late October to November 2023 (Chart 5, Figure 15). In November 2023, a total of five different bucks were recorded traveling through the wildlife crossing. During the summer and fall, juveniles often traveled with their parents, which likely accounts for the increase in passage rates from July to November (Chart 5). Several different female deer were recorded traveling with juveniles. One female deer with two fawns traveled through the wildlife crossing on a weekly basis and even bedded down in the crossing (Figure 15).

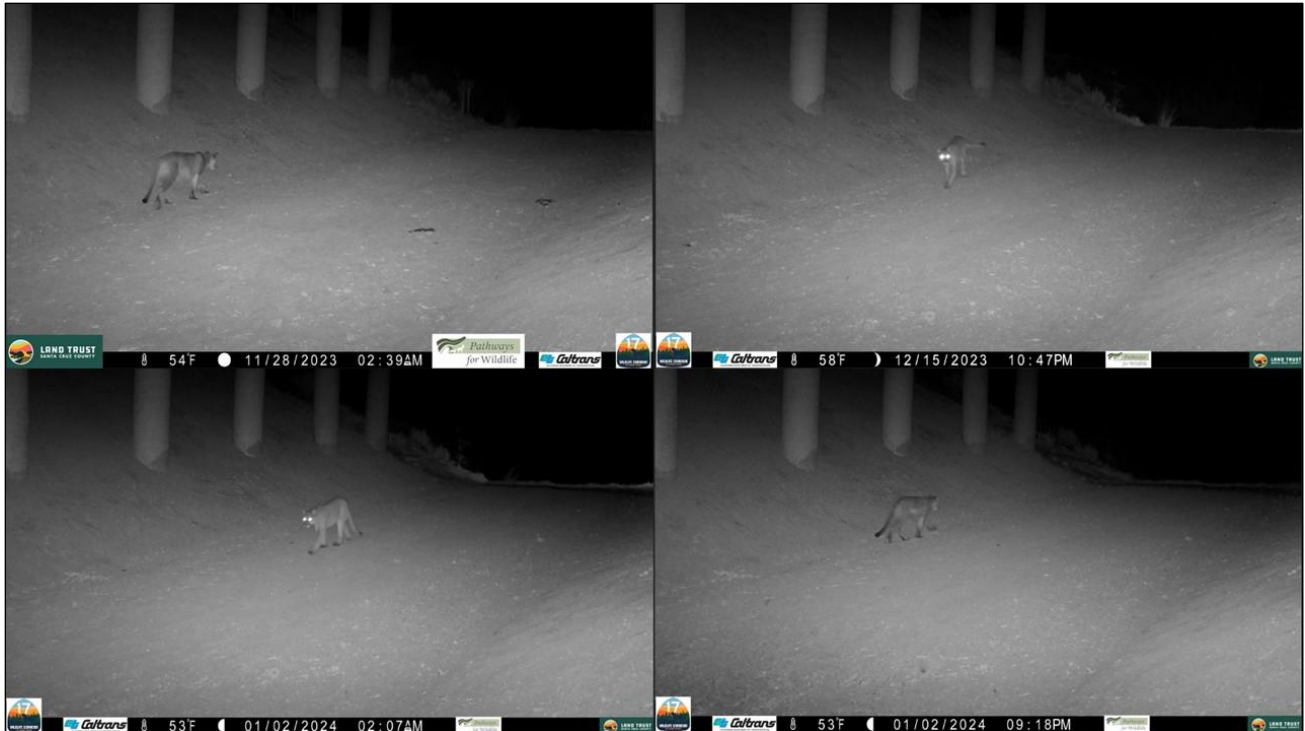
Figure 16. Mountain lion passages at the Highway 17 Laurel Curve Wildlife Crossing.

There were four documented crossings by mountain lions (Chart 6). Based on the camera footage, each crossing was likely conducted by a male mountain lion (Figure 16). The first mountain lion to use the wildlife crossing was recorded on 11/28/2023, and the second record occurred on 12/15/2023. The third and fourth records were observed on the same day on 1/2/2024, where a male mountain lion traveled west through the crossing into Marywood at 2:07 am and then back east into Lions Gate at 9:18 pm.

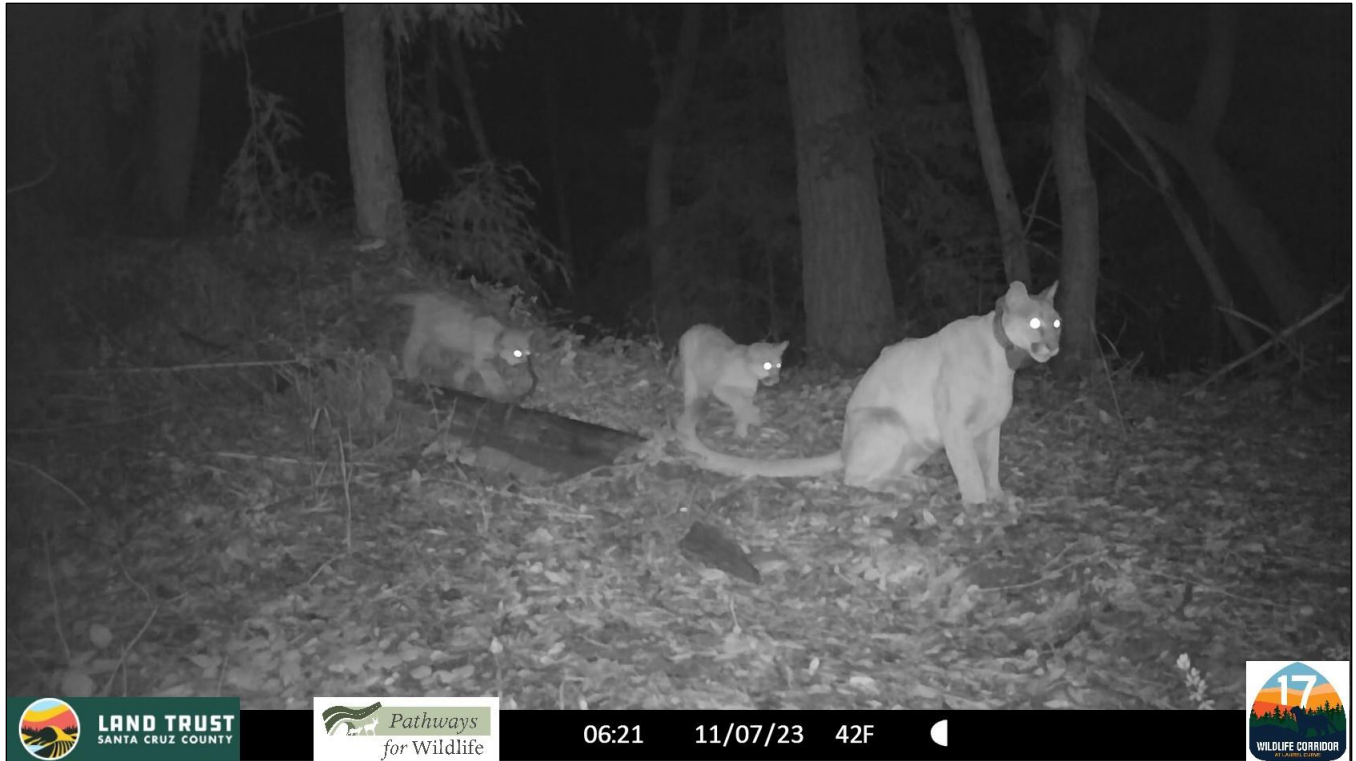
Figure 17. Radio-collared female mountain lion with kittens on the west side of the Highway 17 Laurel Curve Wildlife Crossing.

Interestingly on 11/07/2023, a radio-collared female mountain lion was recorded with three kittens on the west side of the Highway 17 Wildlife Crossing on the Marywood property (Figure 17). One of the study questions entails comparing camera data from the 2013–2016 study to identify species that are not using the structure but that have been previously documented traveling on either side of the crossing.

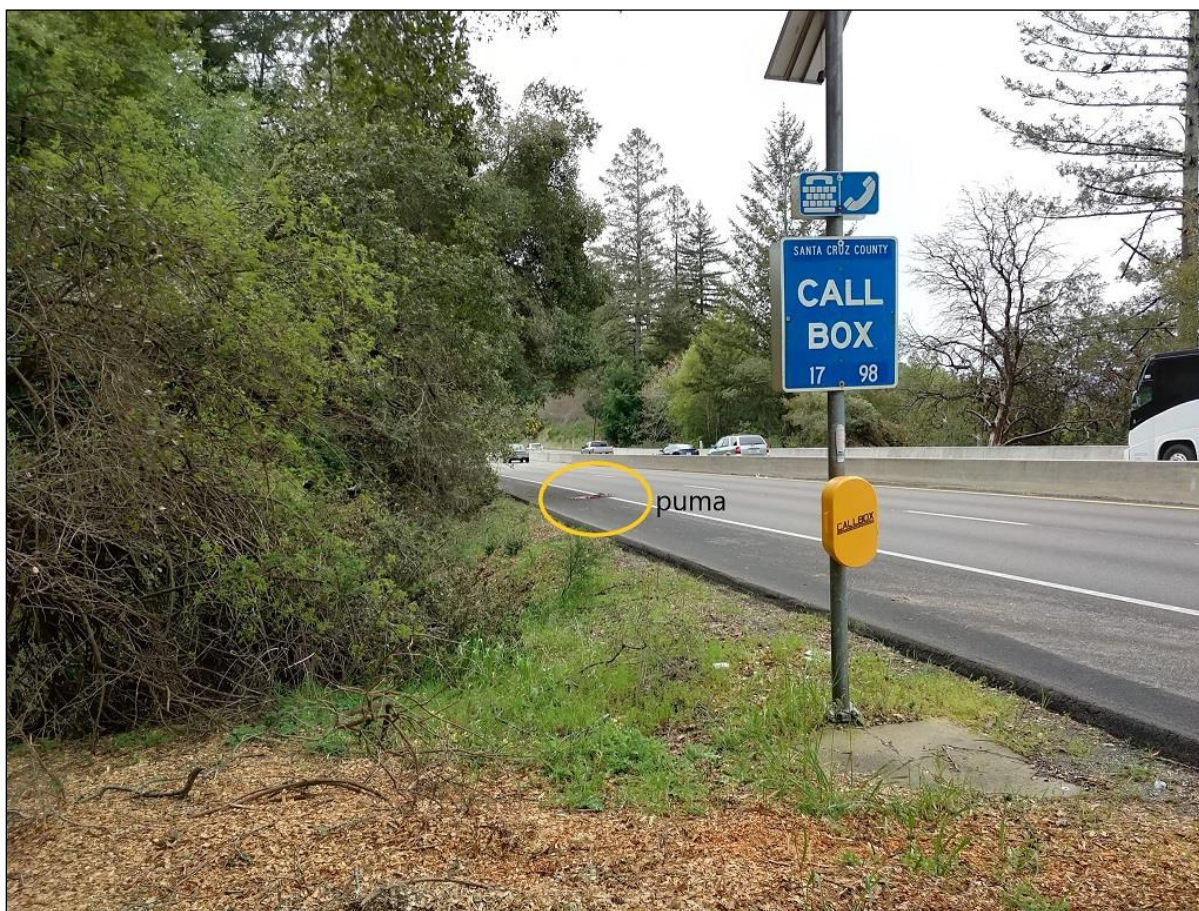
Figure 19. Mountain lion that was found hit on Highway 17 on 4/2/2023.

within the Highway 17 Laurel Curve study area. A sub-adult mountain lion was hit at the end of the directional fencing on the northern side of the study area in the northbound lanes on 4/2/2023 which was approximately 0.38 miles away from the wildlife crossing, at the northernmost extent of the study area (Figures 19 and 20). There is a small ravine leading to the highway where the mountain lion was found. One possible recommendation based on this finding could be to further extend the directional fencing to this ravine area where the mountain lion was hit to mitigate any further collisions. Apart from this mountain lion, there were no other recorded roadkills within the Highway 17 Laurel Curve study area. This was a significant decrease in the wildlife-vehicle collisions when compared with the 2013–2016 data collection, especially for the black-tailed deer. The black-tailed deer roadkills were previously found within the study area throughout the 2013–2016 roadkill surveys (Table 1).

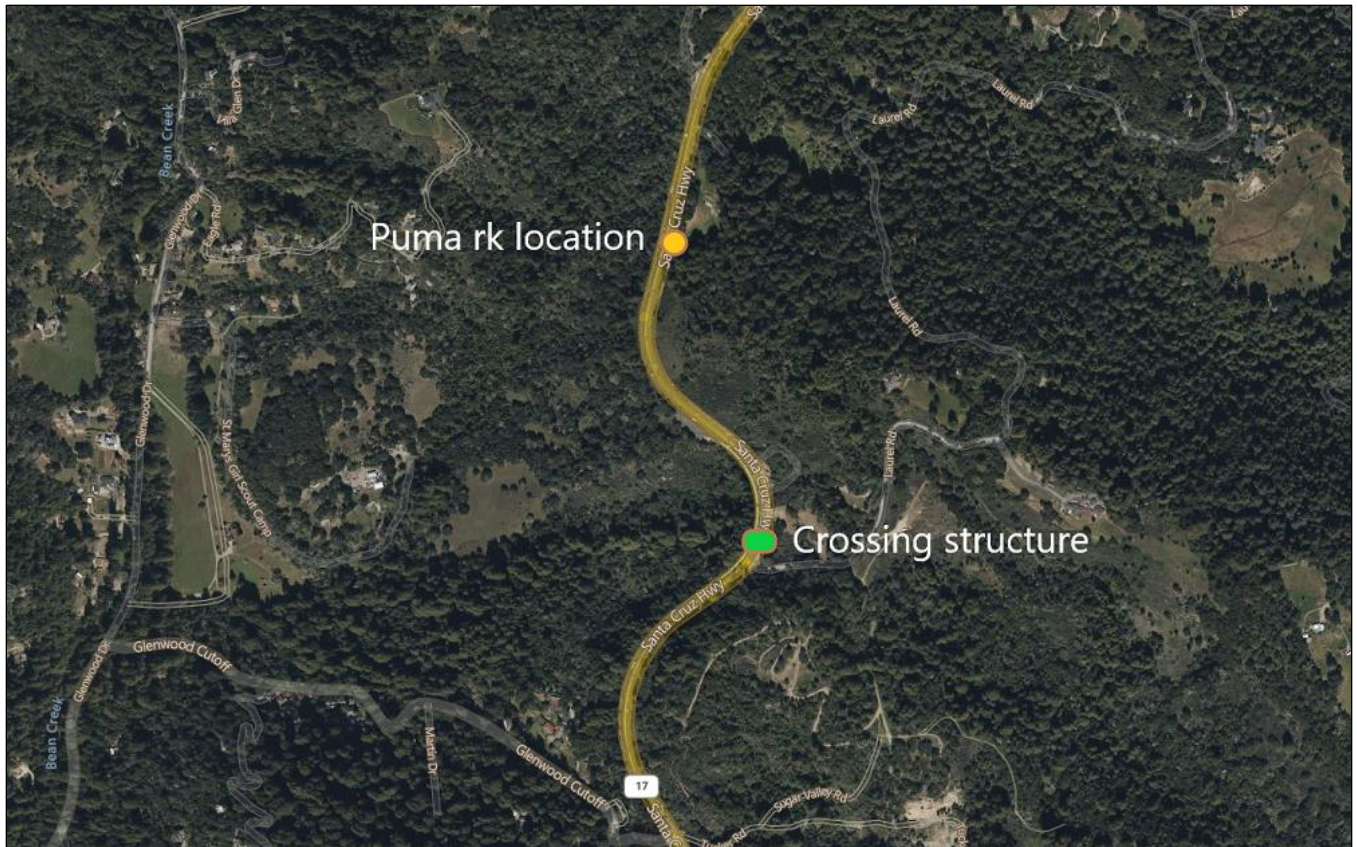
Figure 20. The location where the mountain lion roadkill (Puma roadkill) was recorded on Highway 17 on 4/2/2023.

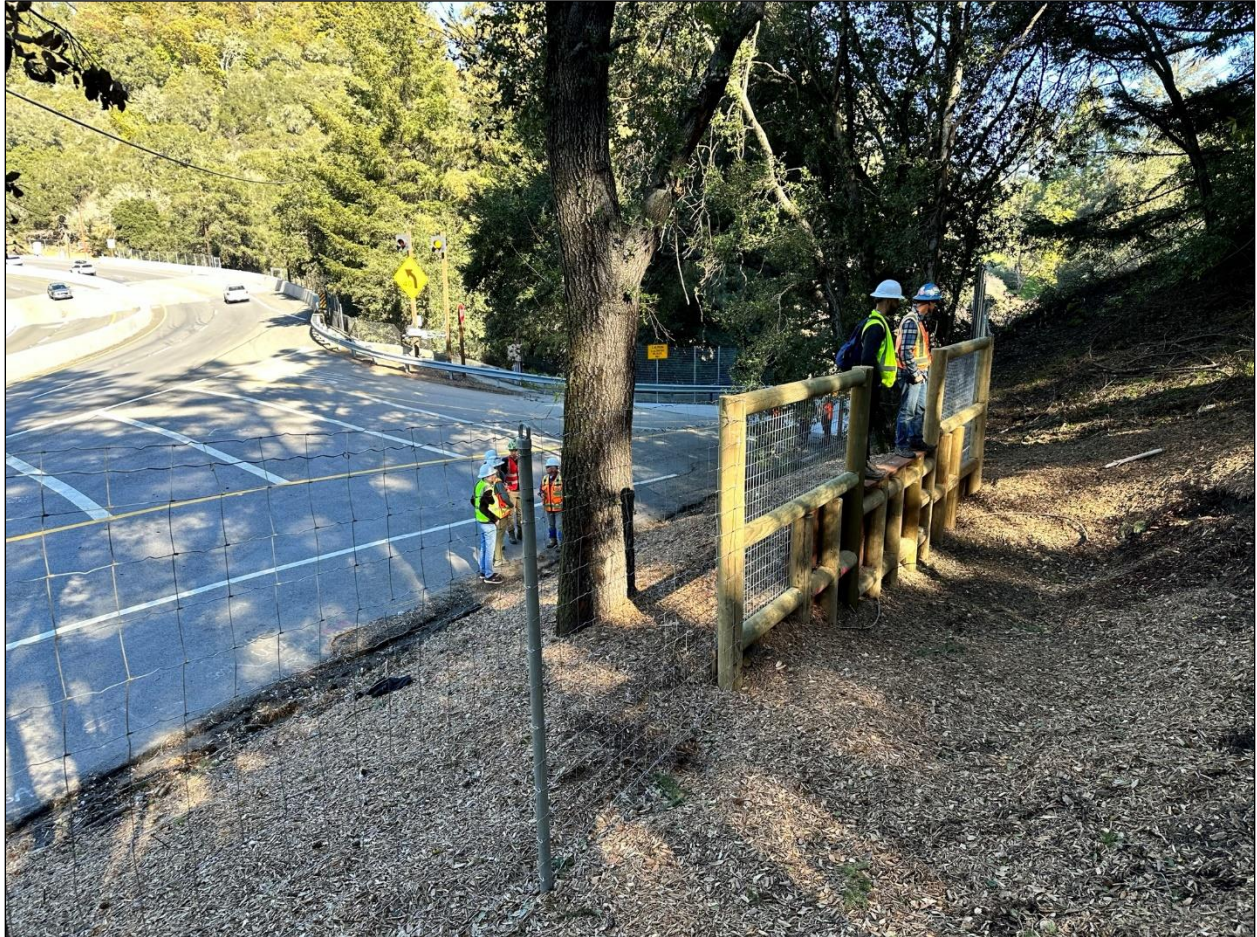
Figure 21. Highway 17 Laurel Curve exit jump-out with exclusionary fencing, south of the wildlife crossing.

There are three jump-outs at the Highway 17 Laurel Curve Wildlife Crossing. There are two jump-outs on the northbound lanes and one jump-out along the southbound lanes. The jump-out located by the Highway 17 Laurel Curve exit, Figure 21, is on the south side of the exit across from the wildlife crossing.

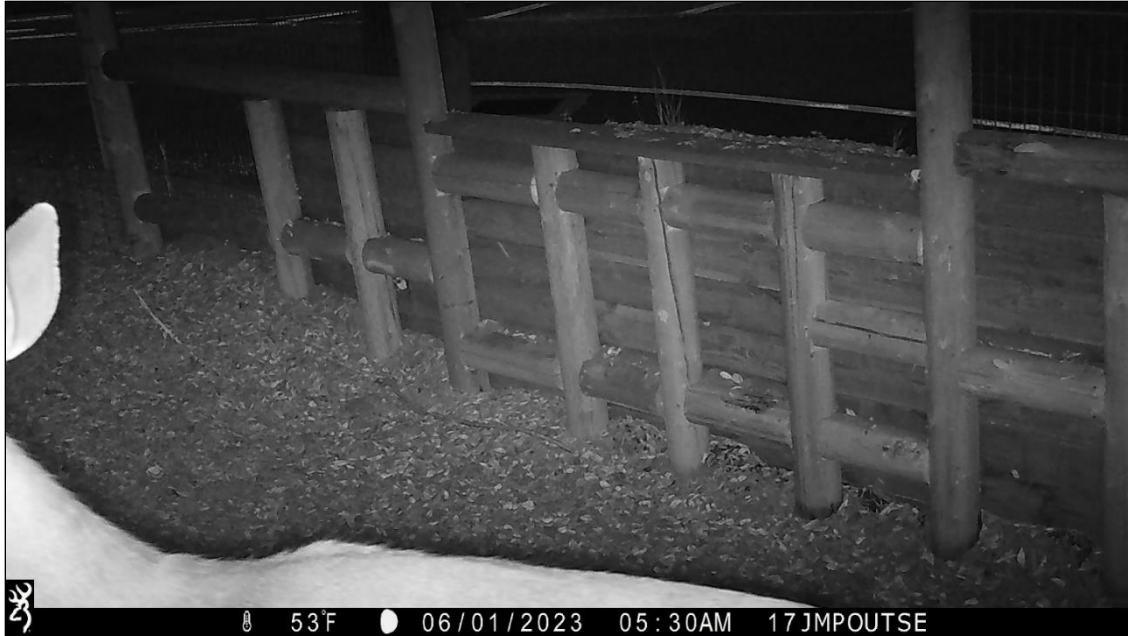
Figure 22. Deer traveling west at the Highway 17 Laurel Curve exit jump-out, south of the wildlife crossing.

Wildlife was recorded traveling on the inside of the jump-out along the fence line, with no records of animals using the jump-out from the highway. There were several records of deer and wild turkeys traveling along the fence line by the jump-out throughout the study period (Figure 22). The fencing seemed to be effective in preventing the deer from accessing the highway.

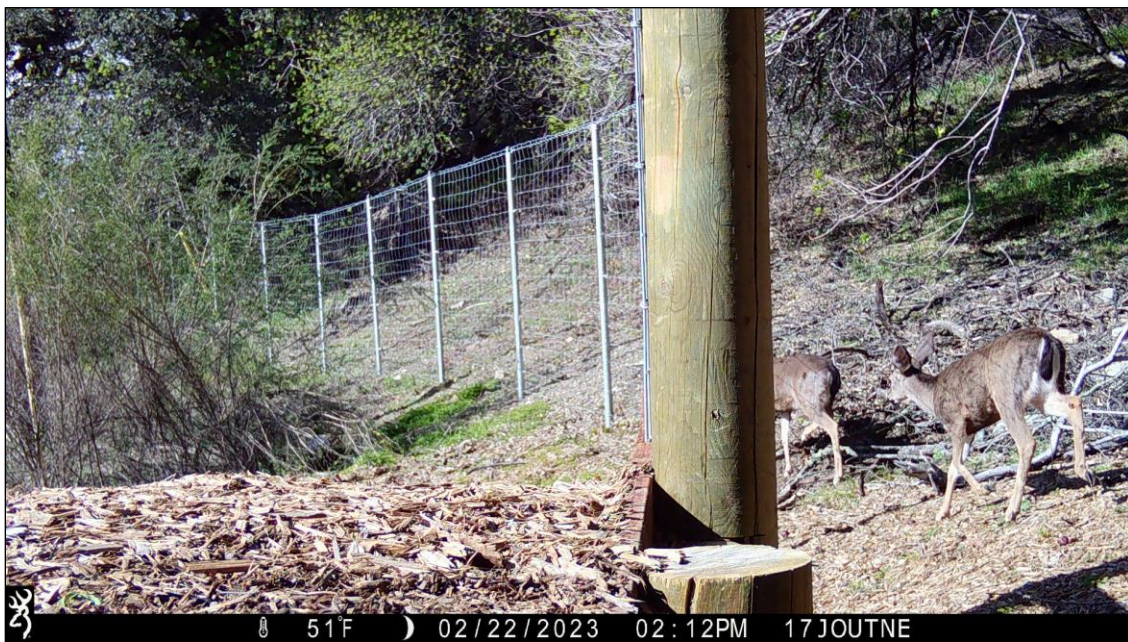
Figure 23. Deer traveling north at the Highway 17 northbound jump-out with exclusionary fencing, north of the wildlife crossing on 2/22/2023.

The second jump-out located along the northbound lanes, is located on the north side of the wildlife crossing (Figure 23). Throughout the study period, multiple individuals of deer were recorded traveling both north and south along the jump-outs.

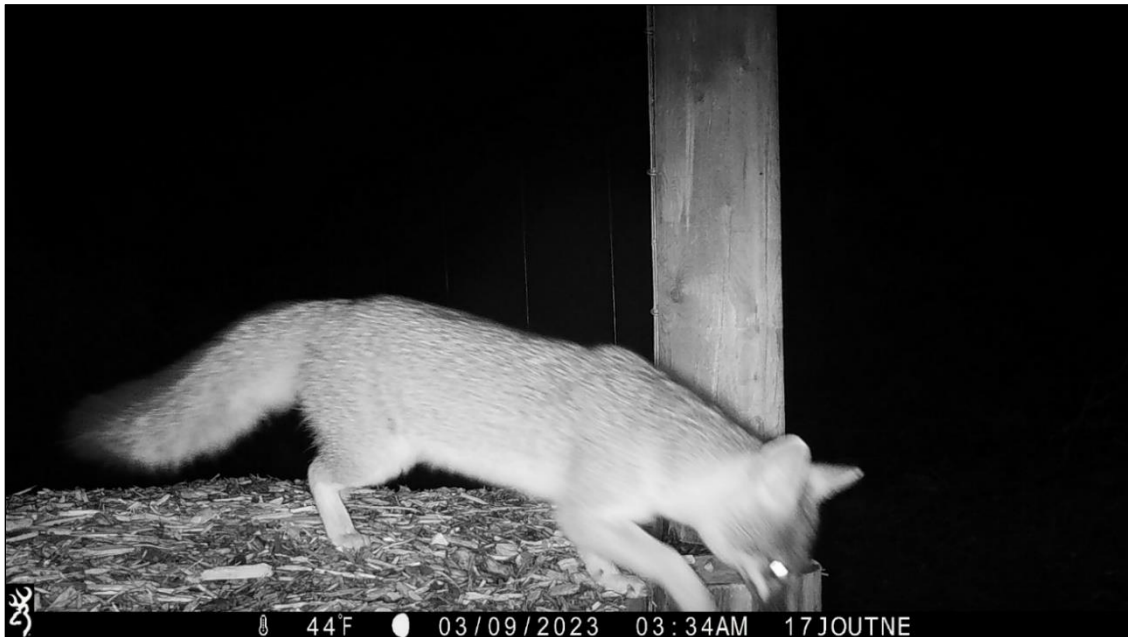
Figure 24. Gray fox traveling from Highway 17 into the northbound jump-out, north of the wildlife crossing on 3/9/2023.

We recorded one animal using the jump-out from the highway to access the protected property at Lions Gate. A gray fox was recorded using the jump-out on 3-9-2023 to travel from the highway and into the Lions Gate property, which is on the east side of the wildlife crossing (Figure 24).

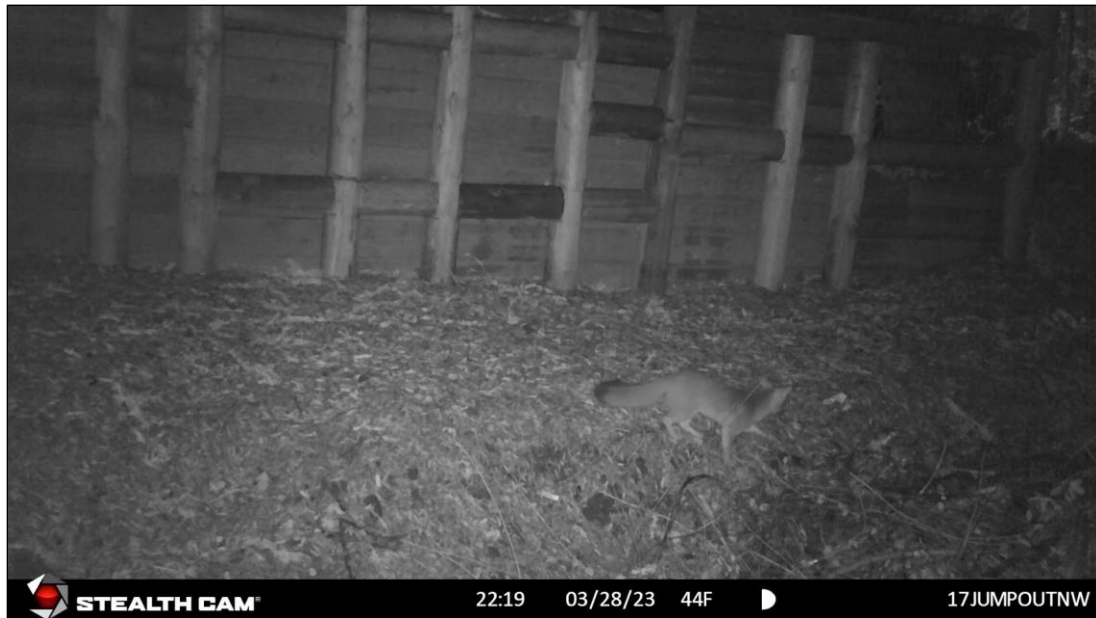
Figure 26. Gray fox traveling south along the Highway 17 southbound jump-out on 3/28/2023.

Wildlife was recorded traveling on the inside of the jump-out along the fence line, with no records of animals using the jump-out from the highway. There were records of bobcats, deer, gray fox, and skunk traveling along the fence line by the jump-out throughout the study period. We recorded several videos of a female bobcat traveling with a juvenile along the fence line along with a female deer traveling with a fawn (Figures 26-28). The fencing seemed to be effective in preventing wildlife from accessing the highway.

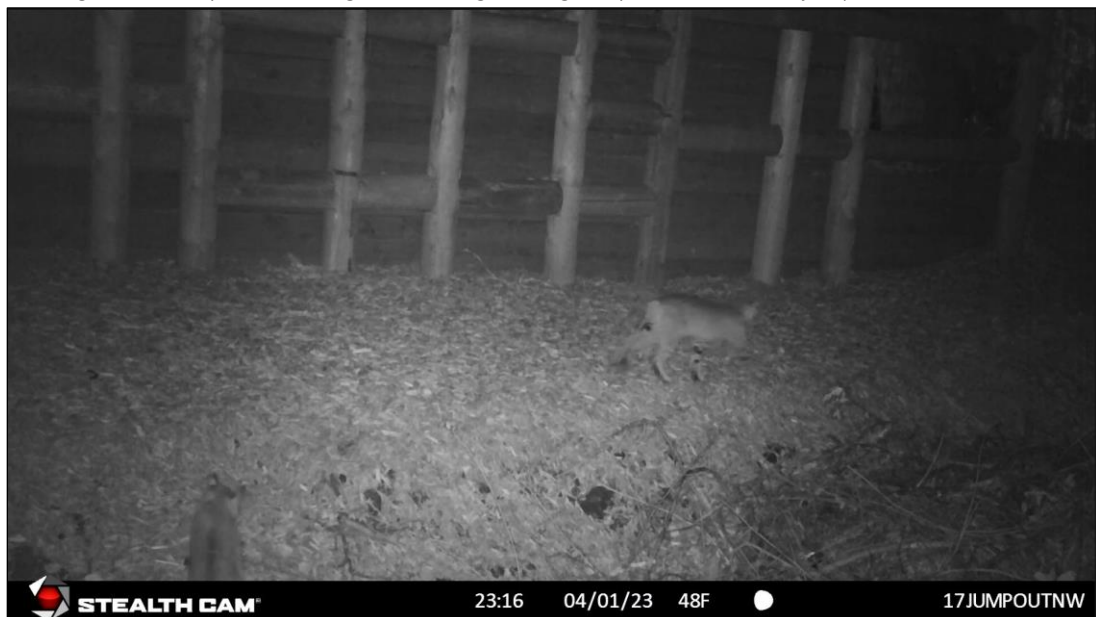
Figure 27. Bobcat with a juvenile traveling south along the Highway 17 southbound jump-out on 4/1/2023.

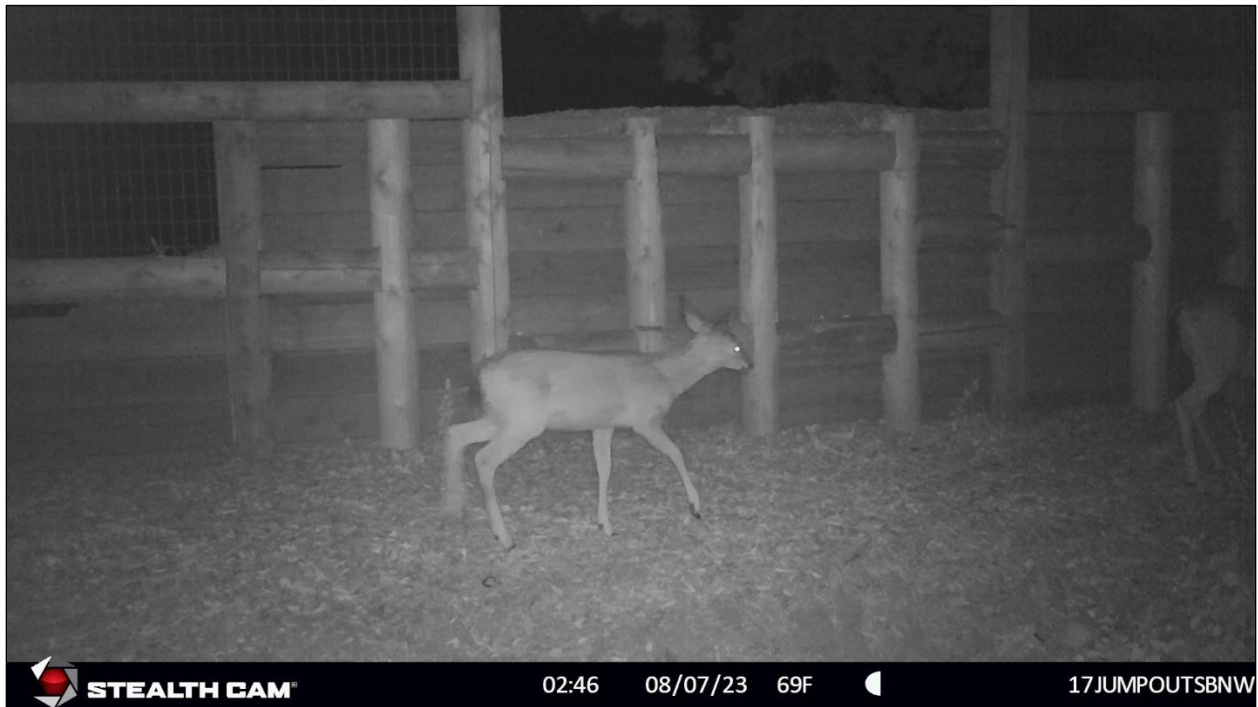
Figure 28. Deer with a juvenile traveling south along the Highway 17 southbound jump-out on 8/7/2023.

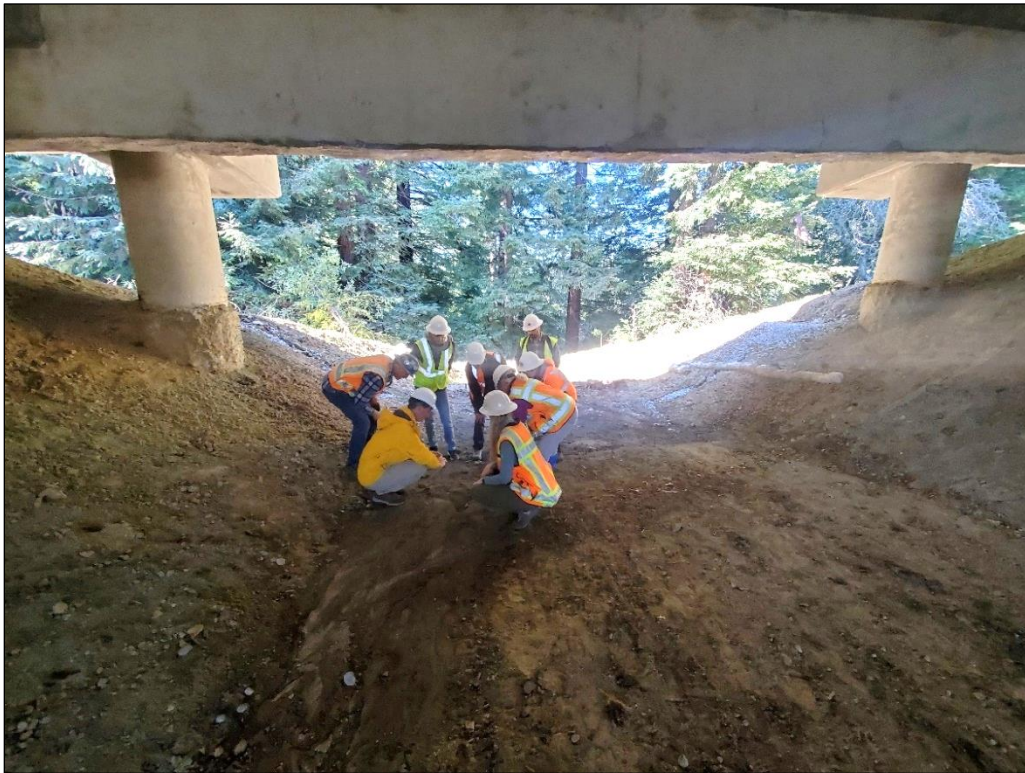
Photo: Land Trust of Santa Cruz, Caltrans, Wildlife Conservation Network, and Pathways for Wildlife observing wildlife tracks within the Highway 17 Wildlife Crossing Structure while setting up the field cameras on January 30<sup>th</sup>, 2023.
