JOINT APPLICATION FOR PROPOSED WORK IN MONTANA'S STREAMS, WETLANDS, FLOODPLAINS, AND OTHER WATER BODIES

Chadwick Consulting conducted an aquatic resources (AR) delineation on July 6 through July 10, 2021, and [\[\[\[date TBD\]\]\]](#) to support a Bureau of Land Management (BLM) stream restoration project on Pumpkin Creek. This memo identifies the aquatic resources occurring at the project site and has been completed in support of environmental permitting. The project is located approximately 15 mi southeast of Miles City, Custer County, Montana, in Section 1, Range 48 East, Township 5 North, Sections 6, 7, and 17, Range 49 East, Township 5 North. The project site is mapped in **Figure 1** and on the aquatic resource delineation maps in **Appendix A**. Additional information about the project site is described in the project design report included with the joint permit application.

Aquatic Resource Map
Pumpkin Creek
Custer County, MT

Delineation Photos: BLM Pumpkin Creek Restoration

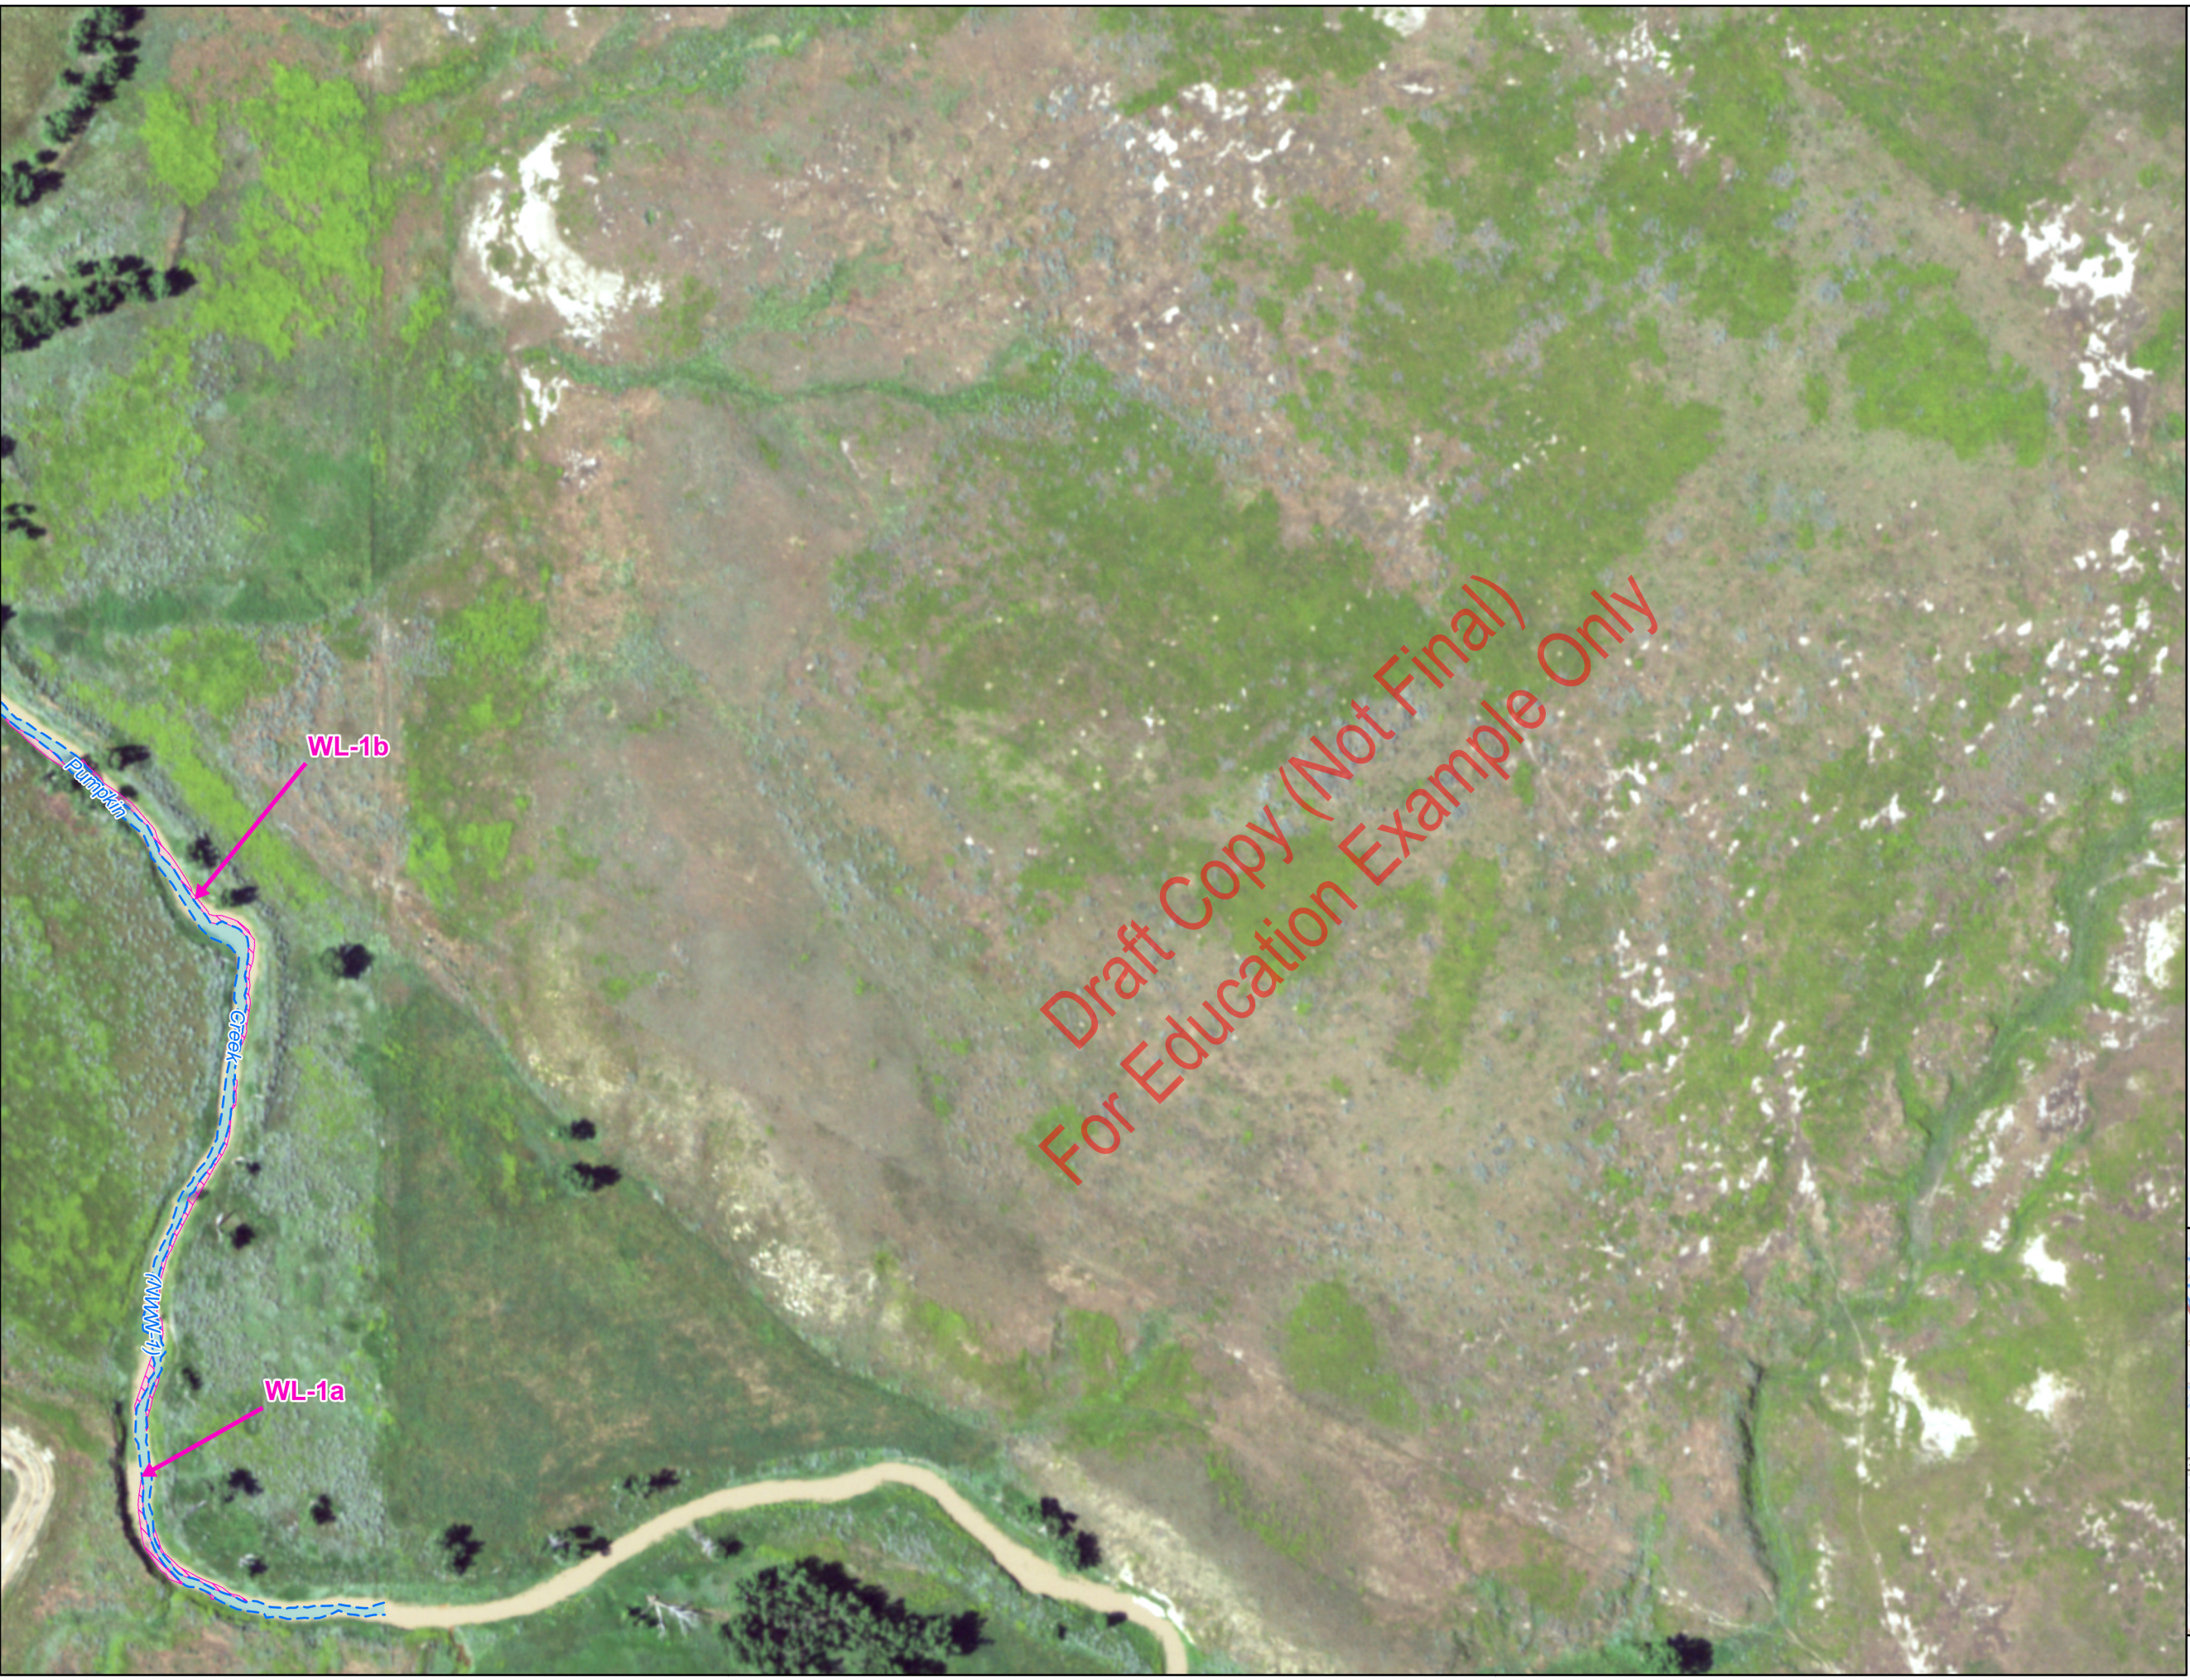
*Note - WL-1a runs along the south bank of Pumpkin Creek starting on page 1.
- WL-1b runs along the north bank of Pumpkin Creek starting on page 1.

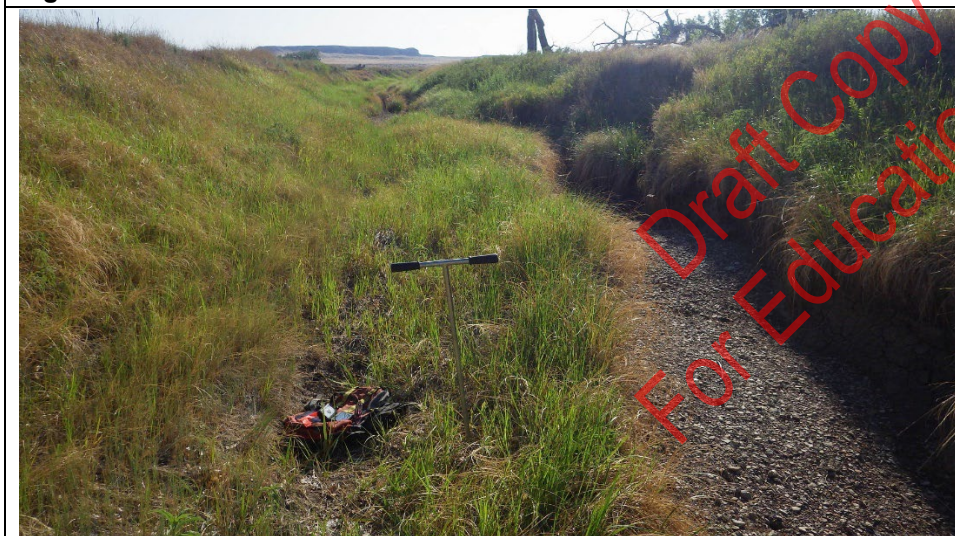
Fig. B-3. DP WL-1b.1. View E. Pumpkin Creek (NWW-1) at right in photo.

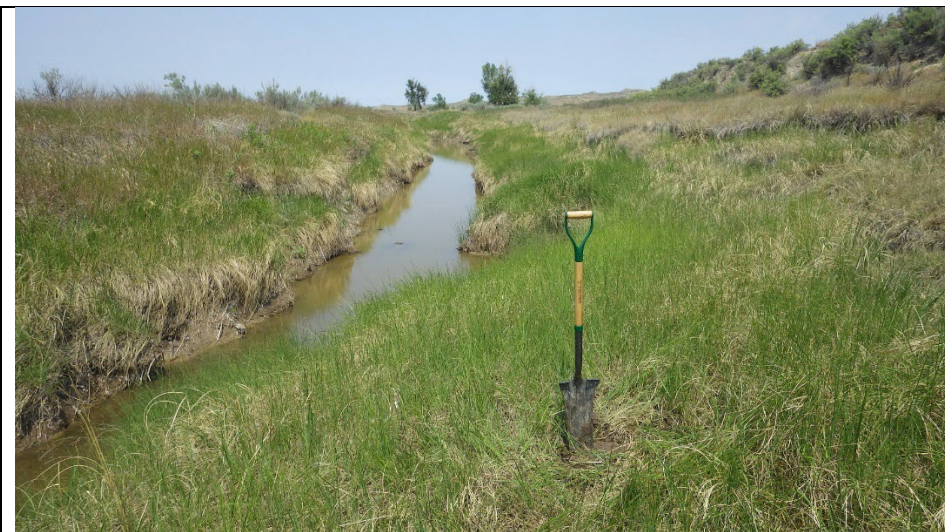
Fig. B-9. DP WL-1a.3. View N. Pumpkin Creek (NW-1) left of plot in photo.

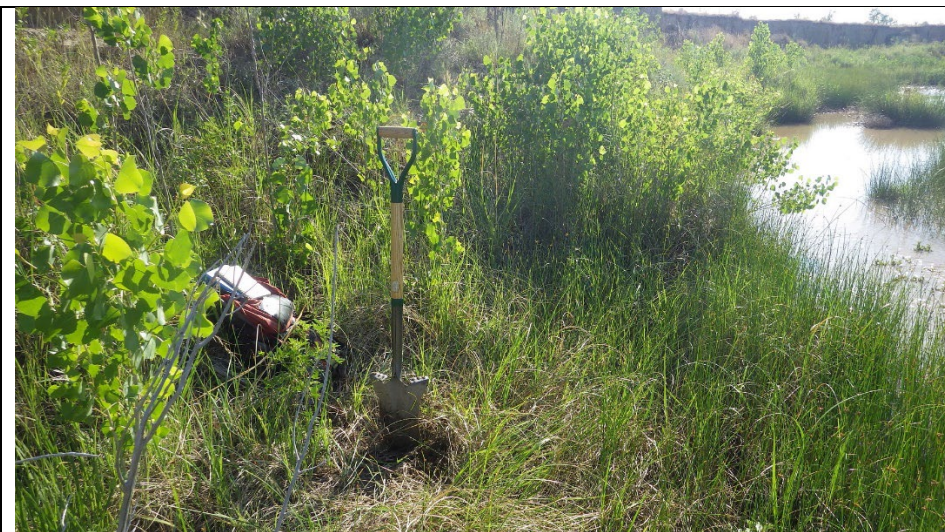
Fig. B-17. DP WL-1a.5, PSS portion of WL-1a. View E.

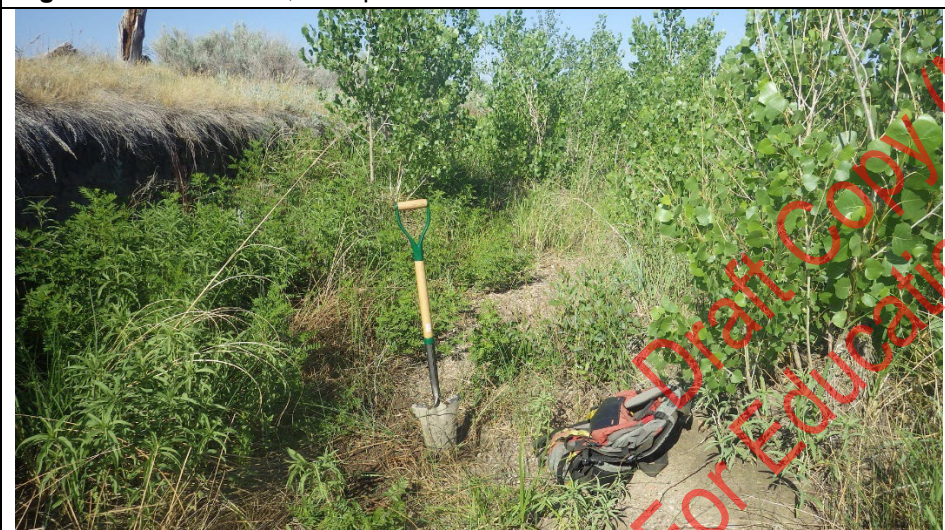
Fig. B-19. DP WL-1b.5, PSS portion of WL-1b. View SW.

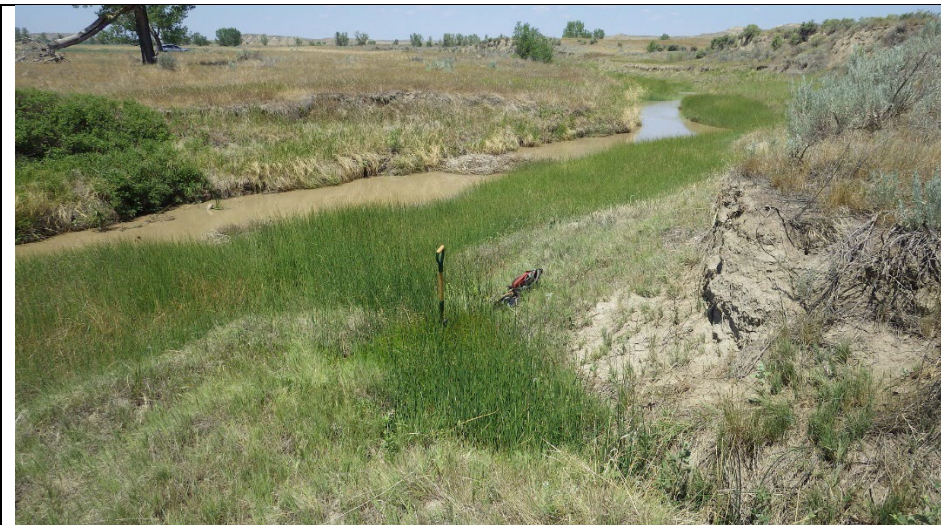
Fig. B-21. DP WL-2. View E toward WL-1 and NWW-1 (Pumpkin Creek).

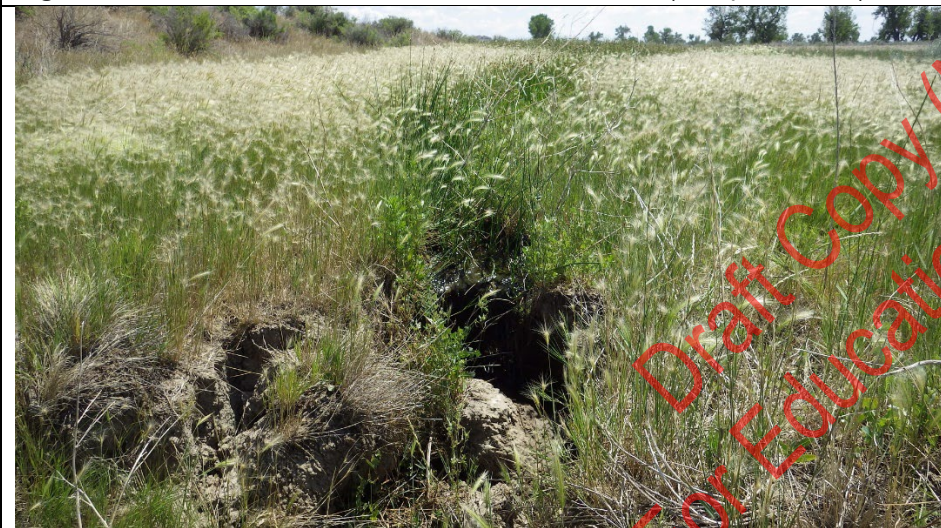
Fig. B-23. Large WL on high terrace draining to area delineated as WL-2 (same wetland, but outside project extent). Headcut at transition from high bank to terrace pictured in foreground.

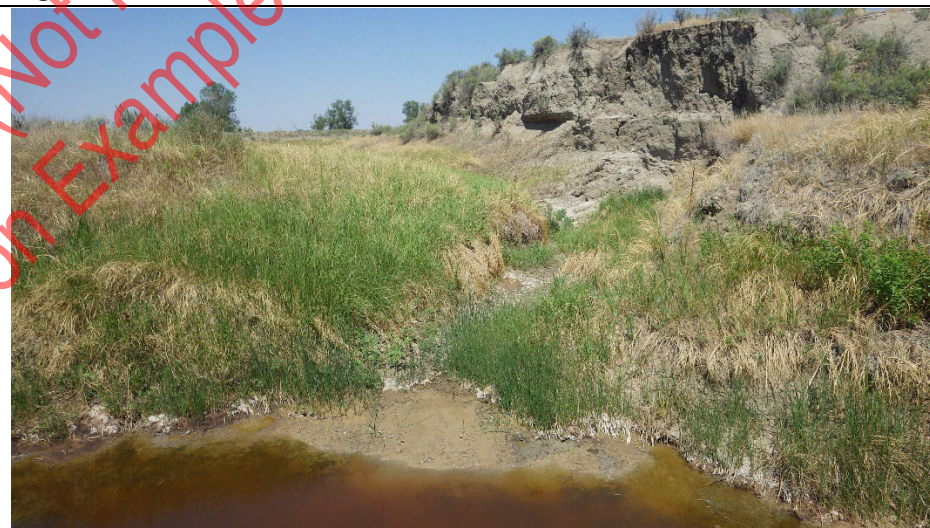
Fig. B-24. Outlet of Johnson Creek (NWW-2). Only the confluence (within Pumpkin Ck flooding zone) is within project boundary

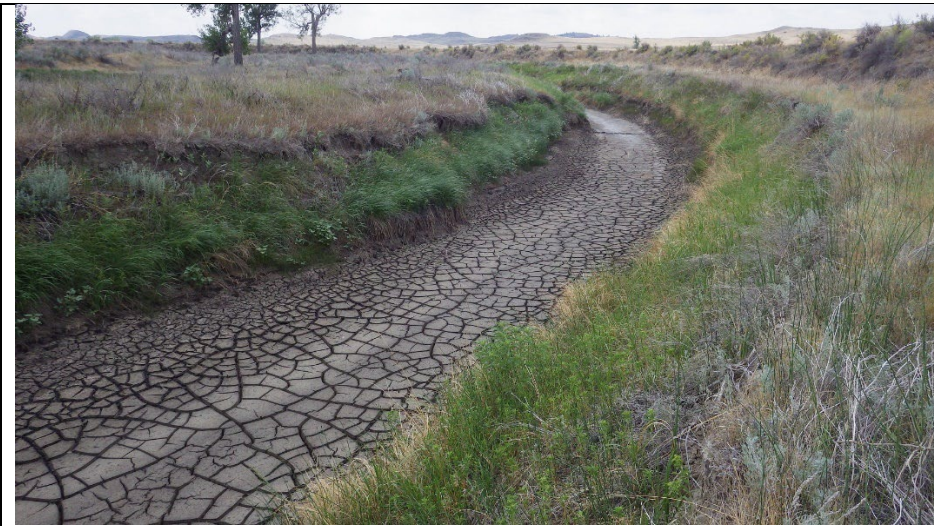
Fig. B-25. Wider channel segment in dry conditions

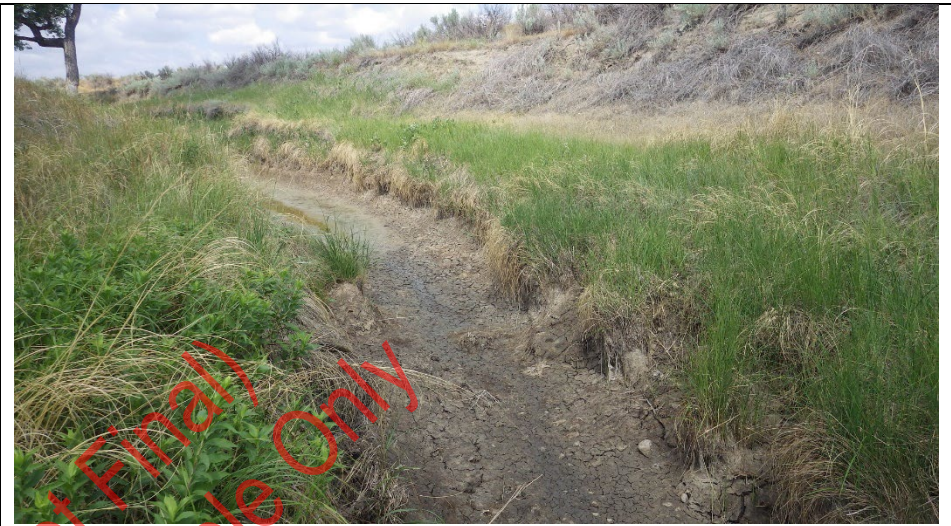
Fig. B-26. Narrow channel with wider low terrace, in dry conditions

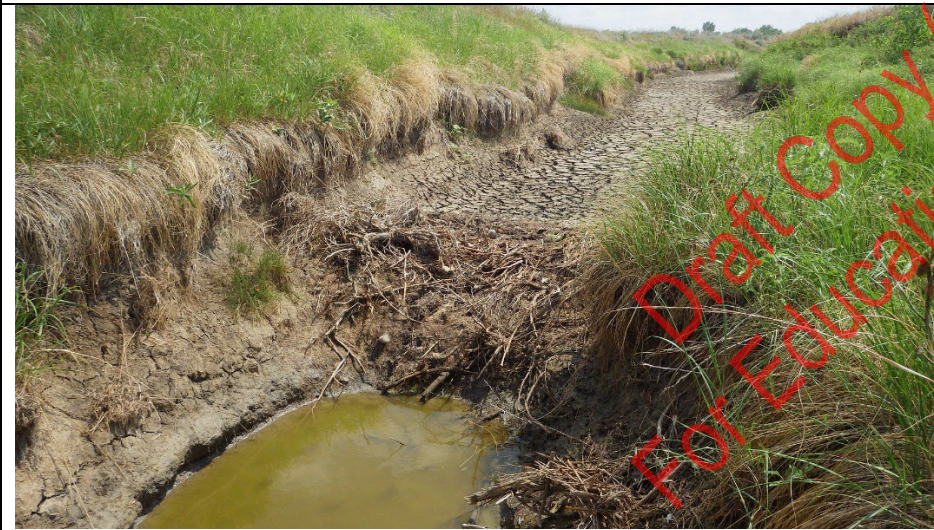
Fig. B-27. Relict beaver dam has maintained higher channel elevation; similar to projected outcome of Phase 1 of low-tech restoration

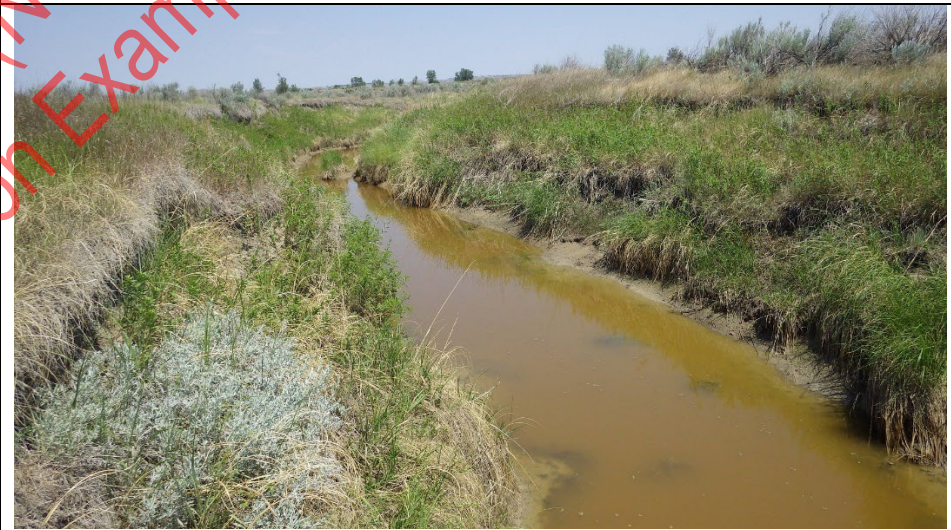
Fig. B-28. Long pool in low water conditions

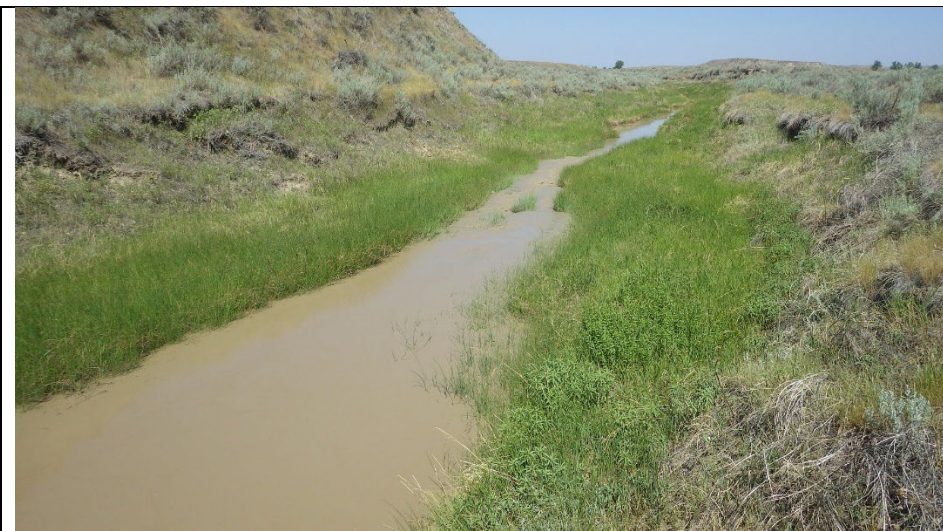
Fig. B-29. Pumpkin Creek after large storm surge, with water filling up lowest scour channel. Wetlands generally occur within 1 to 1.5 ft elevation above storm surge level.

Flows in Pumpkin Creek are highly variable and can change dramatically after a rainstorm. Streamflow was variable during the delineation site visit, with the channel mostly dry at the beginning of the visit, but water rising rapidly in response to a rainstorm in the headwaters, and filling to the low terrace level by the next day. Figures B-25 through B-30 (Appendix B) illustrate the variable flow conditions during the delineation site visit.

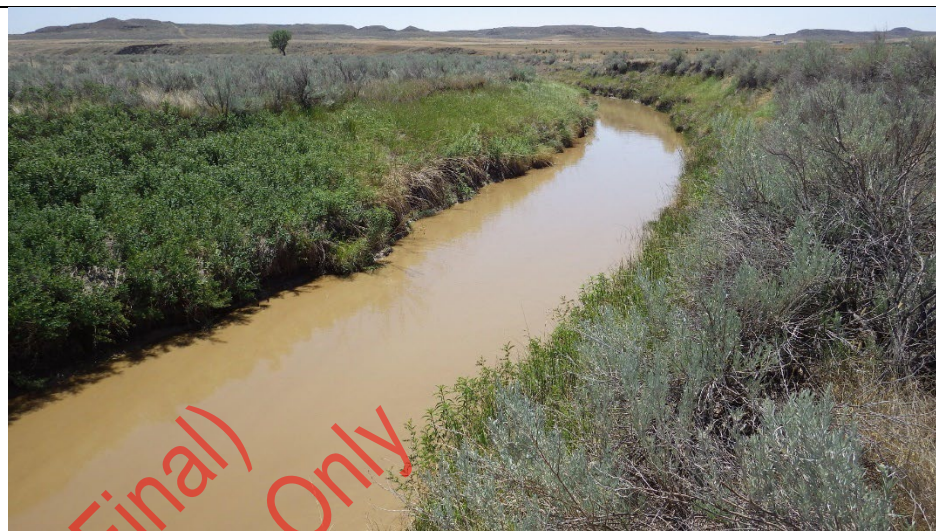
Fig. B-30. Pumpkin Creek after large storm surge, in section with very little wetland at low bank and low terrace now supporting upland vegetation.
