## **Appendices**

Appendices for the U.S. Insular Areas Education Facility Inventory and Condition Assessment Study Phase 1 Report include the following:

## **Appendix A**

### **Program Fundamentals of the Selected Assessment Model**

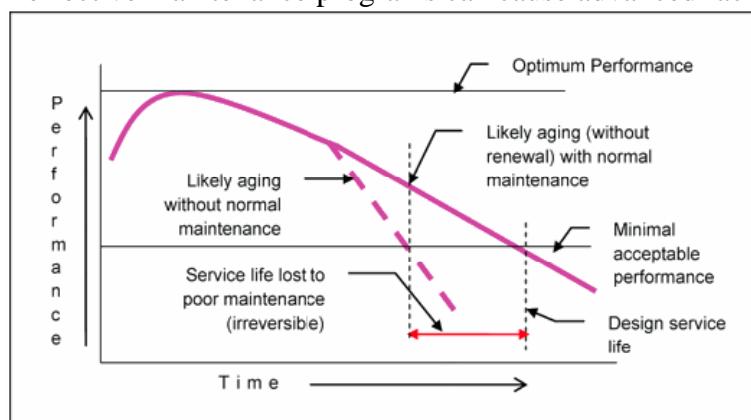
Figure 1 – Service Life Impacts of Deferred Maintenance; (Source: NASA-PR, 2008, p. 129)

Ineffective maintenance programs can cause advanced facility degradation as shown in Figure 1:

Inadequate maintenance is attributed to insufficient funding and ineffective maintenance programs. Both causes lead to deferred maintenance or backlogging of maintenance work needed.

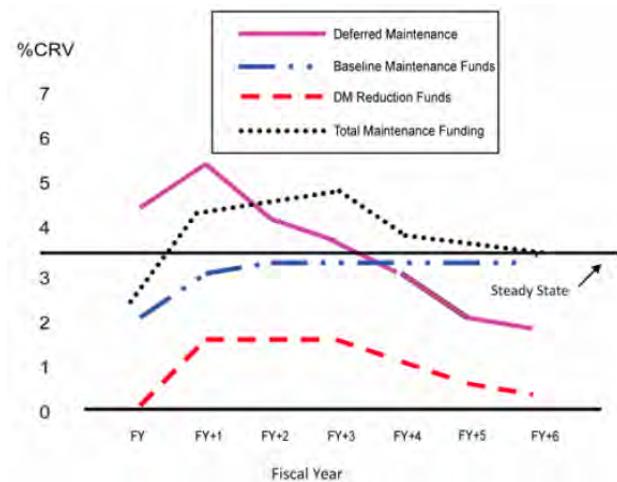
*Figure 2 – Service Life Lost From Inadequate or Untimely Maintenance; (Source: NASA-PR, 2008, p. 131)*

It is assumed that reduced DM corresponds with the amount of adequate and timely maintenance performed. As more resources are directed to programmed and preventative maintenance, the percentage of scheduled work should increase, and the percentage of resources spent on trouble calls should decrease. Total maintenance funds may have to increase until ‘steady state’ expenditures are achieved. By tracking maintenance funding facility managers can illustrate program performance over time. Figure 2 shows a deferred maintenance reduction scheme with additional funding.

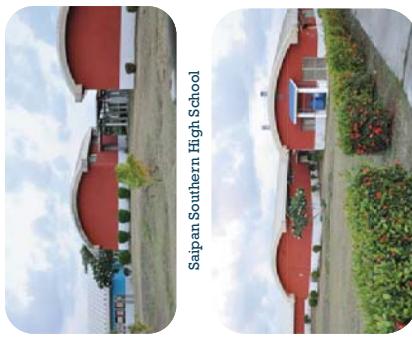
**+ Saipan Southern High School Classrooms**

PSS has determined that eight (8) additional classrooms are needed at Saipan Southern High School which has a design capacity of 600 students. At current enrollment of 535 students, the result is classrooms are loaded at 12 students per classroom. The additional eight classrooms would provide a feasible SSHE over the teacher/student ratio. The current 321 to 231 is still high compared to the national average of 161 but is within the Civil Board of Education maximum ratio of 251.

The classroom cost is based upon the latest estimate for pre-fabricated portable classrooms with freight costs from the states and inclusive of collateral equipment.

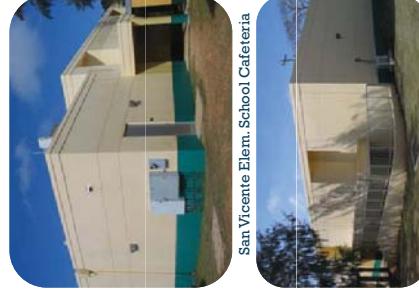
**+ MHS Cafeteria Project**

PSS plans to utilize the design of the San Vicente Cafeteria for a new cafeteria to be located at MHS. The vast majority of students at MHS (over 75%) do not have the opportunity to participate in the school meal program because they bully and the above stated lunch period (30 minutes) limits participation. A new cafeteria is needed at MHS as the old one in 1970 when the school was constructed in 1970 when the school population was 301 students whereas this population today is 1,225 students.

The old cafeteria will be converted into two (2) classrooms. Total cost \$1.1 million. The cost is based upon the cost of the San Vicente Cafeteria Project.

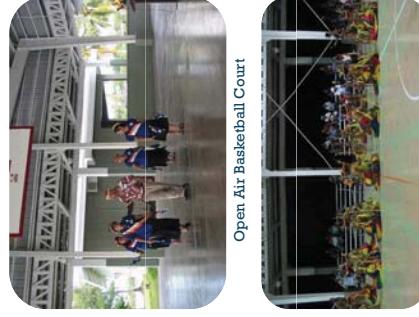
**+ Gymnasium Projects**

PSS has plans for open-air outdoor covered gyms or courts at the Saipan Southern High School, Chalan Chalan High School, and Chalan Opoli High School. Providing a gymnasium at these three locations will provide a community asset in two of the most populated areas of Saipan and Tinian. We have decided on an outdoor gym to decrease the energy costs of running the facility. There will still be a need for an indoor area for storage of equipment, offices, and for a weight room. We will also have an area to make it a facility as green as possible with the use of Solar and Wind energy to power the facilities.
