# Hazardous Building Materials Assessment

**Port of Tacoma  
Crane 2078  
Tacoma, WA**

**Original Assessment Date:  
06 August 2019**

**Revised Assessment Date:  
10 June 2025**

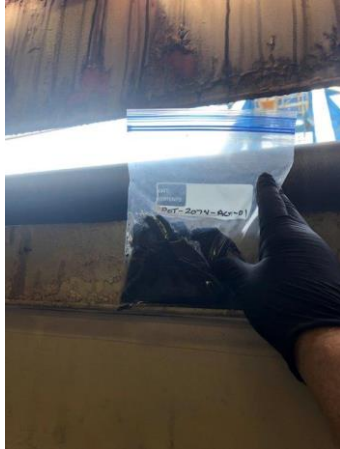
Sample ID: POT-2078-ACM-01

| Sample ID | Material Description | Sample Location | Concentration | Material Quantity Estimate (if applicable) |
|---|--|---|---|--|
| POT-2078-ACM-01 | Layer 1: Black crumbly material embedded with gray interwoven fibrous material and paint | Crane 2078 | ACM (%): ND | NA |

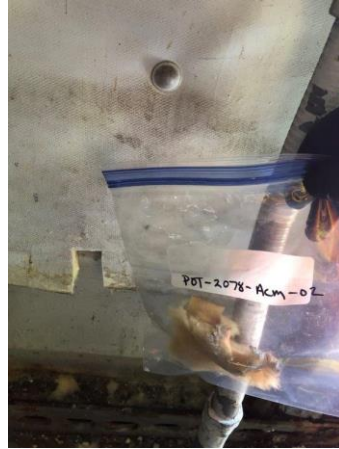
Sample ID: POT-2078-ACM-02

| Sample ID | Material Description | Sample Location | Concentration | Material Quantity Estimate (if applicable) |
|---|--|---|---|--|
| POT-2078-ACM-02 | Layer 1: White interwoven fibrous material with paint | Crane 2078 | ACM (%): ND | NA |

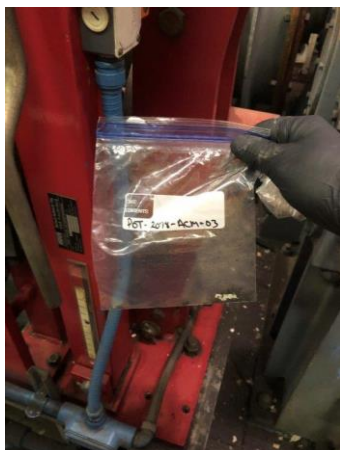
Sample ID: POT-2078-ACM-03

| Sample ID | Material Description | Sample Location | Concentration | Material Quantity Estimate (if applicable) |
|---|--|---|---|--|
| POT-2078-ACM-03 | Layer 1: Black flaky fibrous material with paint | Crane 2078 | ACM (%): ND | NA |

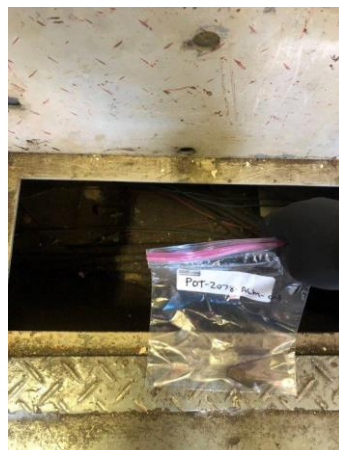
Sample ID: POT-2078-ACM-04

| Sample ID | Material Description | Sample Location | Concentration | Material Quantity Estimate (if applicable) |
|---|--|---|---|--|
| POT-2078-ACM-04 | Layer 1: Black rubbery material with debris | Crane 2078 | ACM (%): ND | NA |

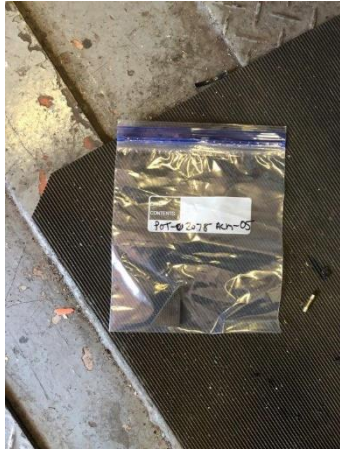
Sample ID: POT-2078-ACM-05

| Sample ID | Material Description | Sample Location | Concentration | Material Quantity Estimate (if applicable) |
|---|--|---|---|--|
| POT-2078-ACM-05 | Layer 1: Black rubbery material | Crane 2078 | ACM (%): ND | NA |

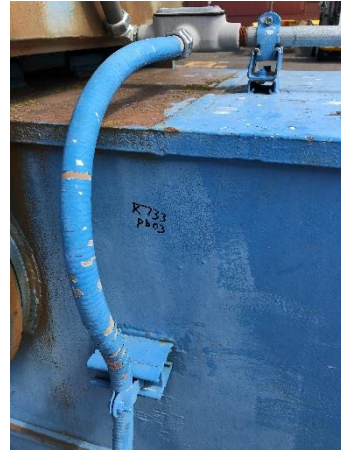
Sample ID: Index# 733-Pb

| Sample ID | Space Name | Component | Substrate | Color | Condition | Concentration | Notes |
|---|---|---|---|---|---|---|---|
| Index# 733<br>Crane 2078 | Exterior | Supporting Framework | Metal | Light Blue | Deteriorated | Lead Concentration:<br>1.3 mg/cm <sup>2</sup> | |

Lead was detected in some of the building materials sampled. Therefore, we recommend implementation of engineering and work practice controls to reduce and maintain employee exposure to lead to or below the permissible exposure limit<sup>2</sup> to the extent that such controls are feasible in accordance with WAC 296-155-17611.

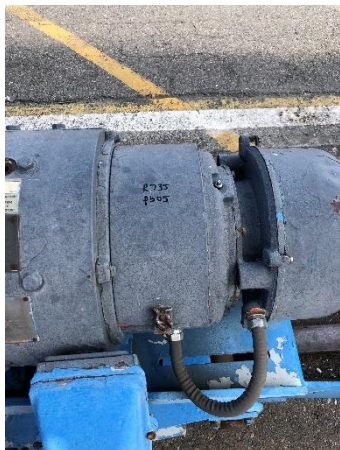
Sample ID: Index# 735-Pb

| Sample ID | Space Name | Component | Substrate | Color | Condition | Concentration | Notes |
|---|---|---|---|---|---|---|---|
| Index# 735<br>Crane 2078 | Exterior | Supporting Framework | Metal | Grey | Deteriorated | Lead Concentration:<br>2.9 mg/cm <sup>2</sup> | |

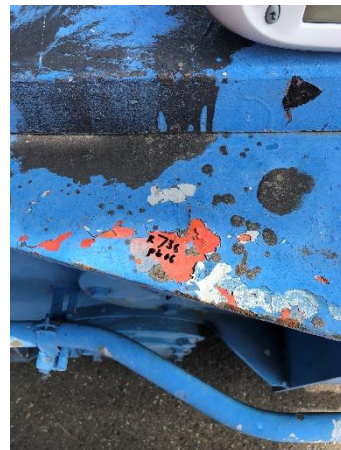
Sample ID: Index# 736-Pb

| Sample ID | Space Name | Component | Substrate | Color | Condition | Concentration | Notes |
|---|---|---|---|---|---|---|---|
| Index# 736<br>Crane 2078 | Exterior | Supporting Framework | Metal | Red | Deteriorated | Lead Concentration:<br>4.7 mg/cm <sup>2</sup> | |

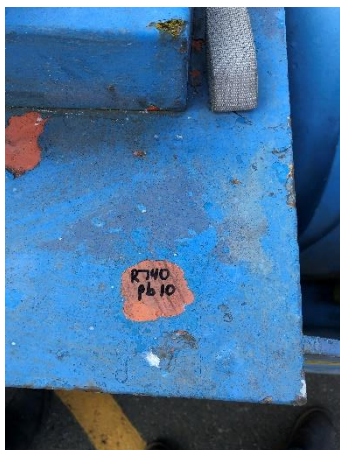
Sample ID: Index# 740-Pb

| Sample ID | Space Name | Component | Substrate | Color | Condition | Concentration | Notes |
|---|---|---|---|---|---|---|---|
| Index# 740<br>Crane 2078 | Exterior | Supporting Framework | Metal | Red | Deteriorated | Lead Concentration:<br>3.6 mg/cm <sup>2</sup> | |

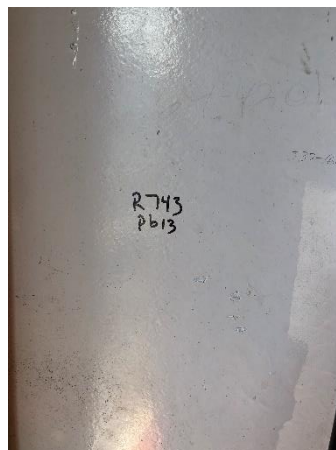
Sample ID: Index# 743-Pb

| Sample ID | Space Name | Component | Substrate | Color | Condition | Concentration | Notes |
|---|---|---|---|---|---|---|---|
| Index# 743<br>Crane 2078 | Exterior | Supporting Framework | Metal | White | Deteriorated | Lead Concentration:<br>2.9 mg/cm <sup>2</sup> | |

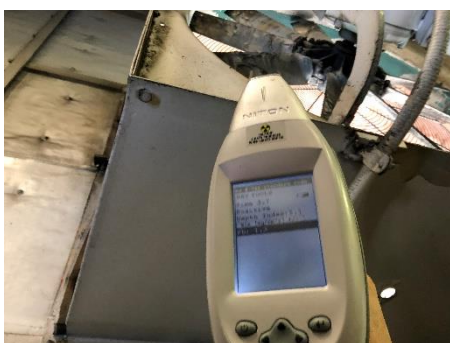
Sample ID: Index# 746-Pb

| Sample ID | Space Name | Component | Substrate | Color | Condition | Concentration | Notes |
|---|---|---|---|---|---|---|---|
| Index# 746<br>Crane 2078 | Exterior | Supporting Framework | Metal | White | Deteriorated | Lead Concentration:<br>1.3 mg/cm <sup>2</sup> | |
