# RP4.2-TY11 No Audio

**Correcting the "No Audio" issue in 2004 - 06  
Lexus LS430's with the Mark Levinson Audio System**

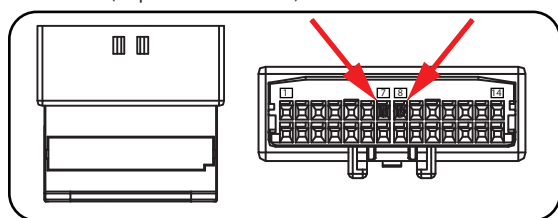
FIG A. (28 pin RP4.2 connector)

**Condition:** No audio heard from the amplifier and amplifier settings not showing in the RadioPro PC Application.

**Fix:** Locate the data wires in the 28 pin connector (FIG A.) of the RP4.2-TY11-HAR. They are the Pink and Pink/Black twisted pair of wires in pins 7 and 8. They need to be cut away from the 28 pin connector and connected to the Data wires in the vehicles 12 pin radio connector (FIG C.). The pink wire will need to be connected to Pin 9 (Yellow) of the 12 pin vehicle connector. The Pink/Black wire will need to be connected to Pin 10 (Black) of the 12 pin vehicle connector.
