Accomplishments and Improvements

PROJECT E1: Coyote Creek Flood Protection Project

PRIORITY E Provide flood protection to homes, businesses, schools, streets and highways

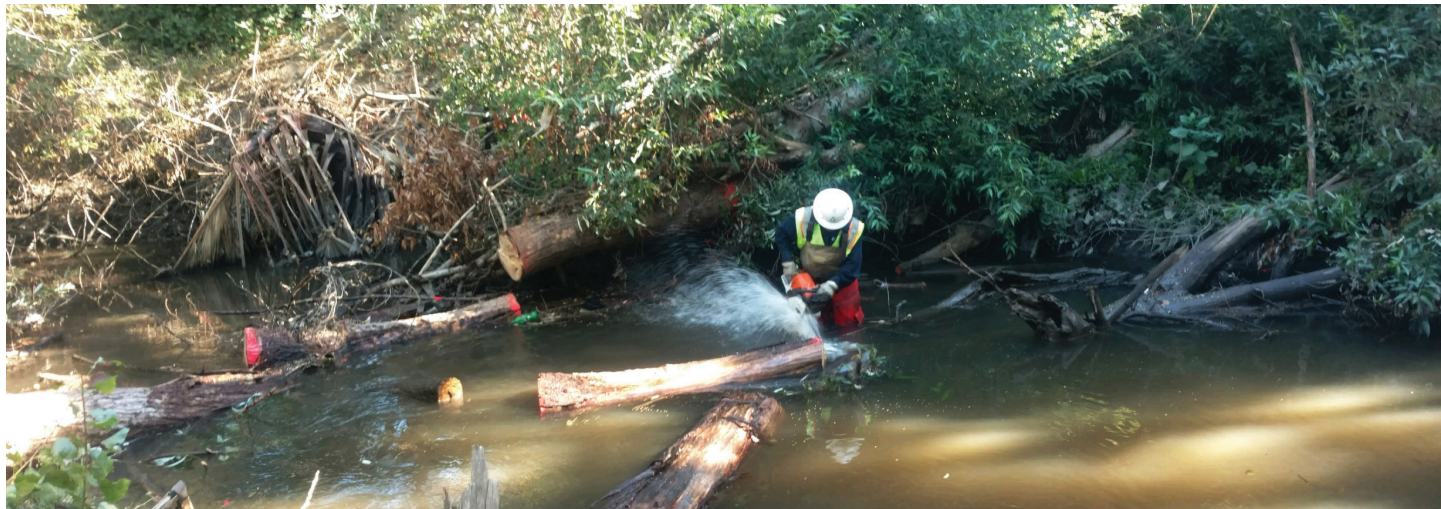
Valley Water crews saw and removed logs along Coyote Creek.

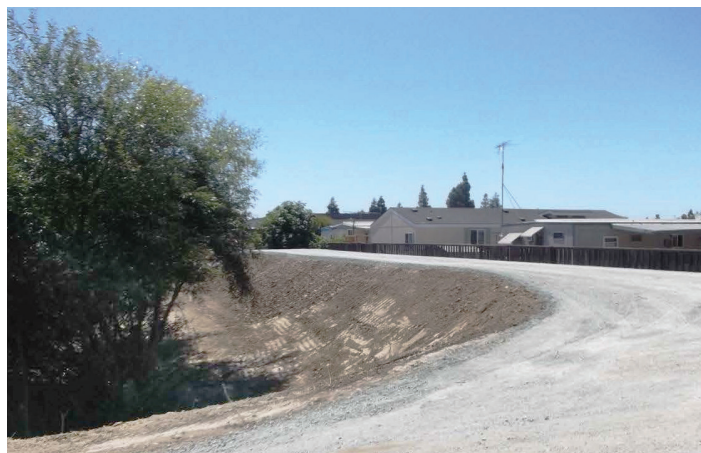
A repaired levee behind the Golden Wheel Mobile Home Park.

Valley Water also repaired a levee damaged when floodwaters spilled over it and entered the Golden Wheel Mobile Home Park. Crews repaired about 150 linear feet of levee that runs along the back of that mobile home community location.

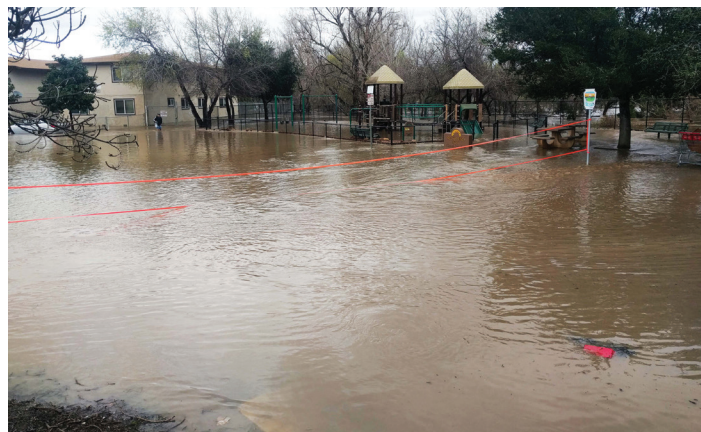
The flooded Rocksprings neighborhood in February 2017.

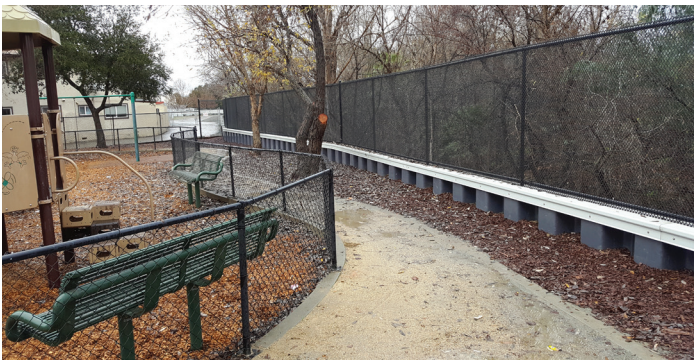
A berm, which is similar to a flood barrier, was installed at Rocksprings Park to help reduce future flood risks.

Construction crews installed 400 feet of vinyl sheet pile wall with a maximum height of up to 3-feet tall and 500 feet of earthen berm with a maximum height of up to 5-feet tall. These measures matched the peak water surface elevation seen in this area during the February 2017 flood event.

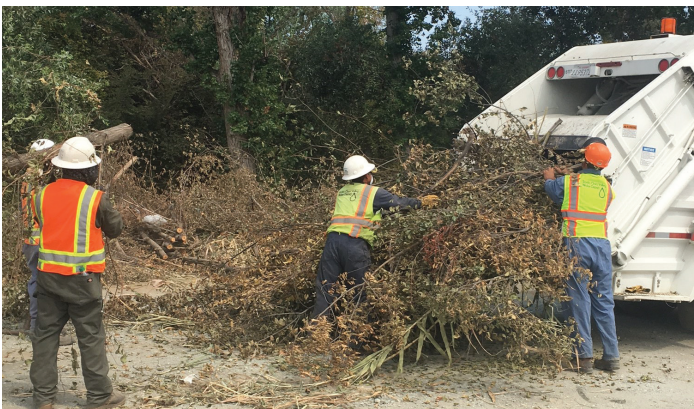
Valley Water crews perform maintenance work along Coyote Creek.

The City of San José granted Valley Water access to city-owned property along Coyote Creek to remove approximately 15 acres of invasive vegetation to benefit ecological habitat and improve the creek's capacity to carry stormwater. Additionally, Valley Water removed almost 4 acres of thickets of Arundo Donax. This giant, invasive weed can act as a barrier, preventing water from moving efficiently through the creek during high flows. Valley Water used its stream maintenance crews to remove this invasive vegetation on district and city-owned property.

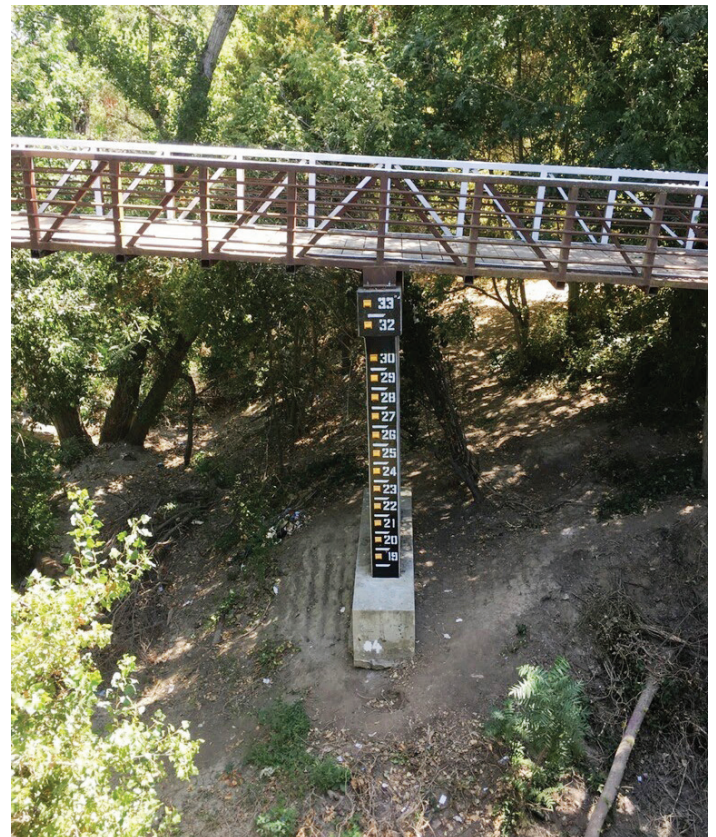
Visible stream gauges were placed at various locations along Coyote Creek to provide "real-time" information on water levels.

As part of the EAP, district staff repaired existing flood gauges and installed several new gauges at various bridge locations along Coyote Creek. Flood gauges provide visual information on water height in the creek, which helps Valley Water and the City of San José determine necessary responses during a major storm. The gauges also provide the public with real-time information about flood levels in the creek.
