# PORT OF TACOMA

### 2021 PIER REPAIRS (PILE CRACKS, SPALL REPAIRS AND MOORING COATING) - EB1, WUT, AND PIER 3

### PROJECT NO. 201130.01, 201130.02, AND 201130.03

### CONTRACT NO. 071569

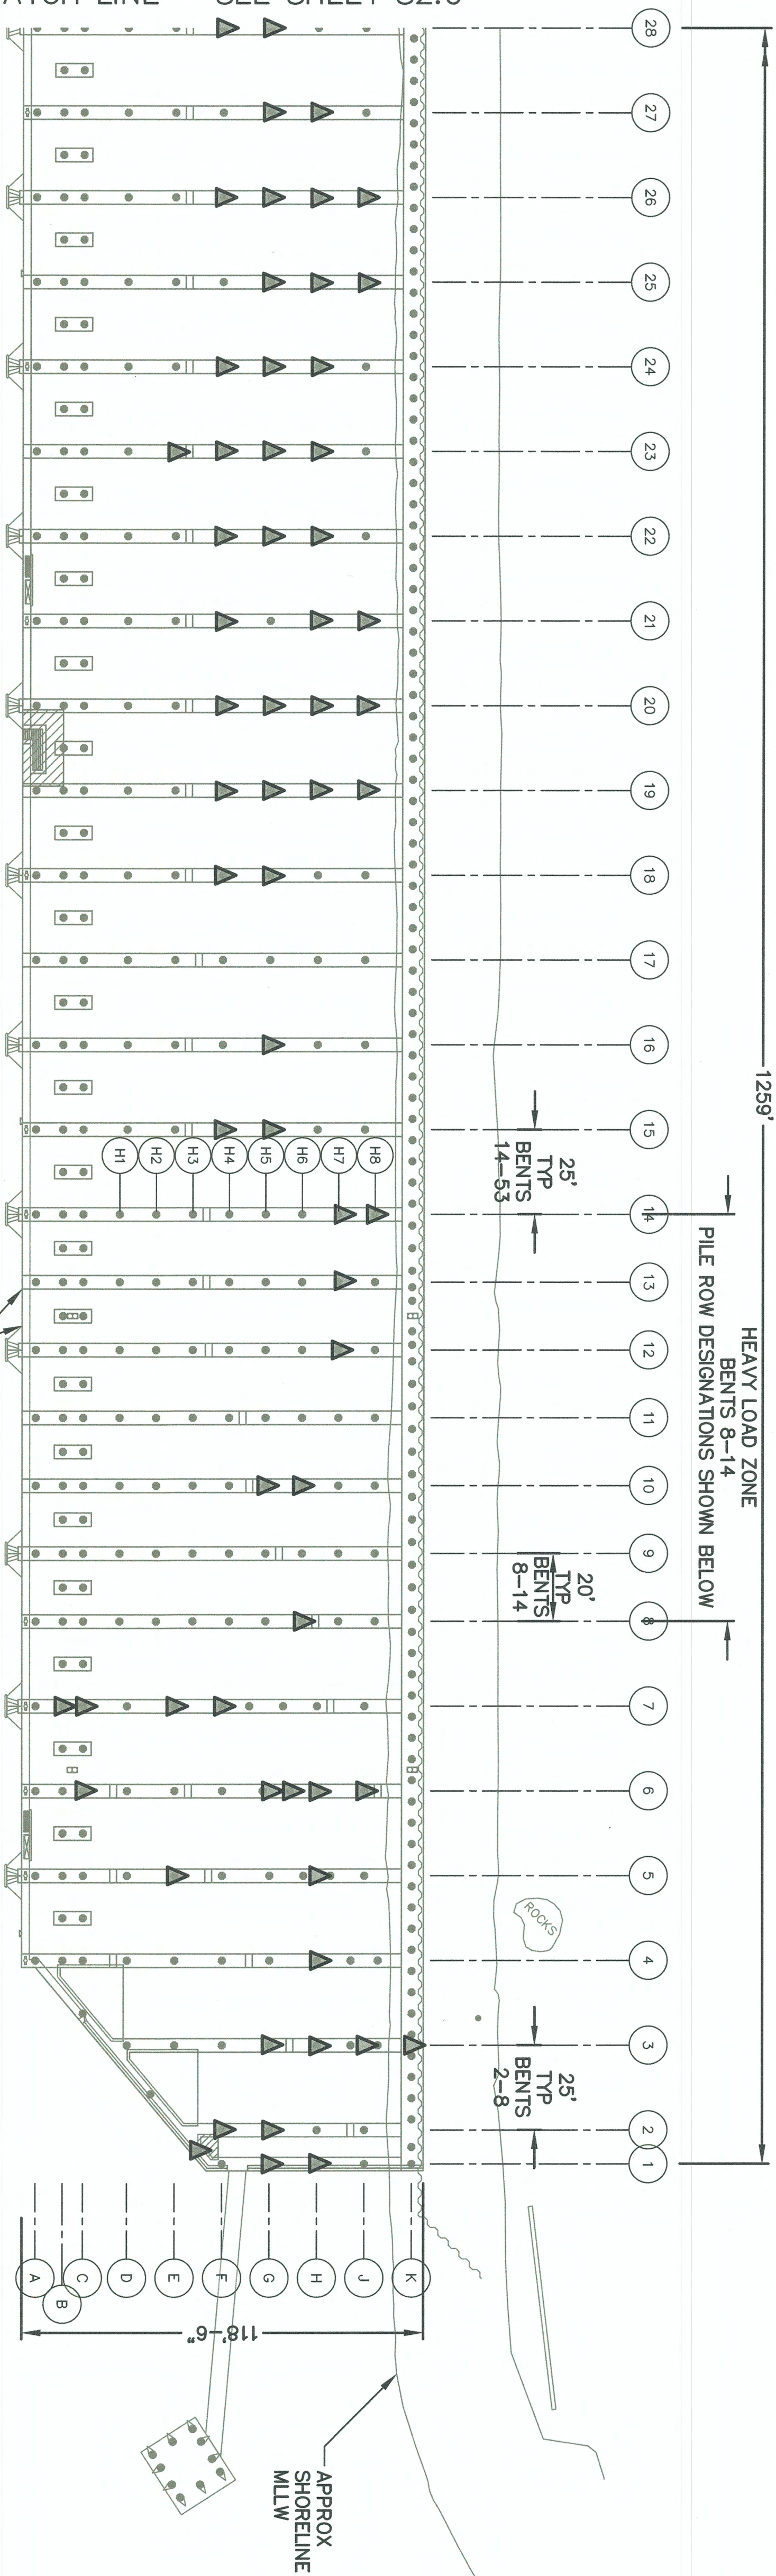
1  
G2.0  
EB1 WHARF - REPAIR PLAN (1 OF 2)  
SCALE: 1"=30'

P1  
-  
EDGE BEAM SPALL - BENT 12.25  
LOOKING EAST

P2  
-  
EDGE BEAM SPALL - BENT 13  
LOOKING EAST

▲ SURFACE APPLIED EPOXY CRACK REPAIR

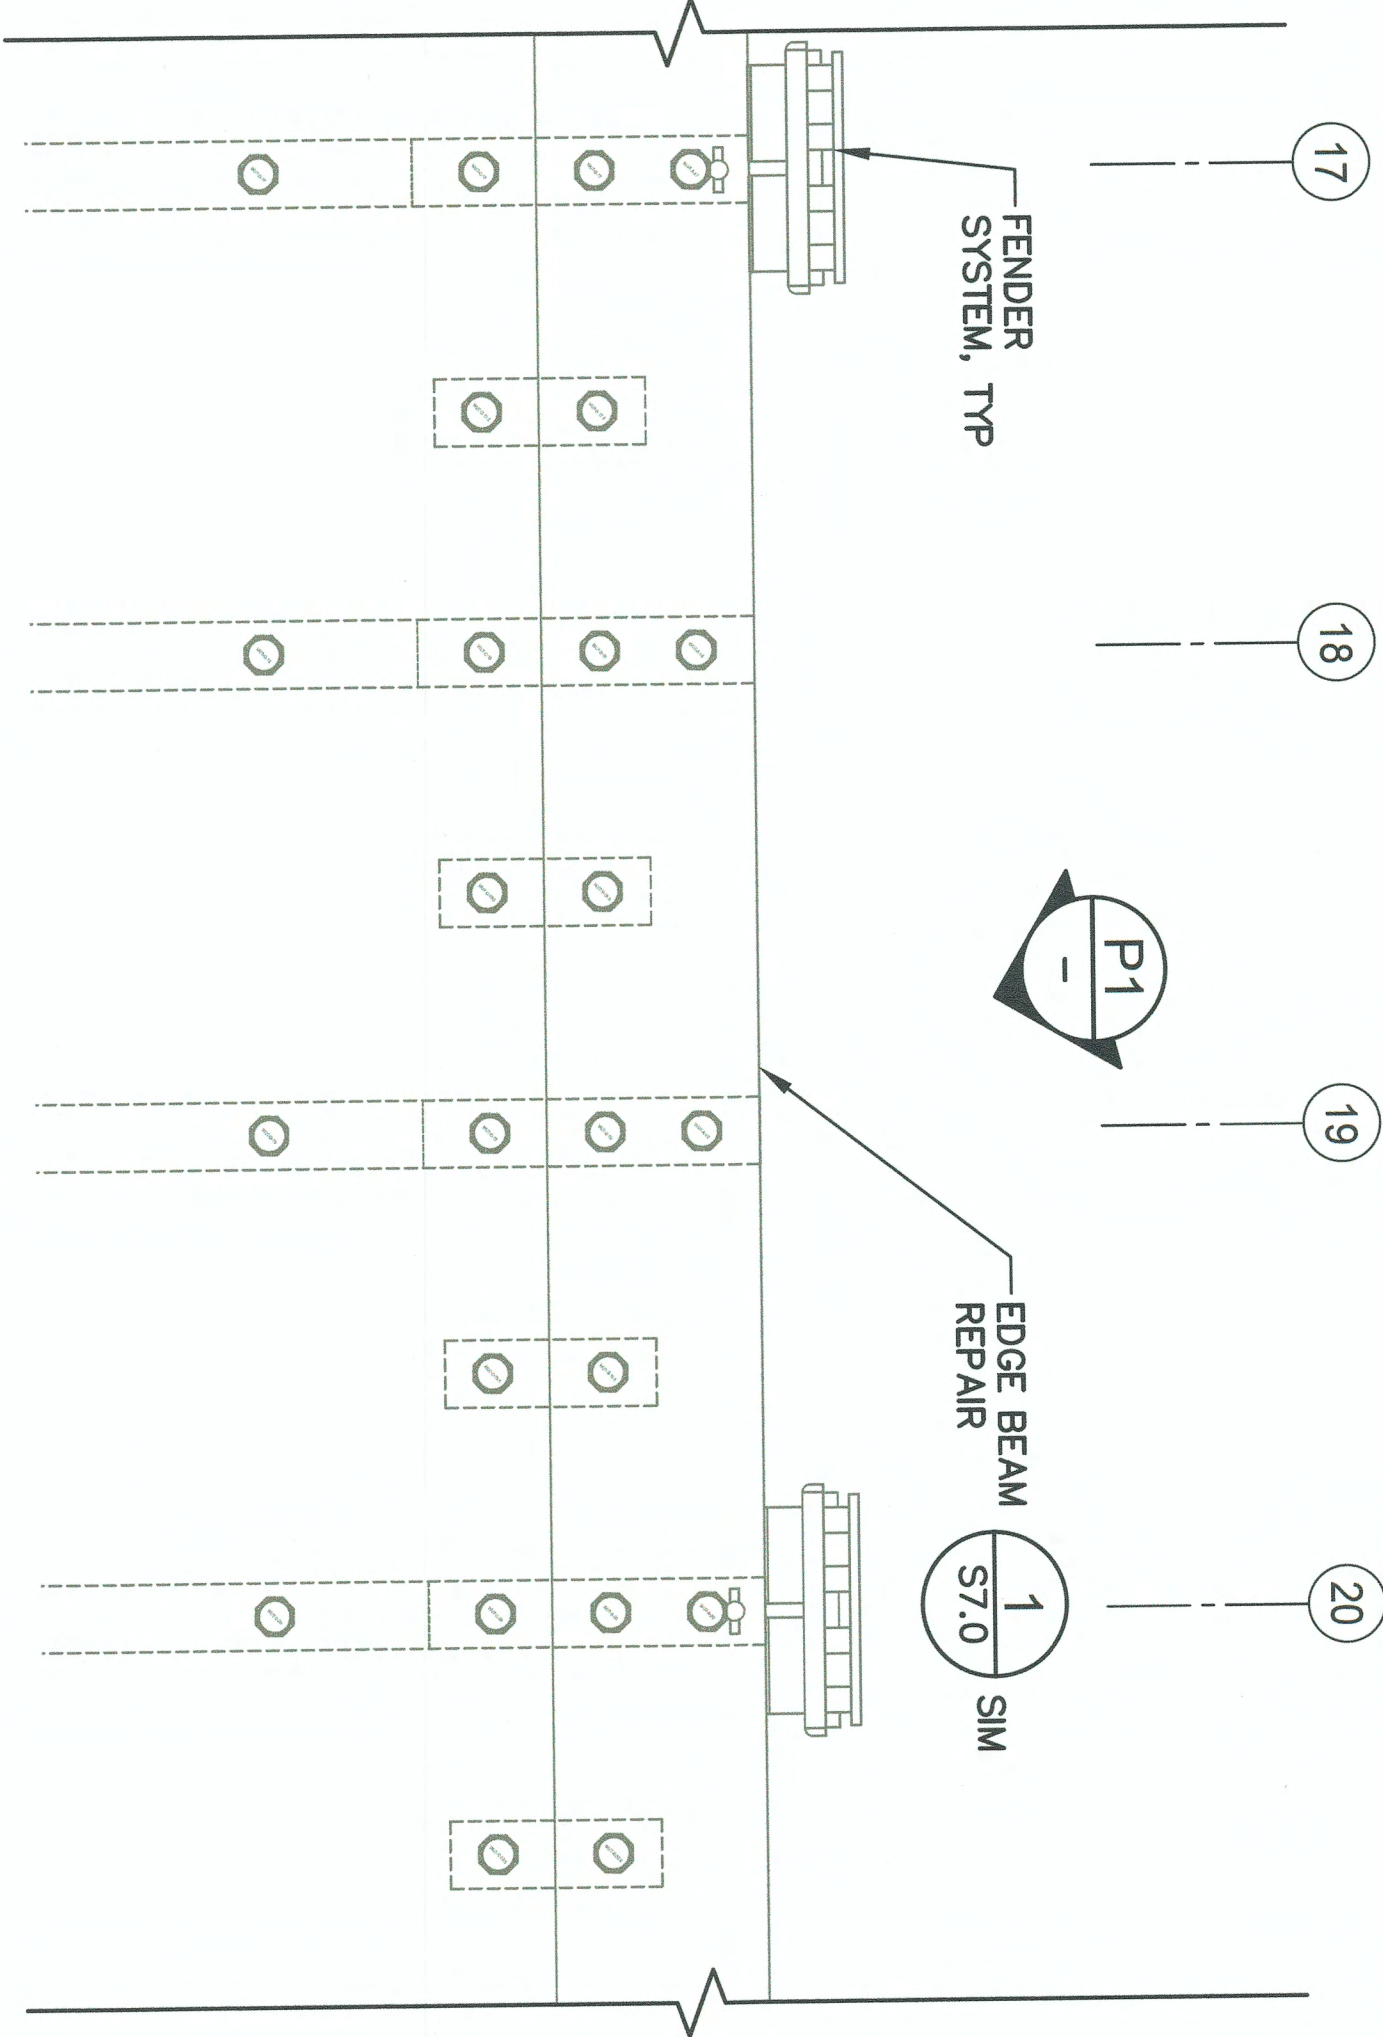
1  
G4.0  
WUT REPAIR PLAN - BENT 19  
SCALE: 1"=10'

P1  
-  
EDGE BEAM SPALL - BENT 19  
LOOKING SOUTH

| CONCRETE SPALL REPAIR QUANTITIES | | | | | |
|---|---|---|---|---|---|
| WUT | BENT 19 | EDGE BEAM | 1/S7.0 (SIM) | 2 | CF |

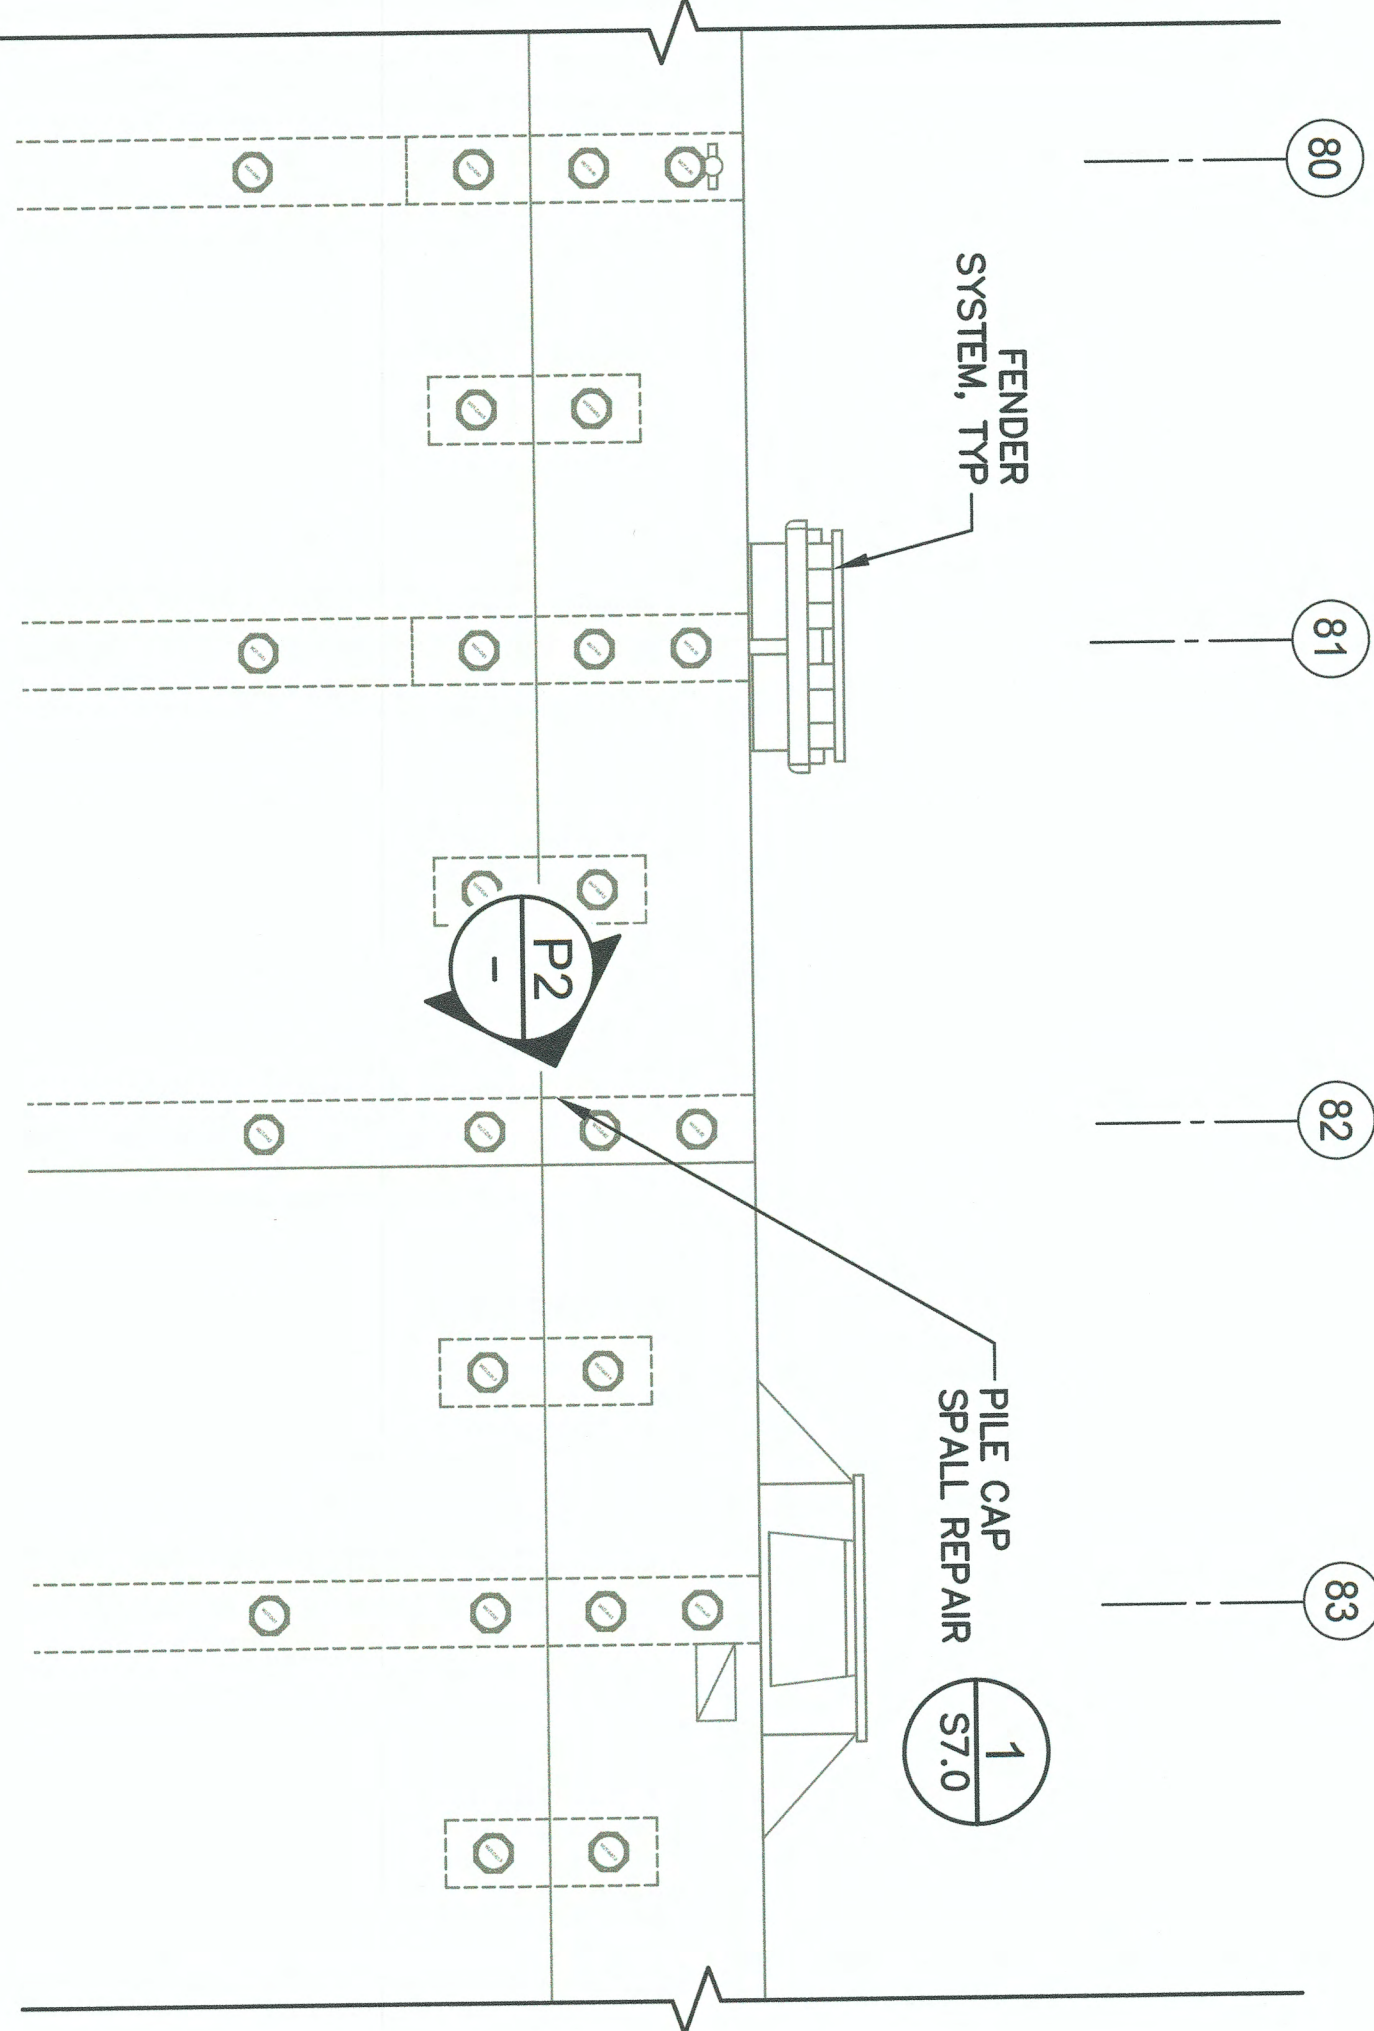
2  
G4.0  
WUT REPAIR PLAN BENT 82  
SCALE: 1"=10'

P2  
-  
PILE CAP SPALL - BENT 82:B  
LOOKING SOUTH

| CONCRETE SPALL REPAIR QUANTITIES | | | | | |
|---|---|---|---|---|---|
| WUT | BENT 82:B | PILE CAP | 1/S7.0 | 1.5 | CF |

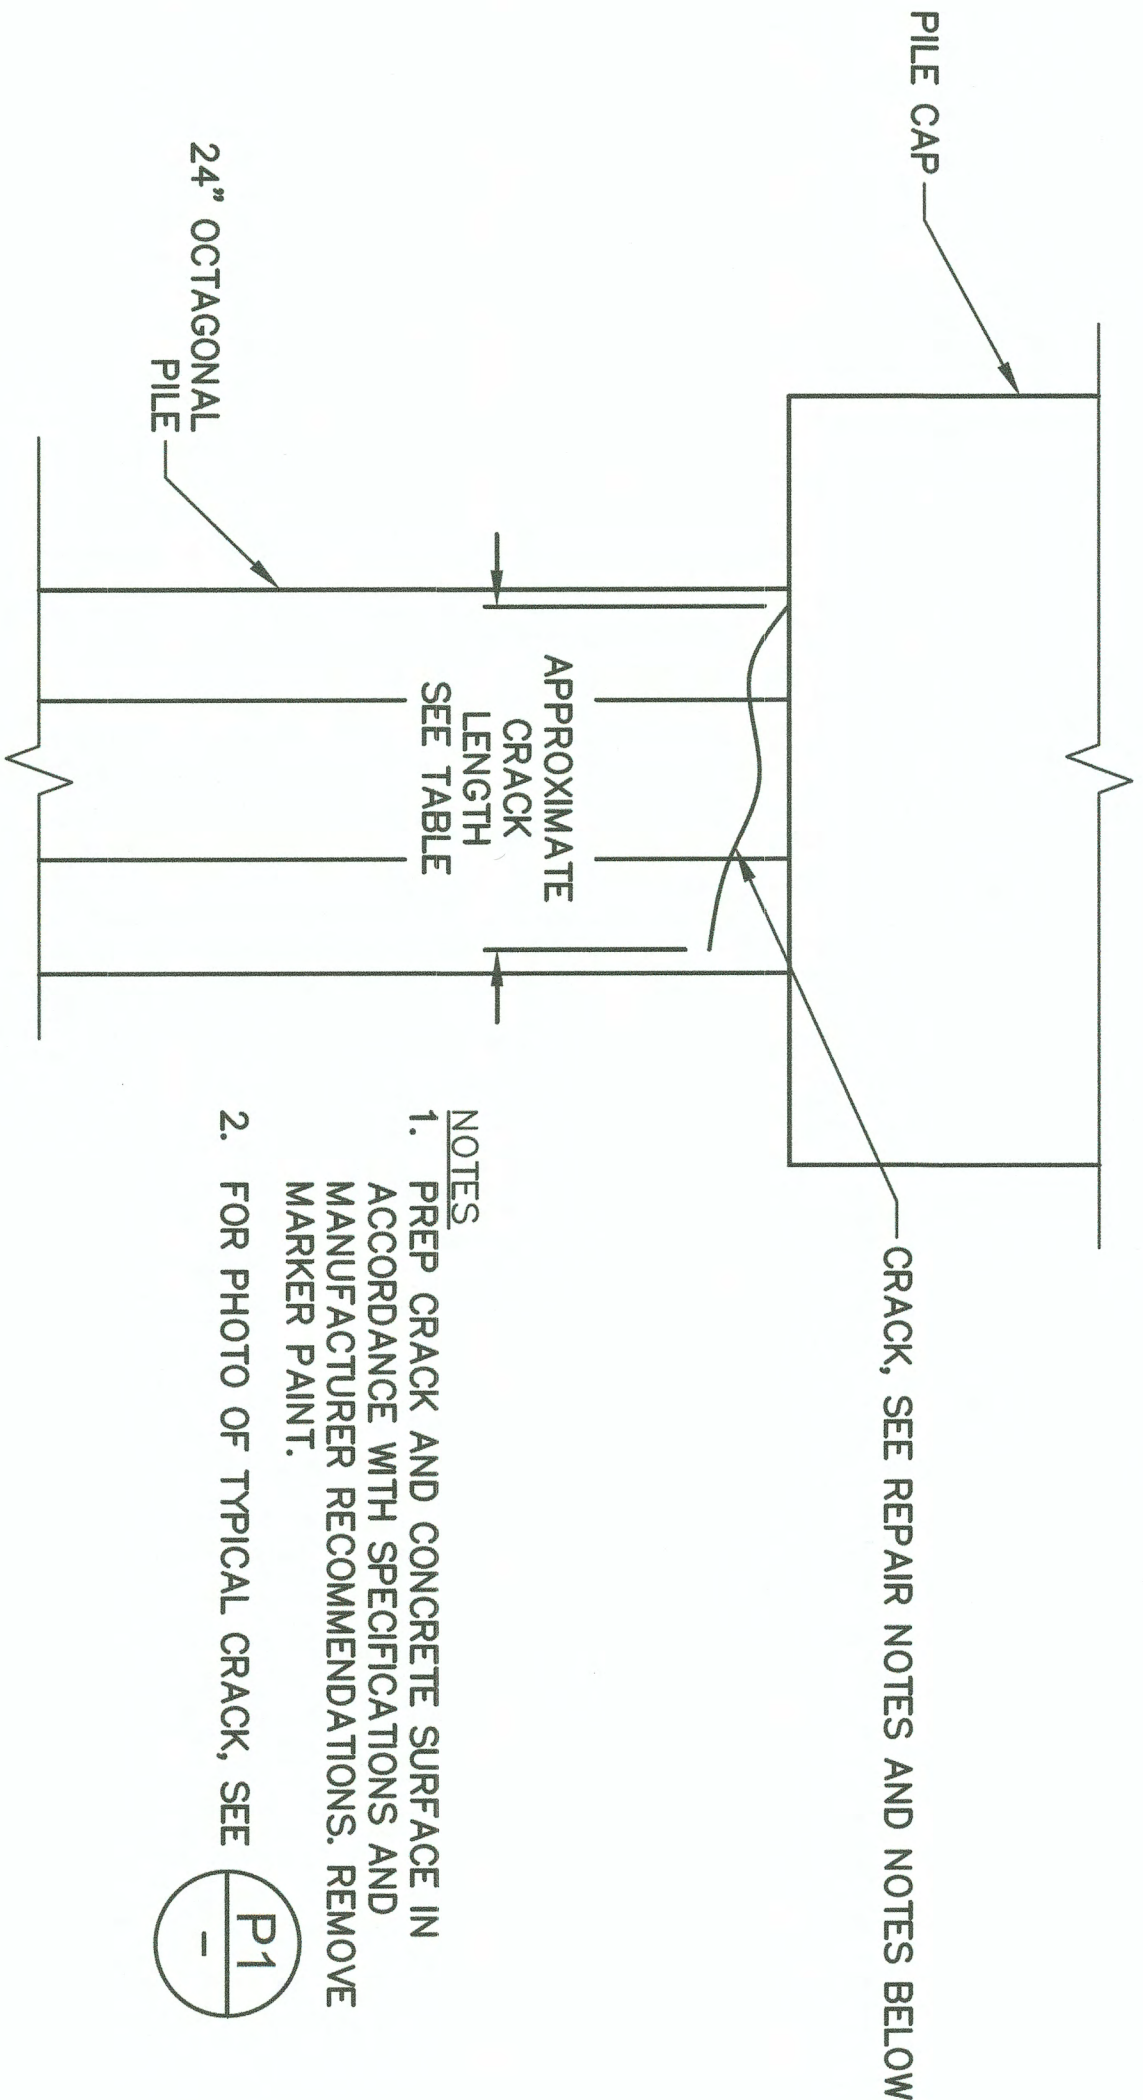
2  
DETAIL - SURFACE APPLIED EPOXY CRACK REPAIR

EXISTING CRACK, MARKED WITH WHITE PAINT

- NOTES
1. PREP CRACK AND CONCRETE SURFACE IN ACCORDANCE WITH SPECIFICATIONS AND MANUFACTURER RECOMMENDATIONS. REMOVE MARKER PAINT.
2. FOR PHOTO OF TYPICAL CRACK, SEE P1
