**THURSTON COUNTY**  
**FACILITY CONDITION ASSESSMENT**  
**FINAL REPORT**  
**MAY 27, 2016**

## I. EXECUTIVE SUMMARY

Thurston County engaged MENG Analysis to conduct Facility Condition Assessments (FCAs) of 21 County owned, operated, and managed facilities. This report includes both summary and detailed results of that assessment.

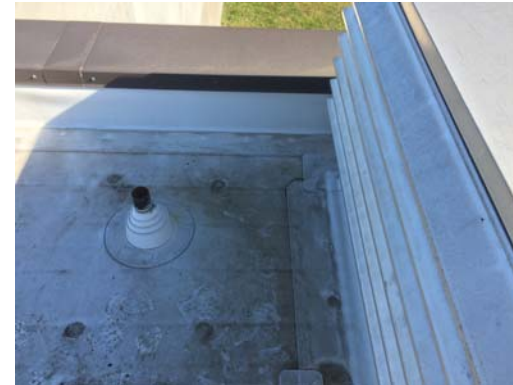
Material	Cond.	Material Useful Life	Survey Year	Condition Notes	Qty	Unit Cost	Unit	Direct Constr. Cost	Marked Up Cost
Deficiency				Action					
Facility: Accountability and Restitution Building					Total System Deficiency Repair Cost (Undiscounted/Unescalated):				\$70,000
System: Plumbing					Total System Deficiency Repair Cost (Marked Up):				\$170,625
Sanitary Waste									
Waste Piping/Vent	4	2	2016		1	\$60,000.00	LS	\$60,000	\$146,250
System at roof penetration is not code compliant.				Modify existing system to correct.

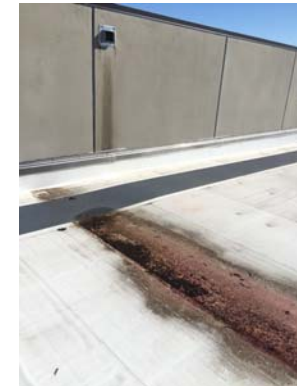
Downspout system does not allow for positive drainage from flashings and exterior walls.

Add downspouts

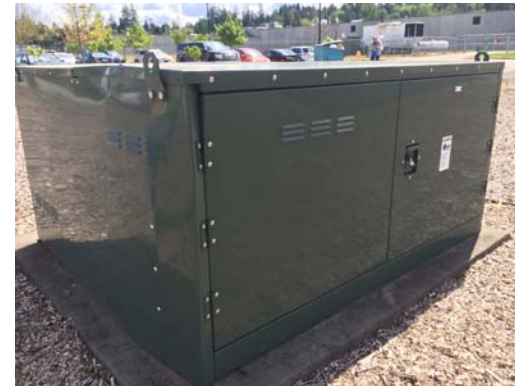
Material	Cond.	Material Useful Life	Survey Year	Condition Notes	Qty	Unit Cost	Unit	Direct Constr. Cost	Marked Up Cost
Deficiency				Action					
Facility: Accountability and Restitution Infrastructure					Total System Deficiency Repair Cost (Undiscounted/Unescalated):				\$7,500
System: Site Electrical utilities					Total System Deficiency Repair Cost (Marked Up):				\$18,281
Site Lighting									
Primary electrical gear	5	0	2016		1	\$7,500.00	LS	\$7,500	\$18,281
Sectionalizing gear is physically damaged.				Repair damage.

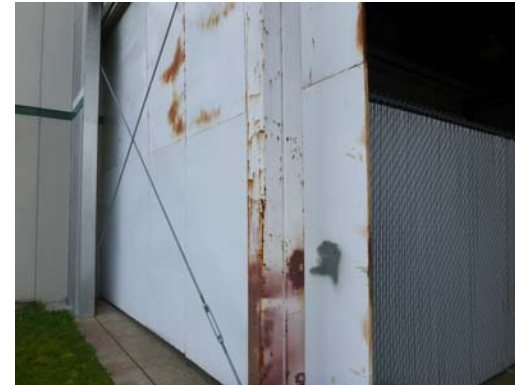
Material	Cond.	Material Useful Life	Survey Year	Condition Notes	Qty	Unit Cost	Unit	Direct Constr. Cost	Marked Up Cost
Deficiency				Action					
Facility: ARC Work Release Building					Total System Deficiency Repair Cost (Undiscounted/Unescalated):				\$7,000
System: Roofing					Total System Deficiency Repair Cost (Marked Up):				\$17,063
Projections									
Storage Canopy	4	2	2016		1	\$7,000.00	LS	\$7,000	\$17,063
Steel columns and frame are rusted.				Prep and re-paint steel structure.

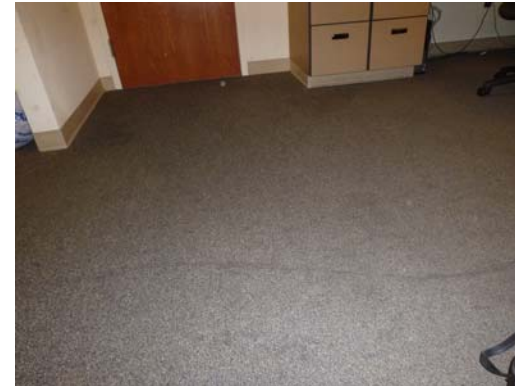
Material	Cond.	Material Useful Life	Survey Year	Condition Notes	Qty	Unit Cost	Unit	Direct Constr. Cost	Marked Up Cost
Deficiency				Action					
Facility: Evaluation and Treatment Building					Total System Deficiency Repair Cost (Undiscounted/Unescalated):				\$33,500
System: Interior Finishes					Total System Deficiency Repair Cost (Marked Up):				\$81,656
Floor Finishes									
Carpet	4	4	2016		5,000	\$6.70	SF	\$33,500	\$81,656
Carpet is worn.				Remove and replace with new carpet.

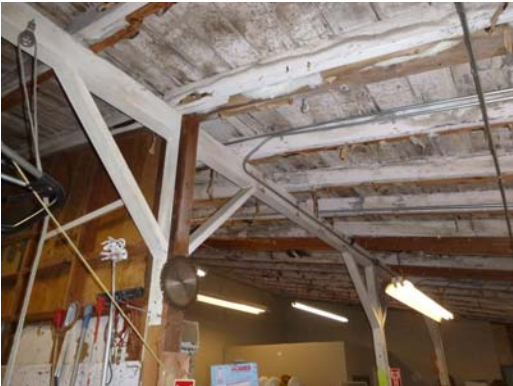
Material		Cond.	Material Useful Life	Survey Year	Condition Notes	Qty	Unit Cost	Unit	Direct Constr. Cost	Marked Up Cost
Deficiency					Action					
Facility:	Heritage Hall				Total System Deficiency Repair Cost (Undiscounted/Unescalated):					\$45,600
System:	Superstructure				Total System Deficiency Repair Cost (Marked Up):					\$111,150
Roof Construction										
Addition Roof Framing		4	4	2016		2,850	\$16.00	SF	\$45,600	\$111,150
Wood framing at addition, reported from recycled buildings, shows deterioration, poor condition.					Remove roofing and framing, reframe with new and install new roof insulation and roofing material.

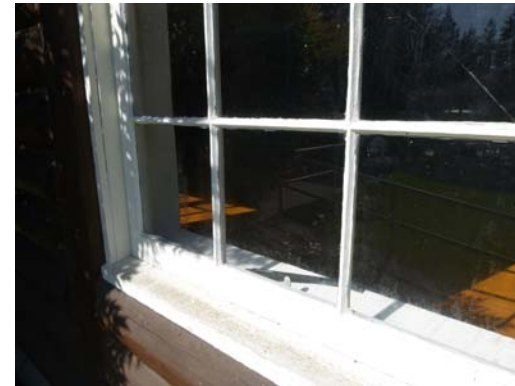
Material	Cond.	Material Useful Life	Survey Year	Condition Notes	Qty	Unit Cost	Unit	Direct Constr. Cost	Marked Up Cost
Deficiency				Action					
Facility: Heritage Hall					Total System Deficiency Repair Cost (Undiscounted/Unescalated):				\$90,150
System: Exterior Closure					Total System Deficiency Repair Cost (Marked Up):				\$219,740
Exterior Windows									
Windows	5	2	2016		230	\$255.00	SF	\$58,650	\$142,959
Single glazed windows in original wood frames, some newer windows set in original wood frames.				Remove and replace with historical register quality windows and frames.

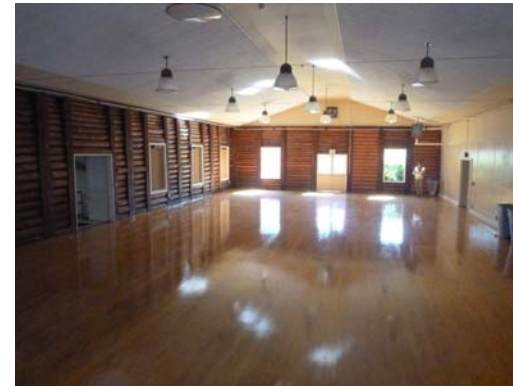
Material	Cond.	Material Useful Life	Survey Year	Condition Notes	Qty	Unit Cost	Unit	Direct Constr. Cost	Marked Up Cost
Deficiency				Action					
Facility: Heritage Hall					Total System Deficiency Repair Cost (Undiscounted/Unescalated):				\$60,450
System: Fire Protection					Total System Deficiency Repair Cost (Marked Up):				\$147,347
Fire Protection Sprinkler Systems									
Fire sprinkler system	5	0	2016		9,300	\$6.50	S.F.	\$60,450	\$147,347
No fire sprinkler system.				Install fire sprinkler system.

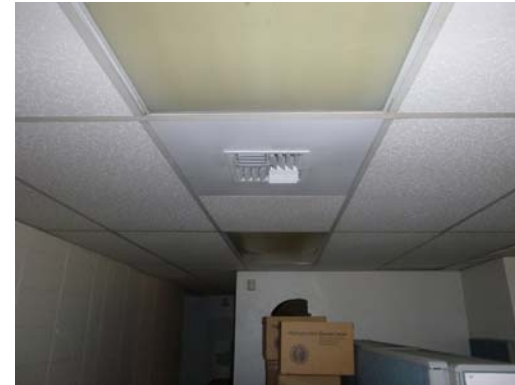
Material	Cond.	Material Useful Life	Survey Year	Condition Notes	Qty	Unit Cost	Unit	Direct Constr. Cost	Marked Up Cost
Deficiency				Action					
Facility: McLane Annex				Total System Deficiency Repair Cost (Undiscounted/Unescalated):					\$19,200
System: Fire Protection				Total System Deficiency Repair Cost (Marked Up):					\$46,800
Fire Protection Sprinkler Systems									
Fire sprinkler system	5	0	2016		3,200	\$6.00	SF	\$19,200	\$46,800
No fire sprinkler system.				Install sprinkler system.

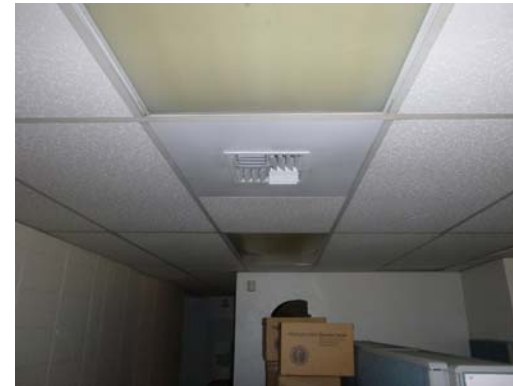
Material	Cond.	Material Useful Life	Survey Year	Condition Notes	Qty	Unit Cost	Unit	Direct Constr. Cost	Marked Up Cost
Deficiency				Action					
Facility: McLane Annex				Total System Deficiency Repair Cost (Undiscounted/Unescalated):					\$64,796
System: Electrical				Total System Deficiency Repair Cost (Marked Up):					\$157,940
Low Voltage Fire Alarm									
Fire alarm system	5	0	2016		3,200	\$2.25	SF	\$7,200	\$17,550
No fire alarm system				Install fire alarm system

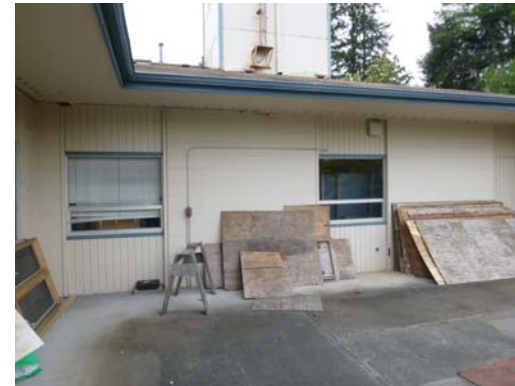
Material	Cond.	Material Useful Life	Survey Year	Condition Notes	Qty	Unit Cost	Unit	Direct Constr. Cost	Marked Up Cost
Deficiency				Action					
Facility: McLane Building					Total System Deficiency Repair Cost (Undiscounted/Unescalated):				\$24,125
System: Exterior Closure					Total System Deficiency Repair Cost (Marked Up):				\$58,804
Exterior Walls									
Wood Siding	4	4	2016		1	\$7,500.00	LS	\$7,500	\$18,281
Wood siding shows signs of deterioration and age.				Remove damaged siding and replace with new siding, prep and re-paint remaining wood siding.

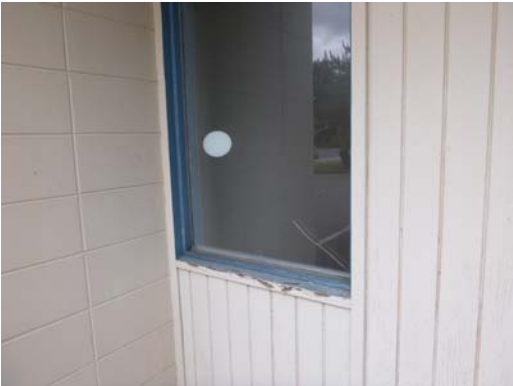
Material	Cond.	Material Useful Life	Survey Year	Condition Notes	Qty	Unit Cost	Unit	Direct Constr. Cost	Marked Up Cost
Deficiency				Action					
Facility:	McLane Building				Total System Deficiency Repair Cost (Undiscounted/Unescalated):				\$24,125
System:	Exterior Closure				Total System Deficiency Repair Cost (Marked Up):				\$58,804
Exterior Windows									
Windows	5	2	2016		175	\$95.00	SF	\$16,625	\$40,523
Original single glazed windows.				Remove and replace windows with new.

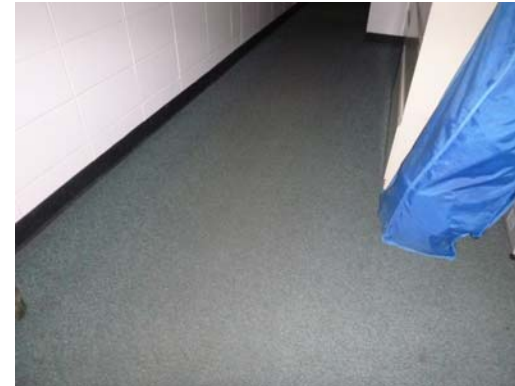
Material	Cond.	Material Useful Life	Survey Year	Condition Notes	Qty	Unit Cost	Unit	Direct Constr. Cost	Marked Up Cost
Deficiency				Action					
Facility: McLane Building				Total System Deficiency Repair Cost (Undiscounted/Unescalated):					\$80,510
System: Interior Finishes				Total System Deficiency Repair Cost (Marked Up):					\$196,244
Floor Finishes									
Flooring	4	1	2016		5,300	\$6.70	SF	\$35,510	\$86,556
Carpet and sheet vinyl in poor condition.				Remove carpet and sheet vinyl and replace with new flooring.

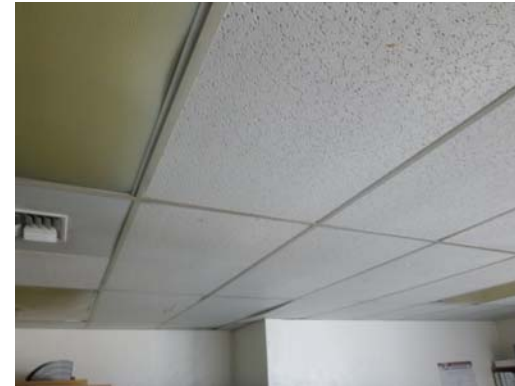
Material	Cond.	Material Useful Life	Survey Year	Condition Notes	Qty	Unit Cost	Unit	Direct Constr. Cost	Marked Up Cost
Deficiency				Action					
Facility: McLane Building					Total System Deficiency Repair Cost (Undiscounted/Unescalated):				\$80,510
System: Interior Finishes					Total System Deficiency Repair Cost (Marked Up):				\$196,244
Ceiling Finishes									
Ceiling Tile	4	2	2016		5,000	\$9.00	SF	\$45,000	\$109,688
2x4 ACT and 12x12 tiles in poor condition.				Remove tiles, abate as necessary, remove ACT system and replace both with new.

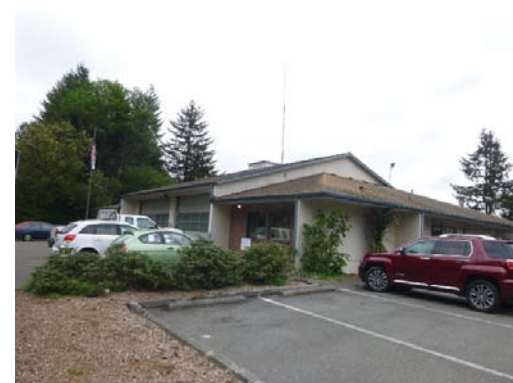
Material	Cond.	Material Useful Life	Survey Year	Condition Notes	Qty	Unit Cost	Unit	Direct Constr. Cost	Marked Up Cost
Deficiency				Action					
Facility: McLane Building					Total System Deficiency Repair Cost (Undiscounted/Unescalated):				\$37,026
System: Electrical					Total System Deficiency Repair Cost (Marked Up):				\$90,251
Electrical Service and Distribution									
Electrical service	4	5	2016		8,228	\$4.50	SF	\$37,026	\$90,251
Electrical service at end of useful life with little or no capacity for additional loads.				Replace electric service with modern 208V, 3-phase system, nominally 400A.

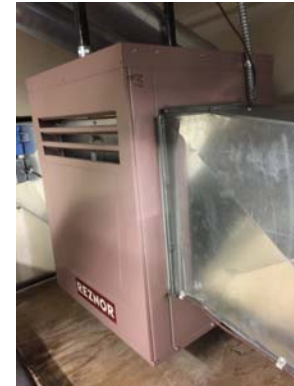
Material	Cond.	Material Useful Life	Survey Year	Condition Notes	Qty	Unit Cost	Unit	Direct Constr. Cost	Marked Up Cost
Deficiency				Action					
Facility: Thurston County Coroners Building					Total System Deficiency Repair Cost (Undiscounted/Unescalated):				\$35,000
System: HVAC					Total System Deficiency Repair Cost (Marked Up):				\$85,313
Heat Generating Systems									
Duct heater	4	2	2016		5	\$4,000.00	EA	\$20,000	\$48,750
Gas-fired duct heaters not operating correctly since original construction.				Repair or replace gas-fired duct heaters.

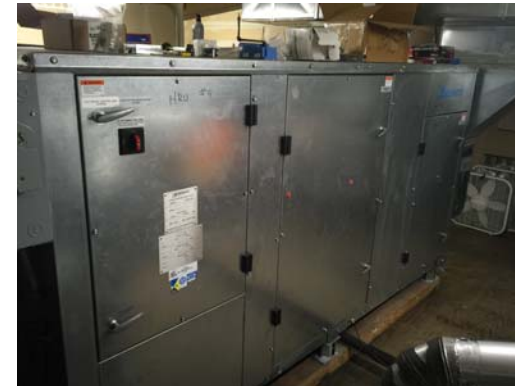
Material	Cond.	Material Useful Life	Survey Year	Condition Notes	Qty	Unit Cost	Unit	Direct Constr. Cost	Marked Up Cost
Deficiency				Action					
Facility: Thurston County Coroners Building					Total System Deficiency Repair Cost (Undiscounted/Unescalated):				\$35,000
System: HVAC					Total System Deficiency Repair Cost (Marked Up):				\$85,313
Heat Generating Systems									
Heat recovery wheel	5	0	2016		1	\$15,000.00	EA	\$15,000	\$36,563
Heat recovery wheel failed, with no heat recovery for 100% outside air system, wasting energy; reportedly system issues with cross-contamination.				Repair or replace heat recovery wheel in heat recovery unit, and modify system as necessary to eliminate cross-contamination.

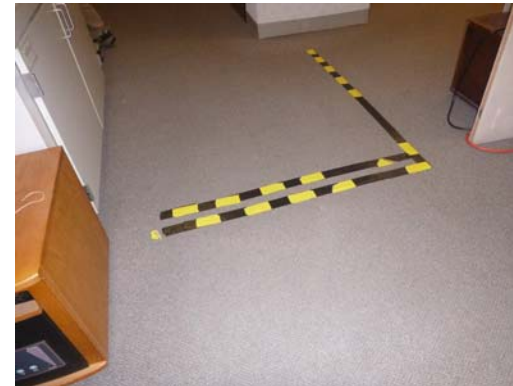
Material	Cond.	Material Useful Life	Survey Year	Condition Notes	Qty	Unit Cost	Unit	Direct Constr. Cost	Marked Up Cost
Deficiency				Action					
Facility: Thurston County Courthouse Building #1					Total System Deficiency Repair Cost (Undiscounted/Unescalated):				\$101,500
System: Superstructure					Total System Deficiency Repair Cost (Marked Up):				\$247,406
Floor Construction									
Floor framing	4	4	2016		14,500	\$7.00	SF	\$101,500	\$247,406
Floor framing sagging, plywood appears deteriorated in places.				Remove flooring, replace plywood where needed, relevel floor, replace flooring.

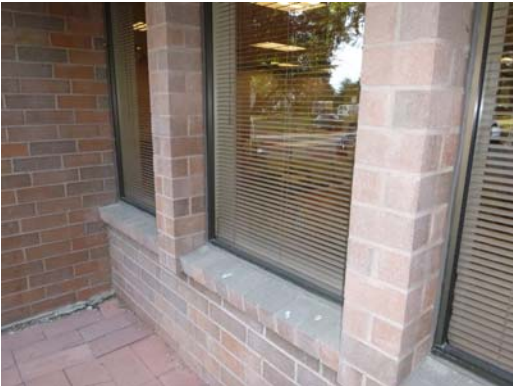
Material	Cond.	Material Useful Life	Survey Year	Condition Notes	Qty	Unit Cost	Unit	Direct Constr. Cost	Marked Up Cost
Deficiency				Action					
Facility:	Thurston County Courthouse Building #1				Total System Deficiency Repair Cost (Undiscounted/Unescalated):				\$278,800
System:	Exterior Closure				Total System Deficiency Repair Cost (Marked Up):				\$679,575
Exterior Windows									
Exterior windows	4	5	2016		2,800	\$95.00	SF	\$266,000	\$648,375
Windows are single glazed units.				Remove and replace windows and frames with new dual glazed units.

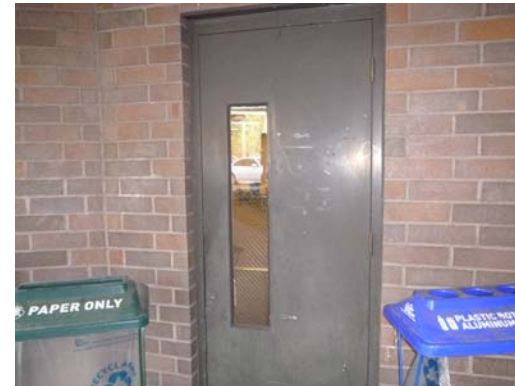
Material	Cond.	Material Useful Life	Survey Year	Condition Notes	Qty	Unit Cost	Unit	Direct Constr. Cost	Marked Up Cost
Deficiency				Action					
Facility: Thurston County Courthouse Building #1					Total System Deficiency Repair Cost (Undiscounted/Unescalated):				\$278,800
System: Exterior Closure					Total System Deficiency Repair Cost (Marked Up):				\$679,575
Exterior Doors									
Door Hardware	4	5	2016		8	\$950.00	EA	\$7,600	\$18,525
Door hardware in poor condition.				Remove and replace door hardware with new accessible hardware.

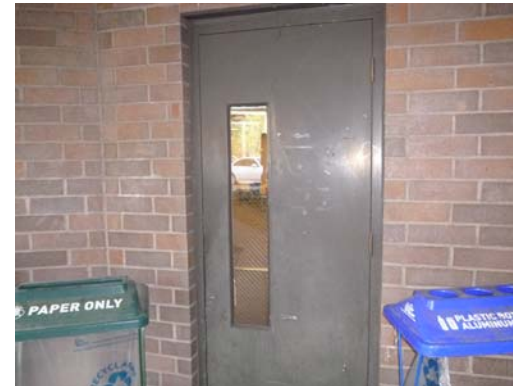
Material	Cond.	Material Useful Life	Survey Year	Condition Notes	Qty	Unit Cost	Unit	Direct Constr. Cost	Marked Up Cost
Deficiency				Action					
Facility: Thurston County Courthouse Building #1					Total System Deficiency Repair Cost (Undiscounted/Unescalated):				\$278,800
System: Exterior Closure					Total System Deficiency Repair Cost (Marked Up):				\$679,575
Exterior Doors									
HM Doors	4	2	2016		8	\$650.00	EA	\$5,200	\$12,675
HM doors dented, paint faded, scratches.				Prep and repaint exterior HM doors, adjust as necessary.

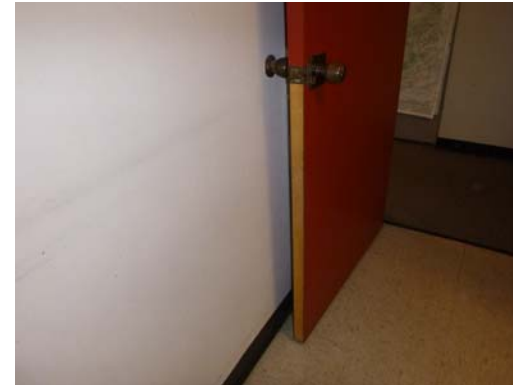
Material	Cond.	Material Useful Life	Survey Year	Condition Notes	Qty	Unit Cost	Unit	Direct Constr. Cost	Marked Up Cost
Deficiency				Action					
Facility: Thurston County Courthouse Building #1					Total System Deficiency Repair Cost (Undiscounted/Unescalated):				\$285,750
System: Interior Construction					Total System Deficiency Repair Cost (Marked Up):				\$696,516
Interior Doors									
Interior doors	4	5	2016		127	\$2,250.00	EA	\$285,750	\$696,516
Doors worn, de-laminating, hardware outdated.				Remove and replace with new doors in existing frames.

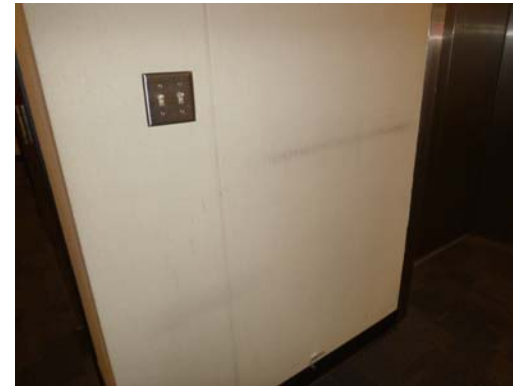
Vinyl wall covering aged, discolored, shows wear and tear.

Remove and replace with new vinyl wall covering.

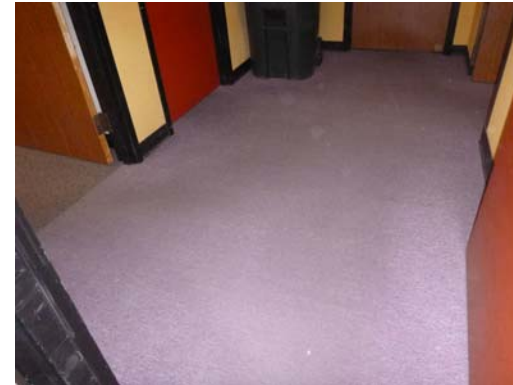
Material	Cond.	Material Useful Life	Survey Year	Condition Notes	Qty	Unit Cost	Unit	Direct Constr. Cost	Marked Up Cost
Deficiency				Action					
Facility: Thurston County Courthouse Building #1					Total System Deficiency Repair Cost (Undiscounted/Unescalated):				\$573,719
System: Interior Finishes					Total System Deficiency Repair Cost (Marked Up):				\$1,398,441
Floor Finishes									
Carpet	4	3	2016		35,000	\$6.70	SF	\$234,500	\$571,594
Carpet is old, stained and worn.				Remove and replace with new carpet.

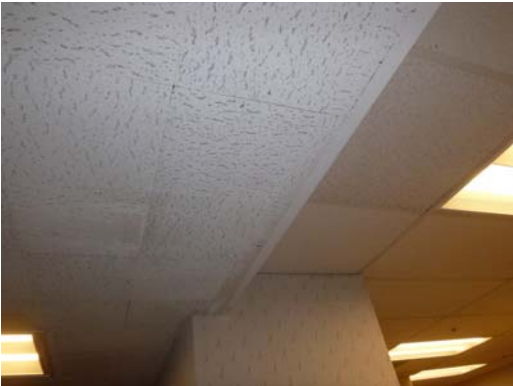
Material	Cond.	Material Useful Life	Survey Year	Condition Notes	Qty	Unit Cost	Unit	Direct Constr. Cost	Marked Up Cost
Deficiency				Action					
Facility:	Thurston County Courthouse Building #1				Total System Deficiency Repair Cost (Undiscounted/Unescalated):				\$573,719
System:	Interior Finishes				Total System Deficiency Repair Cost (Marked Up):				\$1,398,441
Ceiling Finishes									
ACT	4	4	2016		43,588	\$6.75	SF	\$294,219	\$717,159
Ceiling tiles and ACT worn and faded.				Remove older glue on tiles and ACT, replace with all new ACT system, abate as necessary.

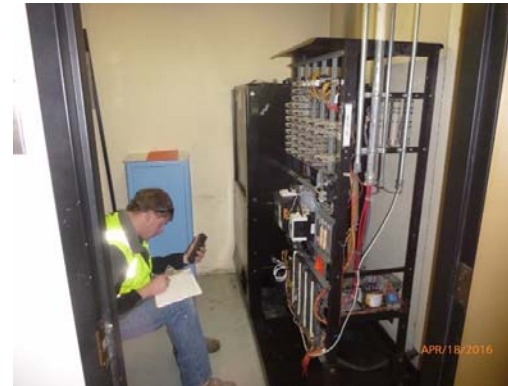
Original elevator in noisy and slow with obsolete relay control; operating under a non-compliance waiver from Labor & Industries.

Renew elevator; three-stop hydraulic, 4 klb capacity.

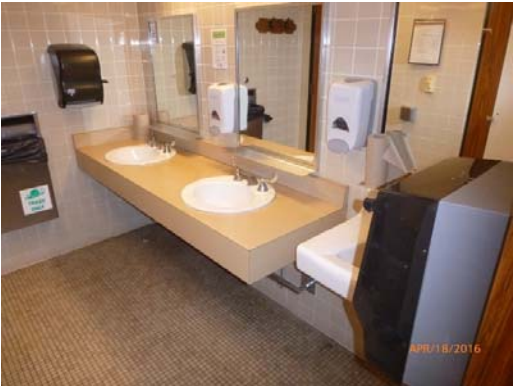
Original faucets at many lavatories are failing; some actively leaking.

Replace original faucets with modern County standard.

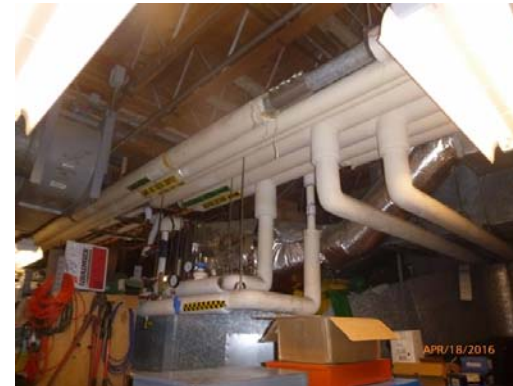
Original water service entry line is galvanized steel pipe with failures patched in several locations. No apparent backflow prevention at service entry.

Replace water service entry piping including code required backflow prevention.

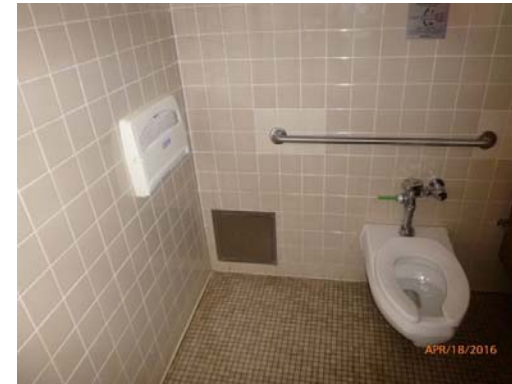
Reports of limited cast iron and/or galvanized drain, waste & vent piping failure (leaks).

Clean, test and inspect drain, waste & vent piping and renew as needed.

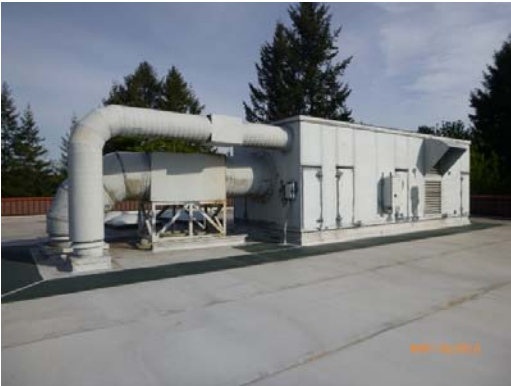
Air handling units are leaking air; have light corrosion;  
have loose, damaged or failing dampers; and marginal  
air filtration.

Refurbish air handling units.

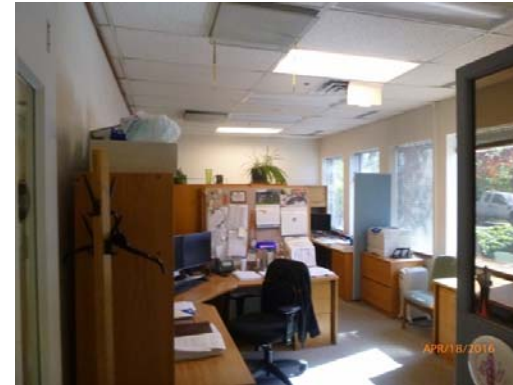
Material	Cond.	Material Useful Life	Survey Year	Condition Notes	Qty	Unit Cost	Unit	Direct Constr. Cost	Marked Up Cost
Deficiency				Action					
Facility: Thurston County Courthouse Building #1				Total System Deficiency Repair Cost (Undiscounted/Unescalated):					\$749,076
System: HVAC				Total System Deficiency Repair Cost (Marked Up):					\$1,825,872
HVAC Distribution Systems									
Ductwork	4	3	2016		43,588	\$3.00	SF	\$130,764	\$318,737
Distribution ductwork especially grills, registers & diffusers are damaged, dirty, loose and provide marginal comfort in many locations.				Refurbish, replace and reconfigure ductwork and grills, registers & diffusers to improve thermal comfort and air quality.

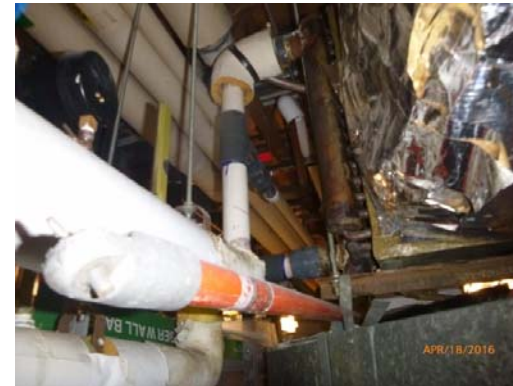
Variable air volume terminal units are obsolete pneumatic units with insufficient capacity in some areas, and poor zoning in others.

Replace and reconfigure terminal units in conjunction with ductwork renewal to improve comfort.

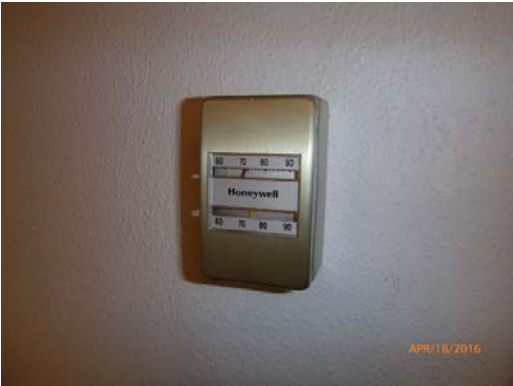
Mix of newer direct digital control controls for air handling units and obsolete pneumatic controls for terminal units; with poor thermal comfort in many areas.

Upgrade all pneumatic controls to County standard.

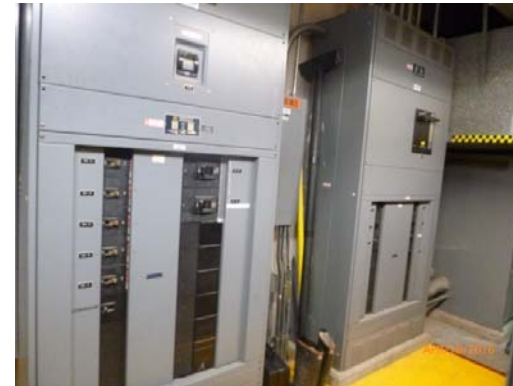
Material	Cond.	Material Useful Life	Survey Year	Condition Notes	Qty	Unit Cost	Unit	Direct Constr. Cost	Marked Up Cost
Deficiency				Action					
Facility: Thurston County Courthouse Building #1					Total System Deficiency Repair Cost (Undiscounted/Unescalated):				\$180,661
System: Electrical					Total System Deficiency Repair Cost (Marked Up):				\$440,362
Electrical Service and Distribution									
208V panels	4	2	2016		6	\$6,500.00	EA	\$39,000	\$95,063
Insufficient panel spaces for needed receptacles.				Install two new receptacle panels per floor.

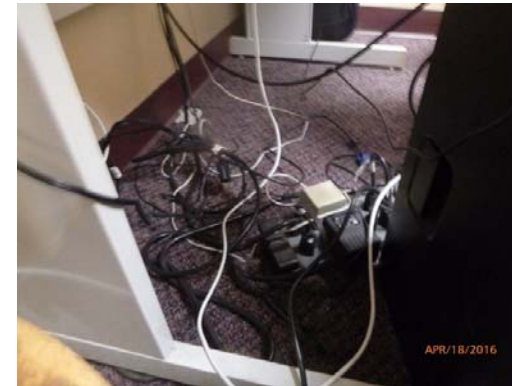
Material	Cond.	Material Useful Life	Survey Year	Condition Notes	Qty	Unit Cost	Unit	Direct Constr. Cost	Marked Up Cost
Deficiency				Action					
Facility: Thurston County Courthouse Building #1					Total System Deficiency Repair Cost (Undiscounted/Unescalated):				\$180,661
System: Electrical					Total System Deficiency Repair Cost (Marked Up):				\$440,362
Lighting and Branch Wiring									
Branch wiring	4	2	2016		43,588	\$1.50	SF	\$65,382	\$159,369
Original wiring, light switches and receptacles, some damaged. Insufficient receptacles for plug loads.				Replace damaged switches and receptacles. Add new receptacles where needed.

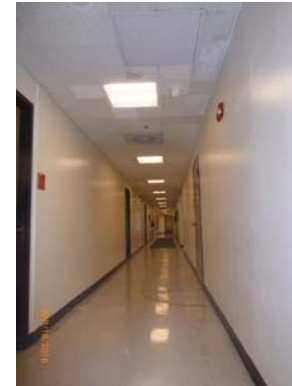
Material	Cond.	Material Useful Life	Survey Year	Condition Notes	Qty	Unit Cost	Unit	Direct Constr. Cost	Marked Up Cost
Deficiency				Action					
Facility: Thurston County Courthouse Building #1					Total System Deficiency Repair Cost (Undiscounted/Unescalated):				\$180,661
System: Electrical					Total System Deficiency Repair Cost (Marked Up):				\$440,362
Other Electrical Systems									
Emergency lighting	4	2	2016		43,588	\$0.50	SF	\$21,794	\$53,123
Some older exit signs hard to see and/or with confusion directioning. No instant-on egress lighting.				Replace older exit signs with new; check directioning and add battery-backed egress lighting to main corridors.

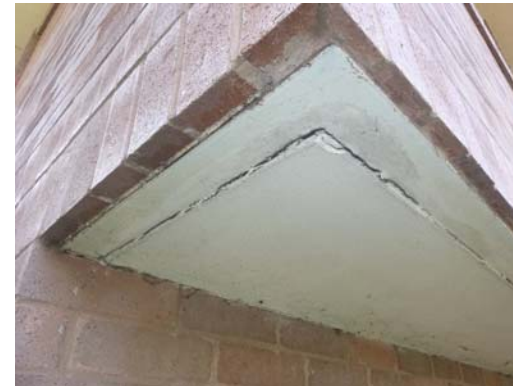
Soffits are water damaged and show signs of leaking.

Repair soffits, replace plaster system as necessary, allowance.

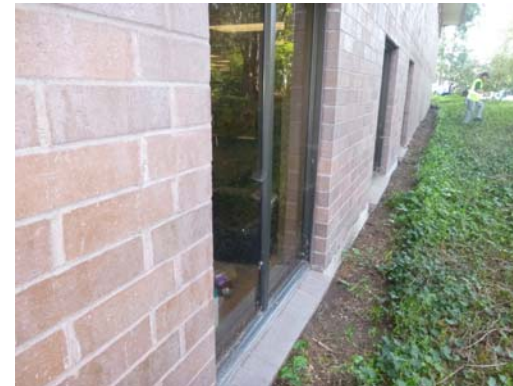
Windows are single glazed units.

Remove and replace windows and frames with new dual glazed units.

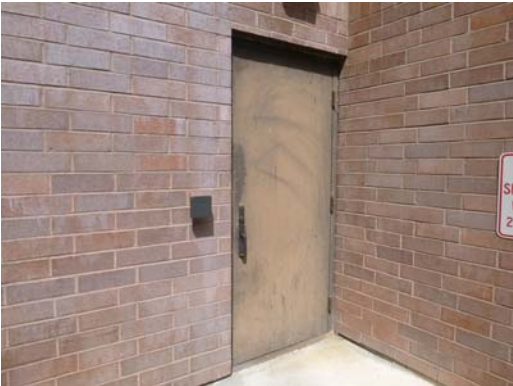
Material	Cond.	Material Useful Life	Survey Year	Condition Notes	Qty	Unit Cost	Unit	Direct Constr. Cost	Marked Up Cost
Deficiency				Action					
Facility: Thurston County Courthouse Building #2					Total System Deficiency Repair Cost (Undiscounted/Unescalated):				\$125,200
System: Exterior Closure					Total System Deficiency Repair Cost (Marked Up):				\$305,176
Exterior Doors									
Door Hardware	4	5	2016		6	\$950.00	EA	\$5,700	\$13,894
Door hardware in poor condition.				Remove and replace door hardware with new accessible hardware.

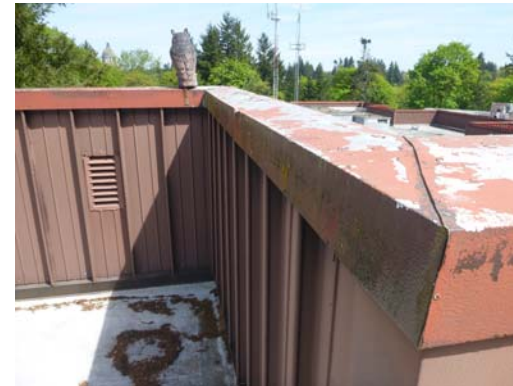
Metal roofing finish deteriorated, painted over multiple times, peeling, flaking, flashings are rusting.

Remove metal roofing and replace with new.

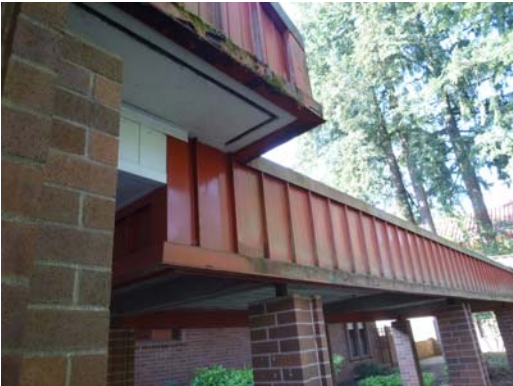
Material	Cond.	Material Useful Life	Survey Year	Condition Notes	Qty	Unit Cost	Unit	Direct Constr. Cost	Marked Up Cost
Deficiency				Action					
Facility: Thurston County Courthouse Building #2					Total System Deficiency Repair Cost (Undiscounted/Unescalated):				\$148,125
System: Roofing					Total System Deficiency Repair Cost (Marked Up):				\$361,055
Projections									
Covered walks	4	3	2016		125	\$375.00	LF	\$46,875	\$114,258
Covered walks wood framing exposed, metal roofing poor condition, soffits cracked.				Replace roofing, replace damaged soffit, paint exposed wood.

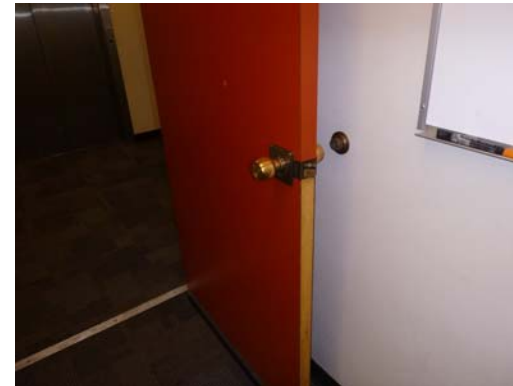
Material	Cond.	Material Useful Life	Survey Year	Condition Notes	Qty	Unit Cost	Unit	Direct Constr. Cost	Marked Up Cost
Deficiency				Action					
Facility: Thurston County Courthouse Building #2					Total System Deficiency Repair Cost (Undiscounted/Unescalated):				\$272,250
System: Interior Construction					Total System Deficiency Repair Cost (Marked Up):				\$663,609
Interior Doors									
Interior doors	4	5	2016		121	\$2,250.00	EA	\$272,250	\$663,609
Doors worn, de-laminating, hardware outdated.				Remove and replace with new doors in existing frames.

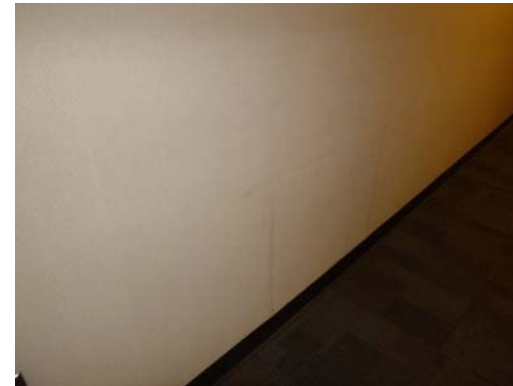
Vinyl wall covering aged, discolored, shows wear and tear.

Remove and replace with new vinyl wall covering.

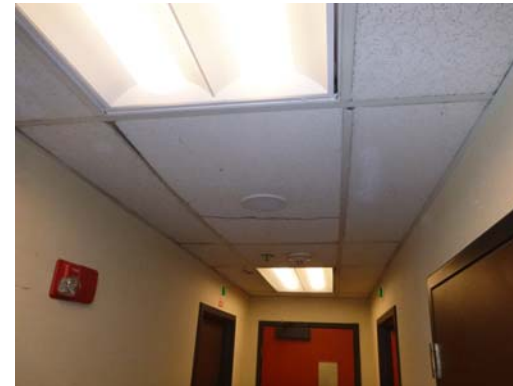
Material	Cond.	Material Useful Life	Survey Year	Condition Notes	Qty	Unit Cost	Unit	Direct Constr. Cost	Marked Up Cost
Deficiency				Action					
Facility:	Thurston County Courthouse Building #2				Total System Deficiency Repair Cost (Undiscounted/Unescalated):				\$314,438
System:	Interior Finishes				Total System Deficiency Repair Cost (Marked Up):				\$766,441
Ceiling Finishes									
ACT	4	4	2016		41,250	\$6.75	SF	\$278,438	\$678,691
Ceiling tiles and ACT worn and faded.				Remove older glue on tiles and ACT, replace with all new ACT system, abate as necessary.

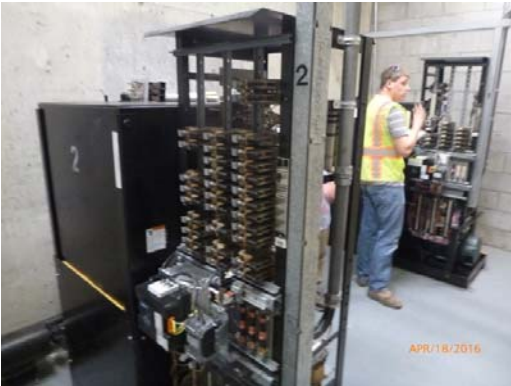
Original elevators are noisy and slow with obsolete relay control.

Renew one 2-stop and one 3-stop hydraulic elevators.

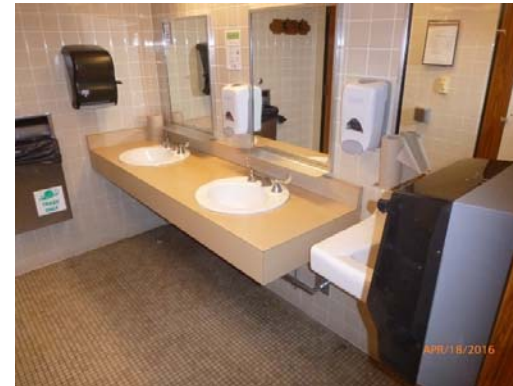
Material	Cond.	Material Useful Life	Survey Year	Condition Notes	Qty	Unit Cost	Unit	Direct Constr. Cost	Marked Up Cost
Deficiency				Action					
Facility: Thurston County Courthouse Building #2					Total System Deficiency Repair Cost (Undiscounted/Unescalated):				\$35,313
System: Plumbing					Total System Deficiency Repair Cost (Marked Up):				\$86,075
Plumbing Fixtures									
Faucets & flush valves	4	3	2016		20	\$750.00	EA	\$15,000	\$36,563
Original faucets and flush valves are failing, especially in public toilet rooms.				Replace with County standard faucets and flush valves.

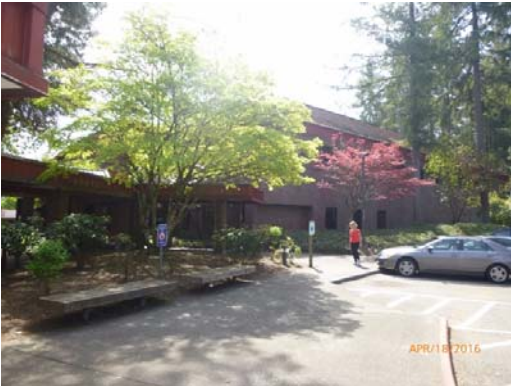
Material	Cond.	Material Useful Life	Survey Year	Condition Notes	Qty	Unit Cost	Unit	Direct Constr. Cost	Marked Up Cost
Deficiency				Action					
Facility: Thurston County Courthouse Building #2					Total System Deficiency Repair Cost (Undiscounted/Unescalated):				\$35,313
System: Plumbing					Total System Deficiency Repair Cost (Marked Up):				\$86,075
Domestic Water Distribution									
Water service	4	5	2016		1	\$10,000.00	LS	\$10,000	\$24,375
Assume original galvanized steel water service at end of life and without backflow prevention.				Replace water service main and add backflow prevention per code.

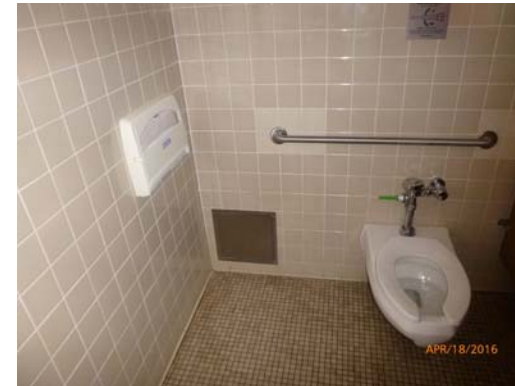
Material	Cond.	Material Useful Life	Survey Year	Condition Notes	Qty	Unit Cost	Unit	Direct Constr. Cost	Marked Up Cost
Deficiency				Action					
Facility: Thurston County Courthouse Building #2					Total System Deficiency Repair Cost (Undiscounted/Unescalated):				\$35,313
System: Plumbing					Total System Deficiency Repair Cost (Marked Up):				\$86,075
Sanitary Waste									
Drain, waste & vent piping	4	5	2016		41,250	\$0.25	SF	\$10,313	\$25,137
Many fixtures slow to flush and at least one on lower level chronically backs-up.				Clean, test, inspect and repair drain, waste & vent piping.

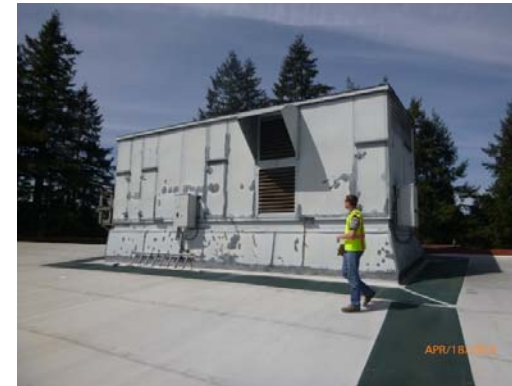
Material	Cond.	Material Useful Life	Survey Year	Condition Notes	Qty	Unit Cost	Unit	Direct Constr. Cost	Marked Up Cost
Deficiency				Action					
Facility: Thurston County Courthouse Building #2					Total System Deficiency Repair Cost (Undiscounted/Unescalated):				\$673,188
System: HVAC					Total System Deficiency Repair Cost (Marked Up):				\$1,640,895
HVAC Distribution Systems									
Air handling unit	4	3	2016		1	\$20,000.00	LS	\$20,000	\$48,750
Air handling unit is leaking air; has light corrosion; has loose, damaged or failing dampers; and marginal air filtration.				Refurbish air handling unit.

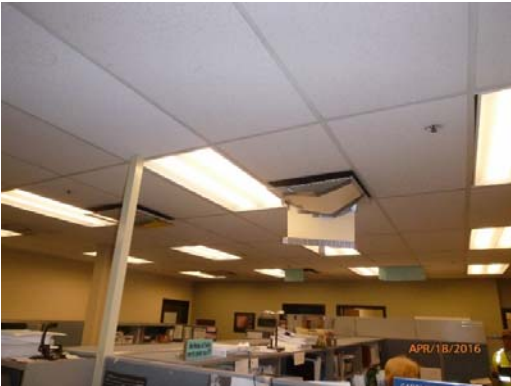
Material	Cond.	Material Useful Life	Survey Year	Condition Notes	Qty	Unit Cost	Unit	Direct Constr. Cost	Marked Up Cost
Deficiency				Action					
Facility: Thurston County Courthouse Building #2					Total System Deficiency Repair Cost (Undiscounted/Unescalated):				\$673,188
System: HVAC					Total System Deficiency Repair Cost (Marked Up):				\$1,640,895
HVAC Distribution Systems									
Ductwork	4	3	2016		41,250	\$3.00	SF	\$123,750	\$301,641
Distribution ductwork especially grills, registers & diffusers are damaged, dirty, loose and provide marginal comfort in many locations.				Refurbish, replace and reconfigure ductwork and grills, registers & diffusers to improve thermal comfort and air quality.

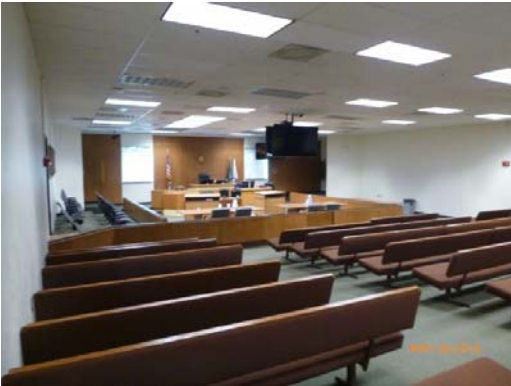
Material	Cond.	Material Useful Life	Survey Year	Condition Notes	Qty	Unit Cost	Unit	Direct Constr. Cost	Marked Up Cost
Deficiency				Action					
Facility: Thurston County Courthouse Building #2					Total System Deficiency Repair Cost (Undiscounted/Unescalated):				\$673,188
System: HVAC					Total System Deficiency Repair Cost (Marked Up):				\$1,640,895
Terminal and Package Units									
Terminal units	4	3	2016		41,250	\$8.00	SF	\$330,000	\$804,375
Variable air volume terminal units are obsolete pneumatic units with insufficient capacity in some areas, and poor zoning in others.				Replace and reconfigure terminal units in conjunction with ductwork renewal to improve comfort.

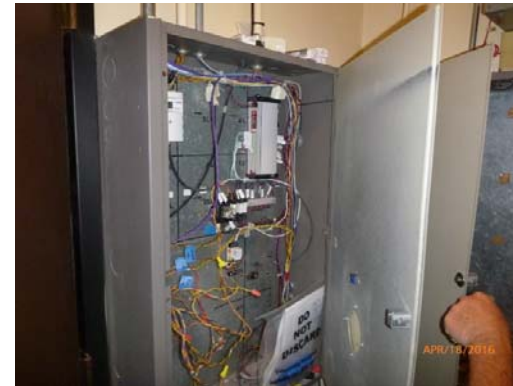
Material	Cond.	Material Useful Life	Survey Year	Condition Notes	Qty	Unit Cost	Unit	Direct Constr. Cost	Marked Up Cost
Deficiency				Action					
Facility: Thurston County Courthouse Building #2					Total System Deficiency Repair Cost (Undiscounted/Unescalated):				\$673,188
System: HVAC					Total System Deficiency Repair Cost (Marked Up):				\$1,640,895
Controls and Instrumentation									
Controls	4	3	2016		41,250	\$3.35	SF	\$138,188	\$336,832
Mix of newer direct digital control controls for air handling units and obsolete pneumatic controls for terminal units; with poor thermal comfort in many areas.				Upgrade all pneumatic controls to County standard.

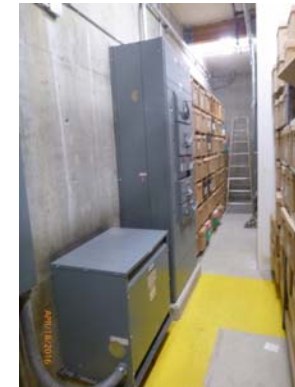
Material	Cond.	Material Useful Life	Survey Year	Condition Notes	Qty	Unit Cost	Unit	Direct Constr. Cost	Marked Up Cost
Deficiency				Action					
Facility: Thurston County Courthouse Building #2					Total System Deficiency Repair Cost (Undiscounted/Unescalated):				\$108,500
System: Electrical					Total System Deficiency Repair Cost (Marked Up):				\$264,469
Electrical Service and Distribution									
208V panels	4	2	2016		4	\$6,500.00	EA	\$26,000	\$63,375
Insufficient panel spaces for needed receptacles.				Install two new receptacle panels per floor.

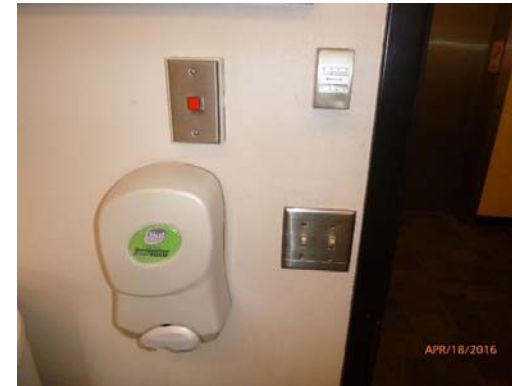
Material	Cond.	Material Useful Life	Survey Year	Condition Notes	Qty	Unit Cost	Unit	Direct Constr. Cost	Marked Up Cost
Deficiency				Action					
Facility: Thurston County Courthouse Building #2					Total System Deficiency Repair Cost (Undiscounted/Unescalated):				\$108,500
System: Electrical					Total System Deficiency Repair Cost (Marked Up):				\$264,469
Lighting and Branch Wiring									
Branch wiring	4	2	2016		41,250	\$1.50	SF	\$61,875	\$150,820
Original wiring, light switches and receptacles, some damaged. Insufficient receptacles for plug loads.				Replace damaged switches and receptacles. Add new receptacles where needed.

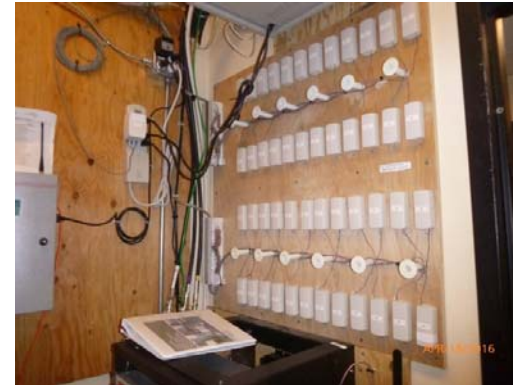
Material	Cond.	Material Useful Life	Survey Year	Condition Notes	Qty	Unit Cost	Unit	Direct Constr. Cost	Marked Up Cost
Deficiency				Action					
Facility: Thurston County Courthouse Building #2					Total System Deficiency Repair Cost (Undiscounted/Unescalated):				\$108,500
System: Electrical					Total System Deficiency Repair Cost (Marked Up):				\$264,469
Low Voltage Security									
Duress system	4	1	2016		41,250	\$0.25	SF	\$10,313	\$25,137
Duress system is residential grade.				Upgrade to County standard duress system.

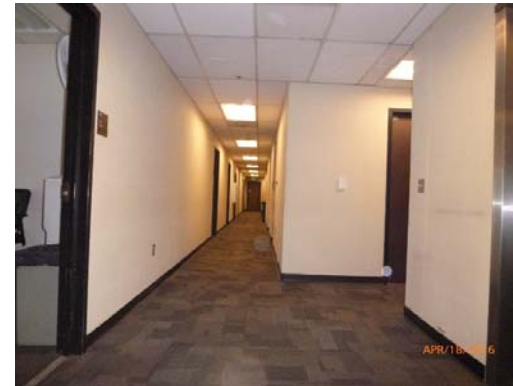
Material	Cond.	Material Useful Life	Survey Year	Condition Notes	Qty	Unit Cost	Unit	Direct Constr. Cost	Marked Up Cost
Deficiency				Action					
Facility: Thurston County Courthouse Building #2					Total System Deficiency Repair Cost (Undiscounted/Unescalated):				\$108,500
System: Electrical					Total System Deficiency Repair Cost (Marked Up):				\$264,469
Other Electrical Systems									
Emergency lighting	4	2	2016		41,250	\$0.25	SF	\$10,313	\$25,137
Some older exit signs hard to see. No instant-on egress lighting.				Replace older exit signs with new; check directioning and add battery-backed egress lighting to main corridors.

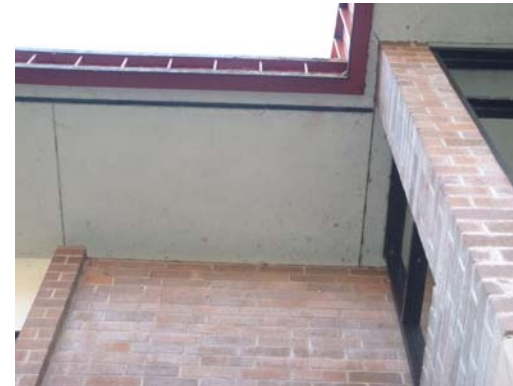
Soffits are water damaged and show signs of leaking.

Repair soffits, replace plaster system as necessary, allowance.

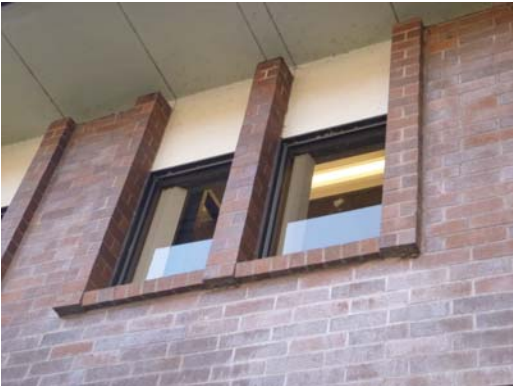
Material	Cond.	Material Useful Life	Survey Year	Condition Notes	Qty	Unit Cost	Unit	Direct Constr. Cost	Marked Up Cost
Deficiency				Action					
Facility: Thurston County Courthouse Building #3					Total System Deficiency Repair Cost (Undiscounted/Unescalated):				\$101,850
System: Exterior Closure					Total System Deficiency Repair Cost (Marked Up):				\$248,260
Exterior Windows									
Exterior windows	4	5	2016		750	\$95.00	SF	\$71,250	\$173,672
Non detention windows are single glazed units.				Remove and replace windows and frames with new dual glazed units.

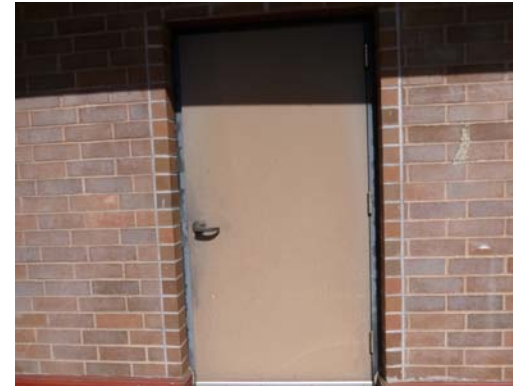
Material	Cond.	Material Useful Life	Survey Year	Condition Notes	Qty	Unit Cost	Unit	Direct Constr. Cost	Marked Up Cost
Deficiency				Action					
Facility: Thurston County Courthouse Building #3					Total System Deficiency Repair Cost (Undiscounted/Unescalated):				\$101,850
System: Exterior Closure					Total System Deficiency Repair Cost (Marked Up):				\$248,260
Exterior Doors									
Door Hardware	4	5	2016		8	\$950.00	EA	\$7,600	\$18,525
Door hardware in poor condition.				Remove and replace door hardware with new accessible hardware.

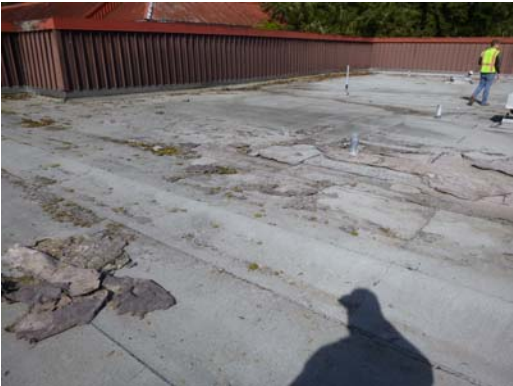
Material	Cond.	Material Useful Life	Survey Year	Condition Notes	Qty	Unit Cost	Unit	Direct Constr. Cost	Marked Up Cost
Deficiency				Action					
Facility:	Thurston County Courthouse Building #3				Total System Deficiency Repair Cost (Undiscounted/Unescalated):				\$264,825
System:	Roofing				Total System Deficiency Repair Cost (Marked Up):				\$645,512
Roof Coverings									
Bitumen roofing	4	3	2016		19,600	\$4.50	SF	\$88,200	\$214,988
Bitumen roofing deteriorated.				Remove roofing and replace with new.

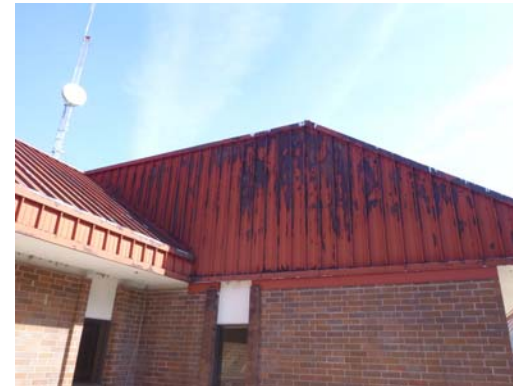
Metal roofing finish deteriorated, painted over multiple times, peeling, flaking, flashings are rusting.

Remove metal roofing and replace with new.

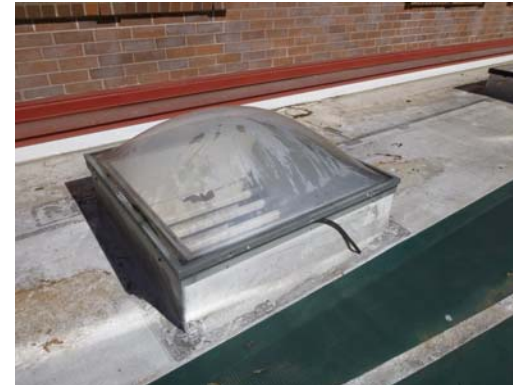
Material	Cond.	Material Useful Life	Survey Year	Condition Notes	Qty	Unit Cost	Unit	Direct Constr. Cost	Marked Up Cost
Deficiency				Action					
Facility: Thurston County Courthouse Building #3				Total System Deficiency Repair Cost (Undiscounted/Unescalated):					\$264,825
System: Roofing				Total System Deficiency Repair Cost (Marked Up):					\$645,512
Roof Openings									
Skylights	4	2	2016		1	\$24,000.00	LS	\$24,000	\$58,500
Glass panel and polycarbonate skylights seals failed, leak.				Remove polycarbonate skylights, replace with new units, remove frames and glazing of glass panel skylight, replace with new glass and seals.

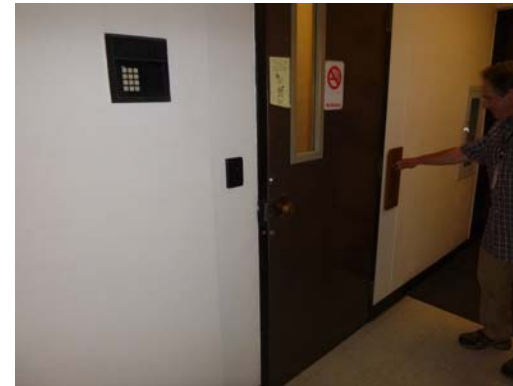
Material	Cond.	Material Useful Life	Survey Year	Condition Notes	Qty	Unit Cost	Unit	Direct Constr. Cost	Marked Up Cost
Deficiency				Action					
Facility: Thurston County Courthouse Building #3					Total System Deficiency Repair Cost (Undiscounted/Unescalated):				\$388,000
System: Interior Construction					Total System Deficiency Repair Cost (Marked Up):				\$945,751
Interior Doors									
Door paint	4	3	2016		140	\$650.00	EA	\$91,000	\$221,813
Detention doors are scratched, scuffed.				Prep and repaint doors.

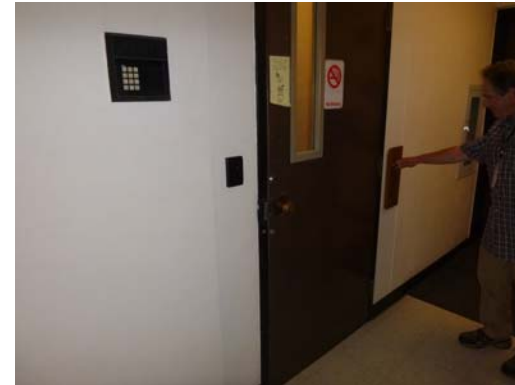
Material	Cond.	Material Useful Life	Survey Year	Condition Notes	Qty	Unit Cost	Unit	Direct Constr. Cost	Marked Up Cost
Deficiency				Action					
Facility: Thurston County Courthouse Building #3					Total System Deficiency Repair Cost (Undiscounted/Unescalated):				\$388,000
System: Interior Construction					Total System Deficiency Repair Cost (Marked Up):				\$945,751
Interior Doors									
Interior doors	4	5	2016		132	\$2,250.00	EA	\$297,000	\$723,938
Doors worn, de-laminating, hardware outdated.				Remove and replace with new doors in existing frames.

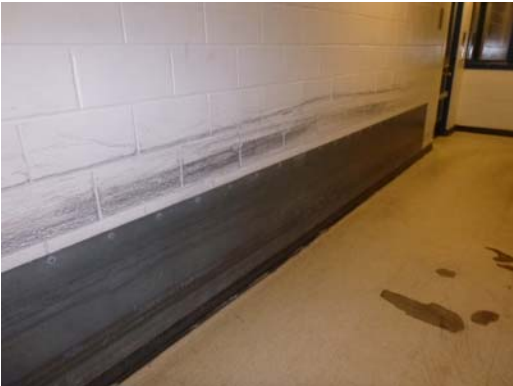
Material	Cond.	Material Useful Life	Survey Year	Condition Notes	Qty	Unit Cost	Unit	Direct Constr. Cost	Marked Up Cost
Deficiency				Action					
Facility:	Thurston County Courthouse Building #3				Total System Deficiency Repair Cost (Undiscounted/Unescalated):				\$952,592
System:	Interior Finishes				Total System Deficiency Repair Cost (Marked Up):				\$2,321,943
Wall Finishes									
Wall paint	4	5	2016		77,248	\$3.50	SF	\$270,368	\$659,022
Wall paint is faded, scratched and shows signs of wear.				Prep and repaint interior walls.

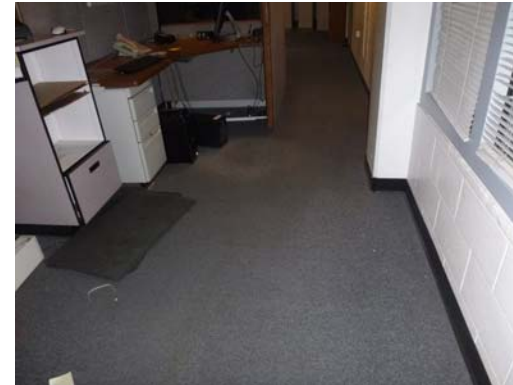
Material	Cond.	Material Useful Life	Survey Year	Condition Notes	Qty	Unit Cost	Unit	Direct Constr. Cost	Marked Up Cost
Deficiency				Action					
Facility: Thurston County Courthouse Building #3					Total System Deficiency Repair Cost (Undiscounted/Unescalated):				\$952,592
System: Interior Finishes					Total System Deficiency Repair Cost (Marked Up):				\$2,321,943
Floor Finishes									
Carpet	4	3	2016		24,000	\$6.70	SF	\$160,800	\$391,950
Carpet is old, stained and worn.				Remove and replace with new carpet.

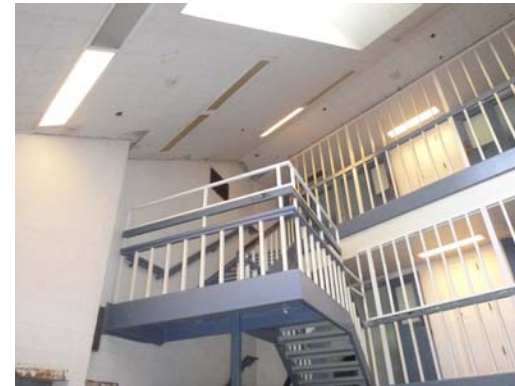
Material	Cond.	Material Useful Life	Survey Year	Condition Notes	Qty	Unit Cost	Unit	Direct Constr. Cost	Marked Up Cost
Deficiency				Action					
Facility: Thurston County Courthouse Building #3					Total System Deficiency Repair Cost (Undiscounted/Unescalated):				\$952,592
System: Interior Finishes					Total System Deficiency Repair Cost (Marked Up):				\$2,321,943
Ceiling Finishes									
ACT	4	4	2016		77,248	\$6.75	SF	\$521,424	\$1,270,971
Ceiling tiles and ACT worn and faded. Some damage to gypsum systems.				Remove older glue on tiles and ACT, replace with all new ACT system, abate as necessary.

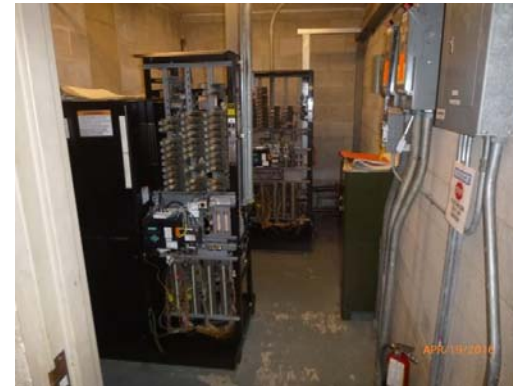
Original elevators are noisy and slow with obsolete relay control.

Renew two hydraulic elevators.
