**THURSTON COUNTY**  
**FACILITY CONDITION ASSESSMENT**  
**FINAL REPORT**  
**MAY 27, 2016**

## I. EXECUTIVE SUMMARY

Thurston County engaged MENG Analysis to conduct Facility Condition Assessments (FCAs) of 21 County owned, operated, and managed facilities. This report includes both summary and detailed results of that assessment.

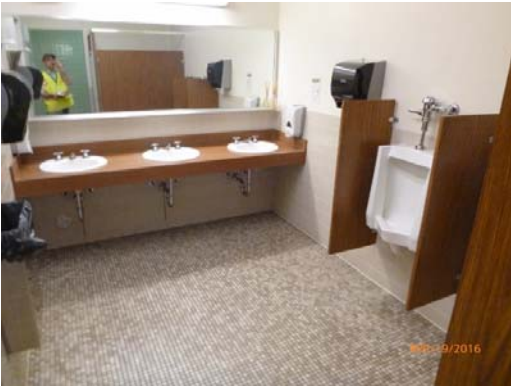
Material	Cond.	Material Useful Life	Survey Year	Condition Notes	Qty	Unit Cost	Unit	Direct Constr. Cost	Marked Up Cost
Deficiency				Action					
Facility: Thurston County Courthouse Building #3					Total System Deficiency Repair Cost (Undiscounted/Unescalated):				\$171,349
System: Plumbing					Total System Deficiency Repair Cost (Marked Up):				\$417,663
Plumbing Fixtures									
Fixtures & trim	4	3	2016		100	\$750.00	EA	\$75,000	\$182,813
Original faucets and flush valves are failing at many fixtures; some detention fixtures have minor damage.				Replace with County standard faucets and flush valves; repair damaged detention fixtures.

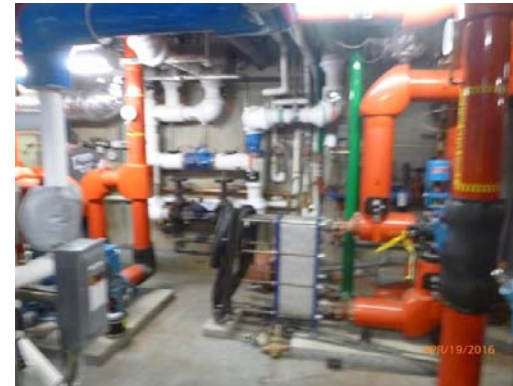
Material	Cond.	Material Useful Life	Survey Year	Condition Notes	Qty	Unit Cost	Unit	Direct Constr. Cost	Marked Up Cost
Deficiency				Action					
Facility: Thurston County Courthouse Building #3					Total System Deficiency Repair Cost (Undiscounted/Unescalated):				\$171,349
System: Plumbing					Total System Deficiency Repair Cost (Marked Up):				\$417,663
Domestic Water Distribution									
Domestic hot water heaters	5	0	2016		2	\$25,000.00	EA	\$50,000	\$121,875
Detention domestic hot water electric resistance heaters appear failed and abandoned in place.				Replace with new gas-fired heaters.

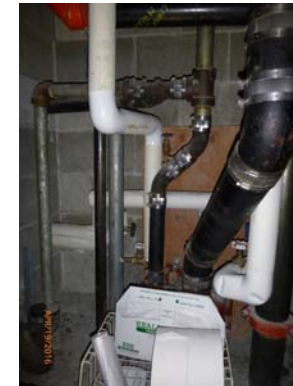
Material	Cond.	Material Useful Life	Survey Year	Condition Notes	Qty	Unit Cost	Unit	Direct Constr. Cost	Marked Up Cost
Deficiency				Action					
Facility: Thurston County Courthouse Building #3					Total System Deficiency Repair Cost (Undiscounted/Unescalated):				\$171,349
System: Plumbing					Total System Deficiency Repair Cost (Marked Up):				\$417,663
Sanitary Waste									
Drain, waste & vent piping	4	5	2016		77,248	\$0.25	SF	\$19,312	\$47,073
Some fixtures slow to flush.				Clean, test, inspect and repair drain, waste & vent piping.

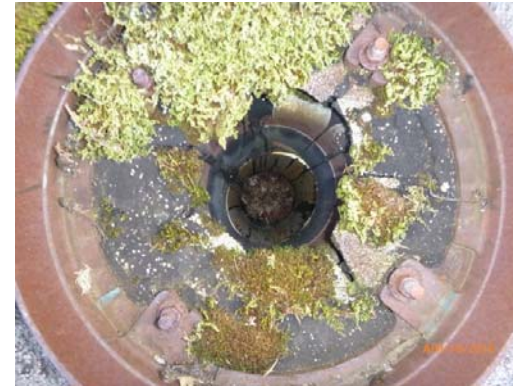
Material	Cond.	Material Useful Life	Survey Year	Condition Notes	Qty	Unit Cost	Unit	Direct Constr. Cost	Marked Up Cost
Deficiency				Action					
Facility:	Thurston County Courthouse Building #3				Total System Deficiency Repair Cost (Undiscounted/Unescalated):				\$171,349
System:	Plumbing				Total System Deficiency Repair Cost (Marked Up):				\$417,663
Rain Water Drainage									
Poly-vinyl chloride rain leaders	4	5	2016		77,248	\$0.35	SF	\$27,037	\$65,902
Poly-vinyl chloride roof drain leader piping nearing end of life.				Replace roof drain & overflow roof drain poly-vinyl chloride rain leader piping with new; inspect

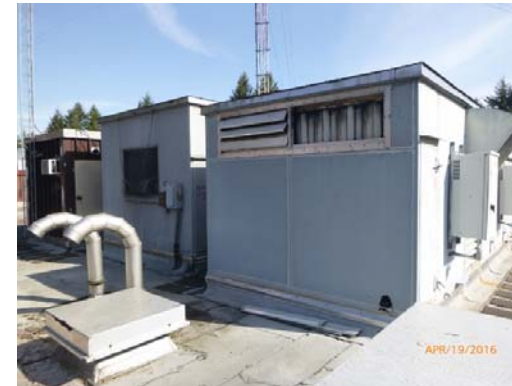
Air handling units are leaking air; have light corrosion; have loose, damaged or failing dampers; and marginal air filtration.

Refurbish air handling units.

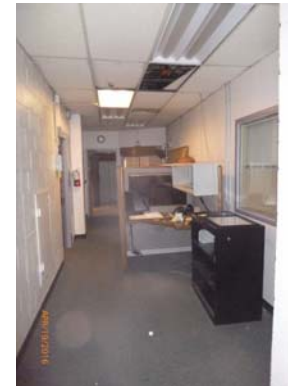
Material	Cond.	Material Useful Life	Survey Year	Condition Notes	Qty	Unit Cost	Unit	Direct Constr. Cost	Marked Up Cost
Deficiency				Action					
Facility:	Thurston County Courthouse Building #3				Total System Deficiency Repair Cost (Undiscounted/Unescalated):				\$1,265,757
System:	HVAC				Total System Deficiency Repair Cost (Marked Up):				\$3,085,283
HVAC Distribution Systems									
Ductwork	4	3	2016		77,248	\$3.00	SF	\$231,744	\$564,876
Distribution ductwork especially grills, registers & diffusers are damaged, dirty, loose and provides marginal comfort in many locations.				Refurbish, replace and reconfigure ductwork and grills, registers & diffusers to improve thermal comfort and air quality.

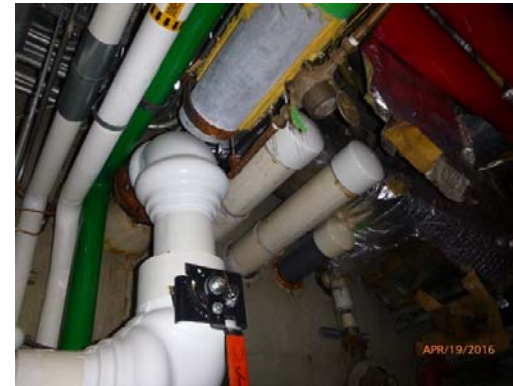
Heating hot water and chilled water piping is poly-vinyl chloride; this piping is inappropriate for heating & cooling water application.

Replace heating hot and chilled water distribution piping with metallic mains and copper and/or cross-linked polyethylene distribution tubing.

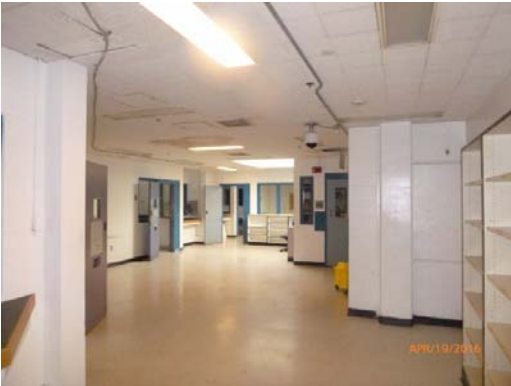
Variable air volume terminal units are obsolete pneumatic units with insufficient capacity in some areas, and poor zoning in others.

Replace and reconfigure terminal units in conjunction with ductwork renewal to improve comfort.

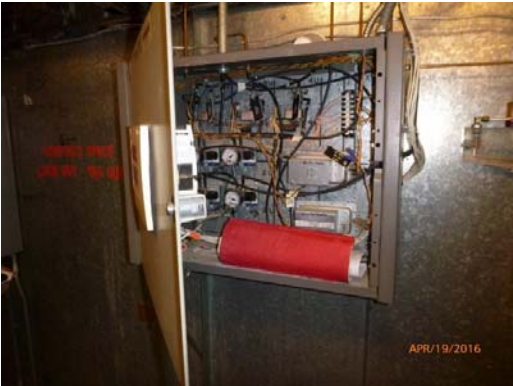
Mix of newer direct digital control controls for central plant and air handling units with obsolete pneumatic controls for terminal units; with poor thermal comfort in many areas.

Upgrade all pneumatic controls to County standard.

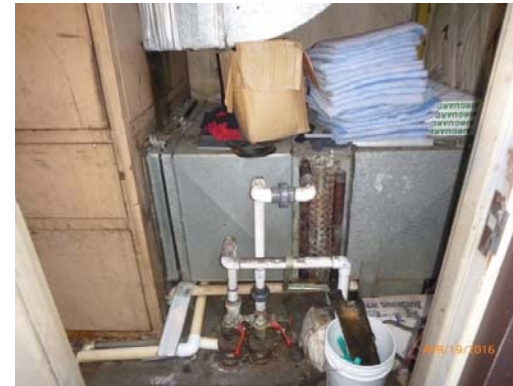
Kitchen make-up, exhaust, and grease & moisture hoods tagged-out and currently inoperable.

Clean, test, inspect and repair or replace kitchen HVAC equipment and ductwork to restore to operable condition.

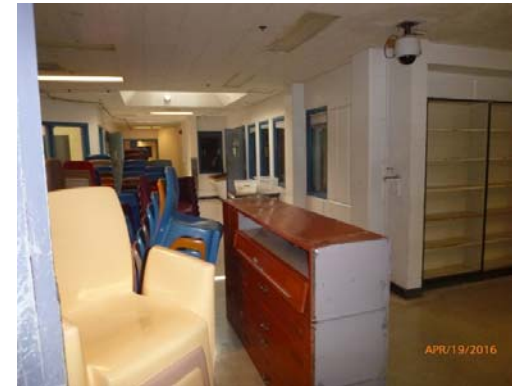
Some detention areas not sprinkled; many detention areas have standard instead of detention-type heads.

Add fire sprinkler protection to currently unprotected areas, and replaced standard with detention heads in detention areas.

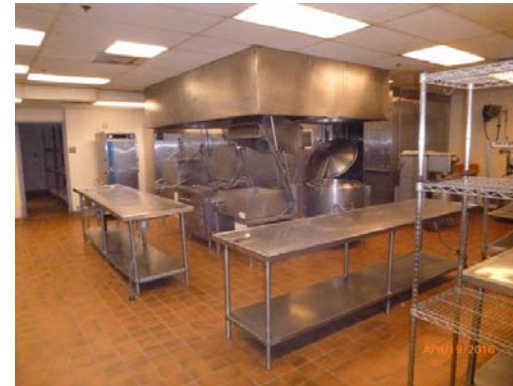
Inoperable grease hood fire suppression system.

Service and return to operable condition prior to grease hood use.

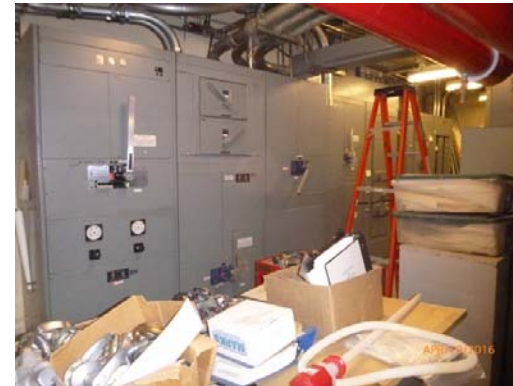
Material	Cond.	Material Useful Life	Survey Year	Condition Notes	Qty	Unit Cost	Unit	Direct Constr. Cost	Marked Up Cost
Deficiency				Action					
Facility: Thurston County Courthouse Building #3					Total System Deficiency Repair Cost (Undiscounted/Unescalated):				\$198,372
System: Electrical					Total System Deficiency Repair Cost (Marked Up):				\$483,533
Electrical Service and Distribution									
208V panels	4	2	2016		5	\$6,500.00	EA	\$32,500	\$79,219
Insufficient panel spaces for needed receptacles.				Install two new receptacle panels per floor.

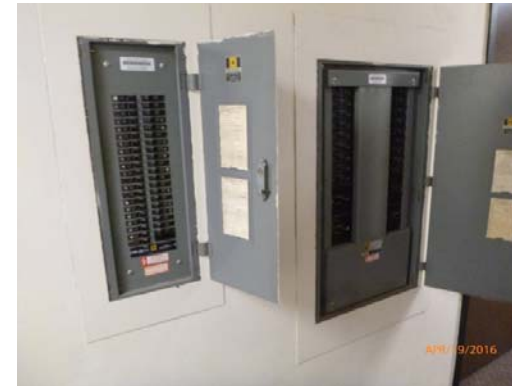
Material	Cond.	Material Useful Life	Survey Year	Condition Notes	Qty	Unit Cost	Unit	Direct Constr. Cost	Marked Up Cost
Deficiency				Action					
Facility: Thurston County Courthouse Building #3					Total System Deficiency Repair Cost (Undiscounted/Unescalated):				\$198,372
System: Electrical					Total System Deficiency Repair Cost (Marked Up):				\$483,533
Lighting and Branch Wiring									
Branch wiring	4	2	2016		77,248	\$1.50	SF	\$115,872	\$282,438
Original wiring, light switches and receptacles, some damaged. Insufficient receptacles for plug loads.				Replace damaged switches and receptacles. Add new receptacles where needed.

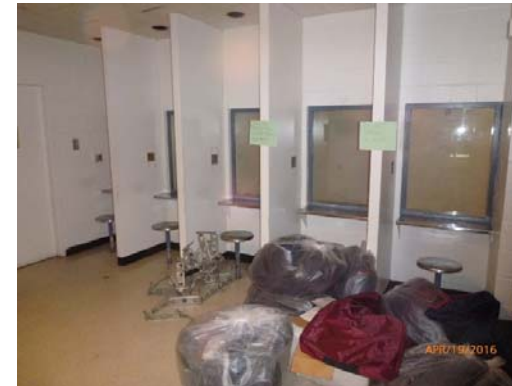
Material	Cond.	Material Useful Life	Survey Year	Condition Notes	Qty	Unit Cost	Unit	Direct Constr. Cost	Marked Up Cost
Deficiency				Action					
Facility: Thurston County Courthouse Building #3					Total System Deficiency Repair Cost (Undiscounted/Unescalated):				\$198,372
System: Electrical					Total System Deficiency Repair Cost (Marked Up):				\$483,533
Low Voltage Communication									
Visitation phones	5	0	2016		1	\$25,000.00	LS	\$25,000	\$60,938
Visitation phone system handsets are removed; system is not operational.				Replace detention visitation phone system.

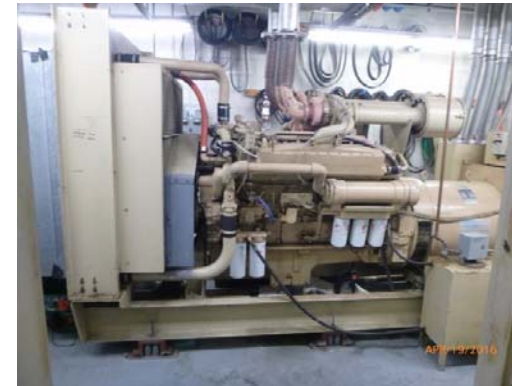
Both life/safety and standby powered loads on one automatic transfer switch and distribution panel.

Install separate transfer switch and panel for standby (non-life/safety) loads.

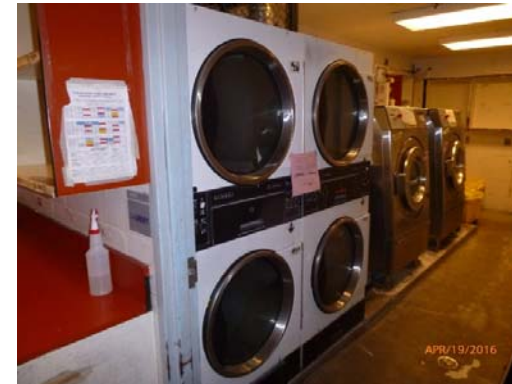
Failed washers and dryers with no trash rack or lint collection systems. Insufficient ventilation.

Install trash rack and lint collection systems; replace two washers and four dryers. Provide ventilation per code.

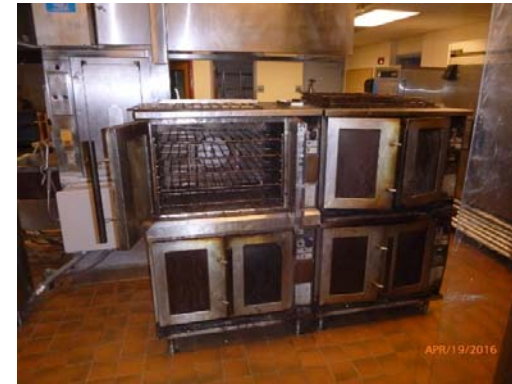
Commercial kitchen equipment including electric and gas-fired appliances, walk-in cooler & freezer, and scullery with dishwasher; all heavily used in failed to poor condition.

Clean, inspect and repair or replace to return kitchen to operable, code compliant condition; assume most equipment to be replaced.

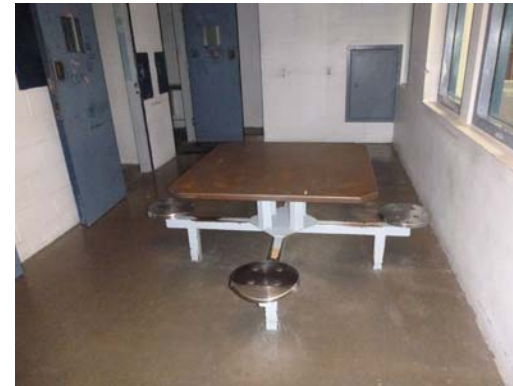
Material	Cond.	Material Useful Life	Survey Year	Condition Notes	Qty	Unit Cost	Unit	Direct Constr. Cost	Marked Up Cost
Deficiency				Action					
Facility: Thurston County Courthouse Building #3					Total System Deficiency Repair Cost (Undiscounted/Unescalated):				\$17,600
System: Special Construction					Total System Deficiency Repair Cost (Marked Up):				\$42,900
Integrated Construction									
Detention area tables	4	4	2016		8	\$2,200.00	EA	\$17,600	\$42,900
Detention area tables are worn, bent in poor condition.				Remove and replace with new detention quality tables.

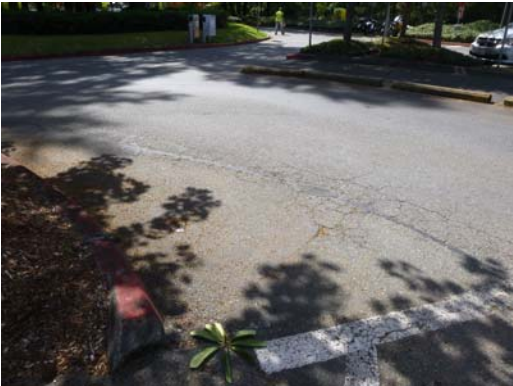
Material	Cond.	Material Useful Life	Survey Year	Condition Notes	Qty	Unit Cost	Unit	Direct Constr. Cost	Marked Up Cost
Deficiency				Action					
Facility:	Thurston County Courthouse Campus Infrastructure				Total System Deficiency Repair Cost (Undiscounted/Unescalated):				\$214,100
System:	Site Improvements				Total System Deficiency Repair Cost (Marked Up):				\$521,869
Roadways									
Roadway AC paving	4	3	2016		21,000	\$1.75	SF	\$36,750	\$89,578
AC paving cracked and worn.				Clean, repair low areas, surface with AC top coat and restripe.

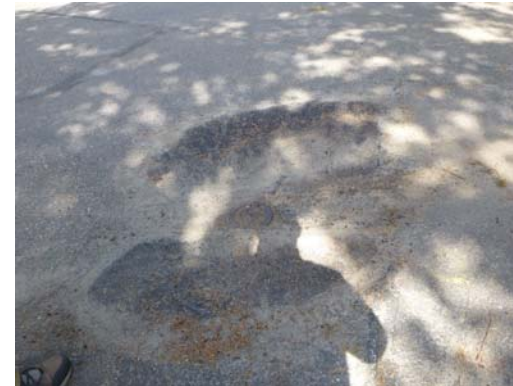
Material	Cond.	Material Useful Life	Survey Year	Condition Notes	Qty	Unit Cost	Unit	Direct Constr. Cost	Marked Up Cost
Deficiency				Action					
Facility: Thurston County Courthouse Campus Infrastructure					Total System Deficiency Repair Cost (Undiscounted/Unescalated):				\$214,100
System: Site Improvements					Total System Deficiency Repair Cost (Marked Up):				\$521,869
Parking Lots									
Parking AC paving	4	3	2016		14,000	\$1.75	SF	\$24,500	\$59,719
AC paving cracked and worn.				Clean, repair low areas, surface with AC top coat and restripe.

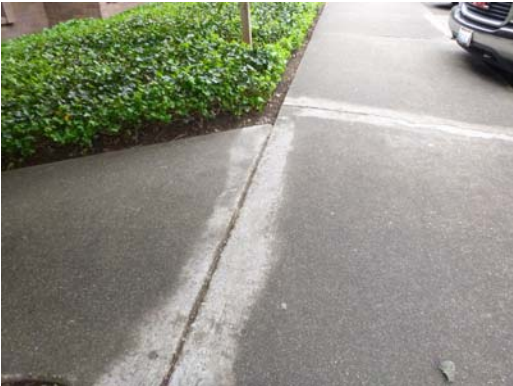
Concrete walks un-level. Remove and replace upheaved concrete walks.

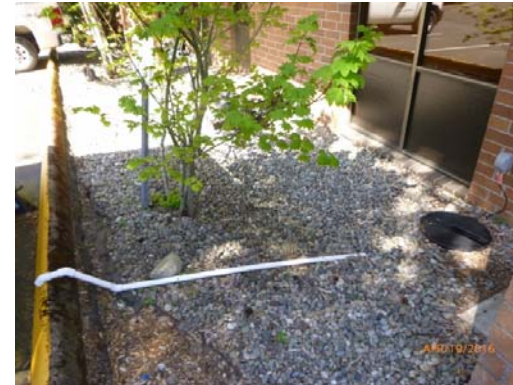
Material	Cond.	Material Useful Life	Survey Year	Condition Notes	Qty	Unit Cost	Unit	Direct Constr. Cost	Marked Up Cost
Deficiency				Action					
Facility: Thurston County Courthouse Campus Infrastructure					Total System Deficiency Repair Cost (Undiscounted/Unescalated):				\$214,100
System: Site Improvements					Total System Deficiency Repair Cost (Marked Up):				\$521,869
Landscaping									
Irrigation	5	0	2016		195,000	\$0.75	SF	\$146,250	\$356,484
Irrigation system not functioning.				Renovate as needed existing irrigation system including new controllers.

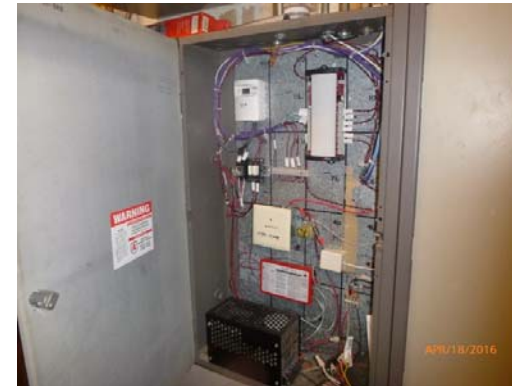
Intermittent fire sprinkler system low pressure alarms at Courthouse Campus Buildings 1, 2 and/or 3.

Test and identify source of low pressure alarms, coordinate with City water utility to provide reliable fire flow and pressure to Courthouse Campus per applicable code and standards.

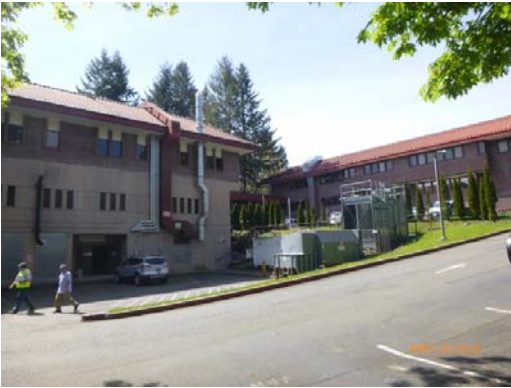
Material	Cond.	Material Useful Life	Survey Year	Condition Notes	Qty	Unit Cost	Unit	Direct Constr. Cost	Marked Up Cost
Deficiency				Action					
Facility:	Thurston County Courthouse Campus Infrastructure				Total System Deficiency Repair Cost (Undiscounted/Unescalated):				\$65,000
System:	Site Civil / Mechanical Utilities				Total System Deficiency Repair Cost (Marked Up):				\$158,438
Heating Distribution									
Heating water poly-vinyl chloride piping	4	3	2016		300	\$100.00	FT	\$30,000	\$73,125
Poly-vinyl chloride not suitable for heating hot water application.				Replace with metallic piping.

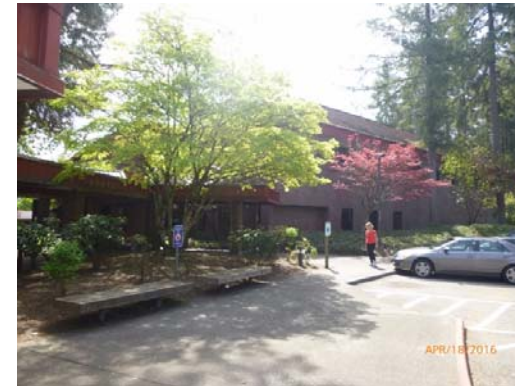
Poor lighting at Judges Building entry south of Building 2. No lighting at covered walks between Buildings 1, 2 & 3. Obsolete and damaged pedestrian bollard-type lighting. Failed in-ground up-lights.

Improve lighting at judges approach to Building 2. Add lighting per code to covered walks between Buildings. Modernize bollard fixtures. Repair or replace in-ground lighting.

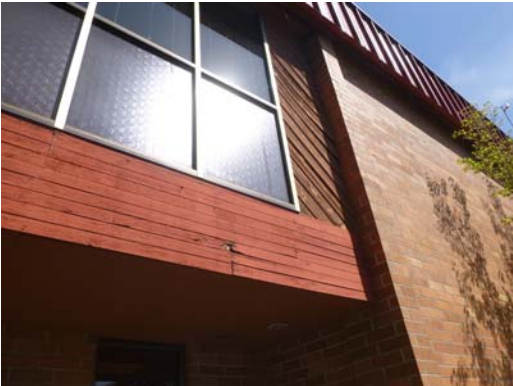
Material	Cond.	Material Useful Life	Survey Year	Condition Notes	Qty	Unit Cost	Unit	Direct Constr. Cost	Marked Up Cost
Deficiency				Action					
Facility:	Thurston County Courthouse 4				Total System Deficiency Repair Cost (Undiscounted/Unescalated):				\$135,663
System:	Exterior Closure				Total System Deficiency Repair Cost (Marked Up):				\$330,678
Exterior Walls									
Wood siding	4	2	2016		4,155	\$7.50	SF	\$31,163	\$75,959
Wood siding is faded, cracked and checked.				Replace damaged areas, prep and repaint or reseal.

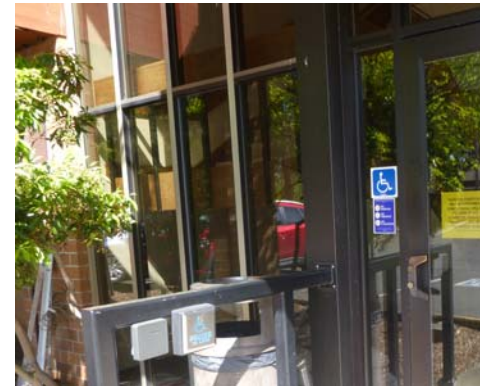
Material	Cond.	Material Useful Life	Survey Year	Condition Notes	Qty	Unit Cost	Unit	Direct Constr. Cost	Marked Up Cost
Deficiency				Action					
Facility: Thurston County Courthouse 4					Total System Deficiency Repair Cost (Undiscounted/Unescalated):				\$135,663
System: Exterior Closure					Total System Deficiency Repair Cost (Marked Up):				\$330,678
Exterior Windows									
Windows	5	1	2016		1,100	\$95.00	SF	\$104,500	\$254,719
Dual glazed windows set incorrectly in frames.				Remove windows and frames, install new dual glazed windows and frames.

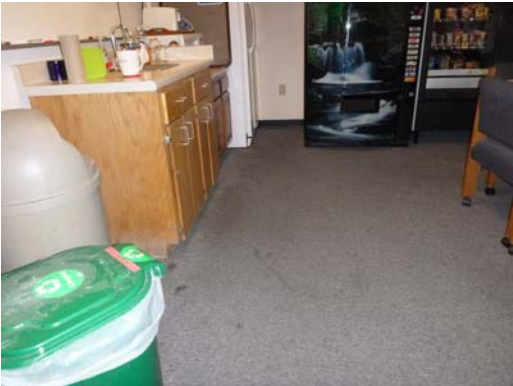
Carpet in most office areas in poor condition, heavy traffic marks and discoloration.

Remove and replace with new carpet.

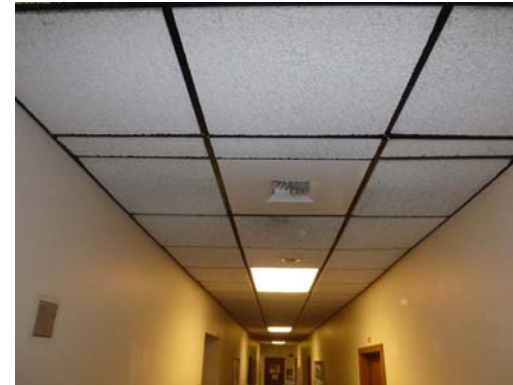
Material	Cond.	Material Useful Life	Survey Year	Condition Notes	Qty	Unit Cost	Unit	Direct Constr. Cost	Marked Up Cost
Deficiency				Action					
Facility: Thurston County Courthouse 4					Total System Deficiency Repair Cost (Undiscounted/Unescalated):				\$180,816
System: Interior Finishes					Total System Deficiency Repair Cost (Marked Up):				\$440,738
Ceiling Finishes									
ACT	4	3	2016		22,651	\$3.25	SF	\$73,616	\$179,438
ACT is aged, discolored, grid in good condition.				Remove ceiling tiles and replace with new.

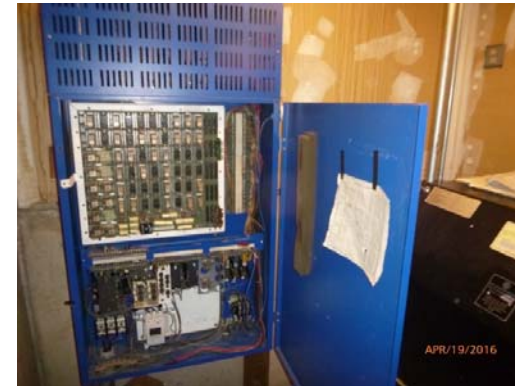
Material	Cond.	Material Useful Life	Survey Year	Condition Notes	Qty	Unit Cost	Unit	Direct Constr. Cost	Marked Up Cost
Deficiency				Action					
Facility: Thurston County Courthouse 4					Total System Deficiency Repair Cost (Undiscounted/Unescalated):				\$75,000
System: Vertical Transportation					Total System Deficiency Repair Cost (Marked Up):				\$182,813
Elevators and Lifts									
Elevator	4	2	2016		1	\$75,000.00	LS	\$75,000	\$182,813
Original two-stop hydraulic elevator is slow, noisy and past useful life.				Refurbish or replace elevator.

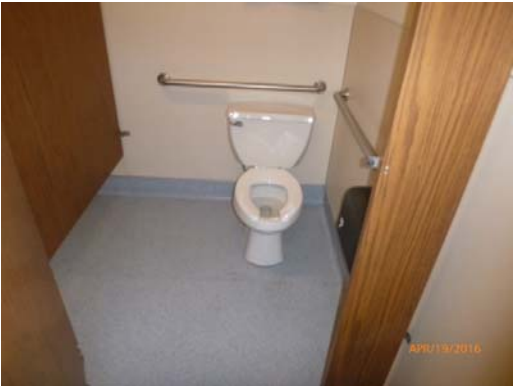
Material	Cond.	Material Useful Life	Survey Year	Condition Notes	Qty	Unit Cost	Unit	Direct Constr. Cost	Marked Up Cost
Deficiency				Action					
Facility:	Thurston County Courthouse 4				Total System Deficiency Repair Cost (Undiscounted/Unescalated):				\$39,329
System:	Plumbing				Total System Deficiency Repair Cost (Marked Up):				\$95,864
Plumbing Fixtures									
Fixture trim	4	3	2016		20	\$750.00	EA	\$15,000	\$36,563
Failing trim (faucets & flush valves).				Replace with County standard.

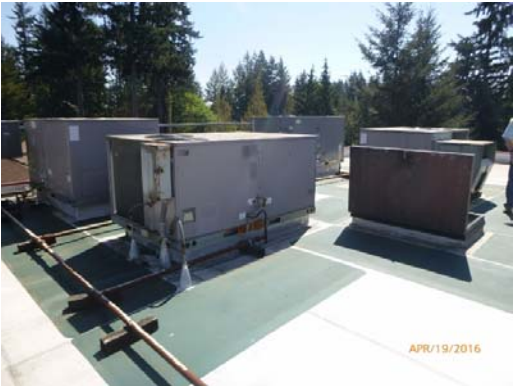
Older roof top units approaching end of life with failing economizers, rust & corrosion and noise.

Replace older gas-pack roof top units with new.

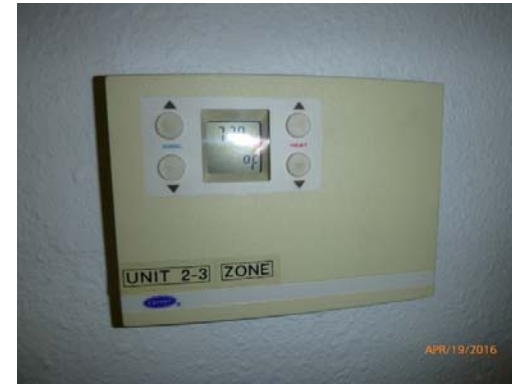
Older stand-alone thermostats, one for each roof top unit; no direct digital controls.

Install County standard direct digital control controls upon replacement of roof top units.

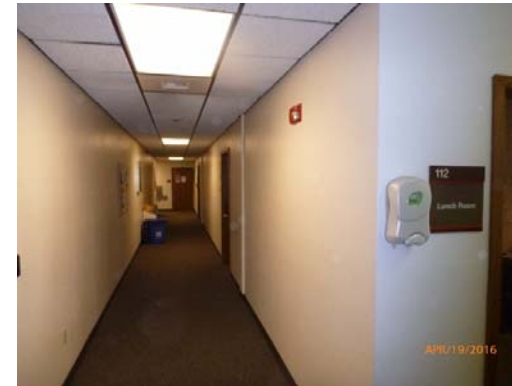
Material	Cond.	Material Useful Life	Survey Year	Condition Notes	Qty	Unit Cost	Unit	Direct Constr. Cost	Marked Up Cost
Deficiency				Action					
Facility: Thurston County Courthouse 4					Total System Deficiency Repair Cost (Undiscounted/Unescalated):				\$89,205
System: Fire Protection					Total System Deficiency Repair Cost (Marked Up):				\$217,436
Fire Protection Sprinkler Systems									
Fire sprinkler	5	0	2016		16,219	\$5.50	SF	\$89,205	\$217,436
No fire sprinkler.				Install wet pipe fire sprinkler system per code and County standards.

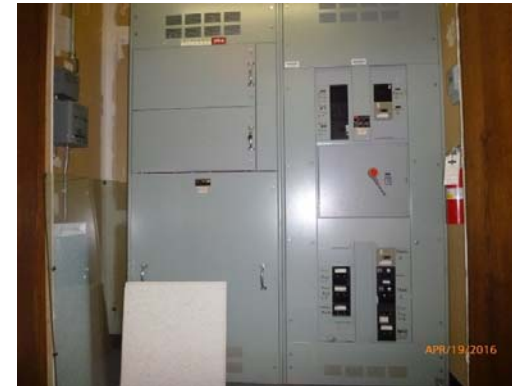
Circuits reportedly cross-wired.

Test, troubleshoot and uncross crossed wiring per code.

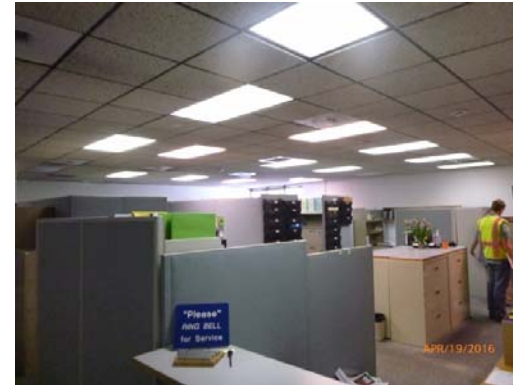
Material	Cond.	Material Useful Life	Survey Year	Condition Notes	Qty	Unit Cost	Unit	Direct Constr. Cost	Marked Up Cost
Deficiency				Action					
Facility: Thurston County Courthouse 4					Total System Deficiency Repair Cost (Undiscounted/Unescalated):				\$170,300
System: Electrical					Total System Deficiency Repair Cost (Marked Up):				\$415,105
Lighting and Branch Wiring									
Lighting & wiring	4	3	2016		16,219	\$9.00	SF	\$145,971	\$355,804
Obsolete T-12 lighting with older manual controls.				Upgrade to modern T-8 lighting with controls per energy code.

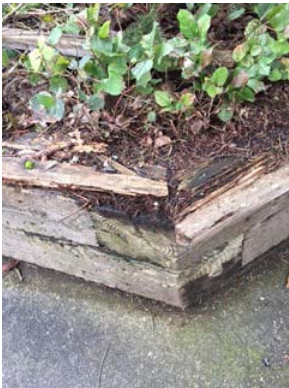
Assumes demo at \$2,000 and CIP concrete replacement at \$5,000 for labor and materials.

Remove treated lumber and replace with cast-in-place concrete retaining walls for improved durability and lower maintenance.

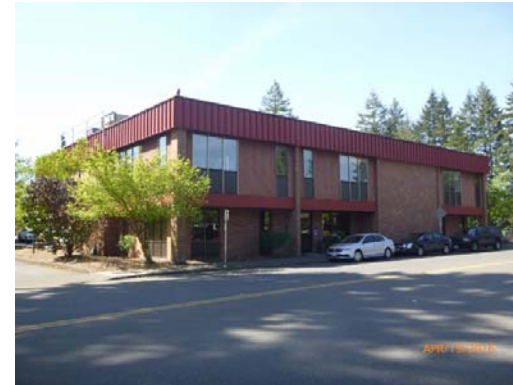
City side sewer partially collapsed between building and city main to north, periodically backing-up.

Coordinate with City to repair or replace the side sewer.

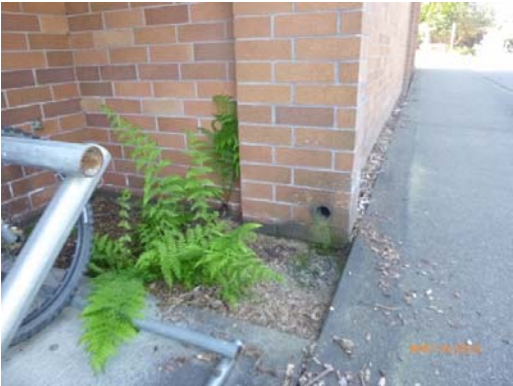
Roof drains to grade are not piped to storm, resulting in basement flooding and risk of water intrusion around building perimeter.

Pipe roof drains to site storm drain system.

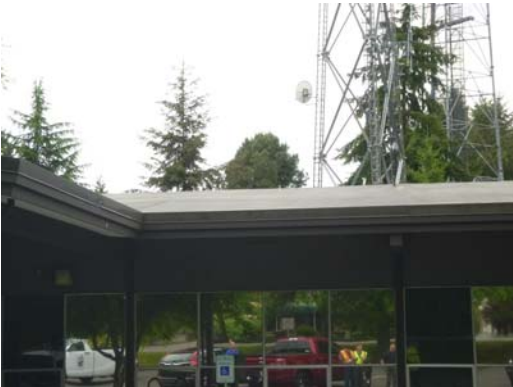
Material	Cond.	Material Useful Life	Survey Year	Condition Notes	Qty	Unit Cost	Unit	Direct Constr. Cost	Marked Up Cost
Deficiency				Action					
Facility:	Thurston County Emergency Services Building				Total System Deficiency Repair Cost (Undiscounted/Unescalated):				\$101,250
System:	Roofing				Total System Deficiency Repair Cost (Marked Up):				\$246,797
Roof Coverings									
Roofing	3	4	2016		13,500	\$7.50	SF	\$101,250	\$246,797
Roofing appears to have less than five years remaining life.				Remove roofing and replace with composition shingle roofing.

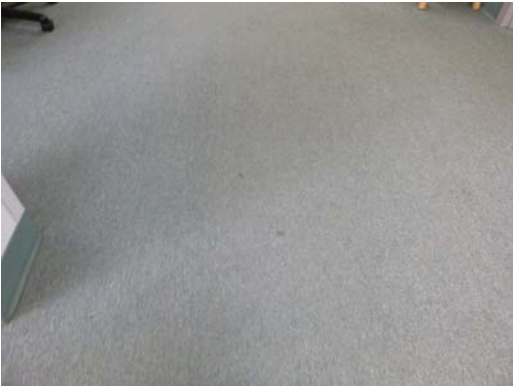
Carpet on main level corridors and east end of building worn, stained.

Remove carpet and replace with new carpet.

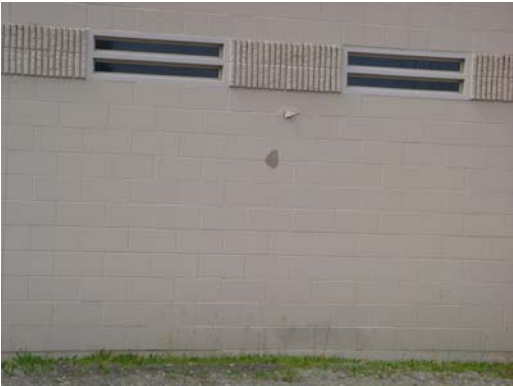
CMU paint bubbling, peeling. Remove last coat of paint, prep and repaint CMU walls.

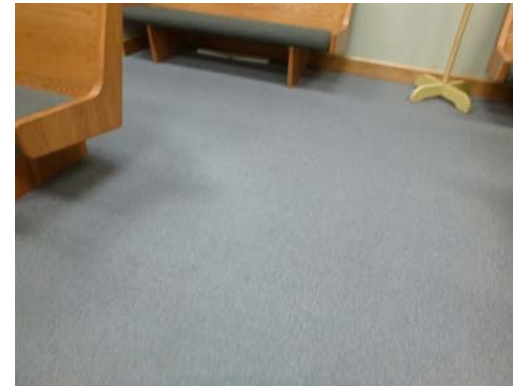
Carpet in offices and courtrooms is showing signs of wear and age.

Remove and replace with new carpet.

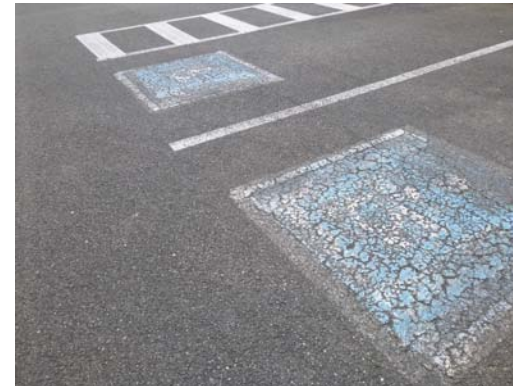
Parking area striping worn and faded.

Prep and repaint parking lot striping.

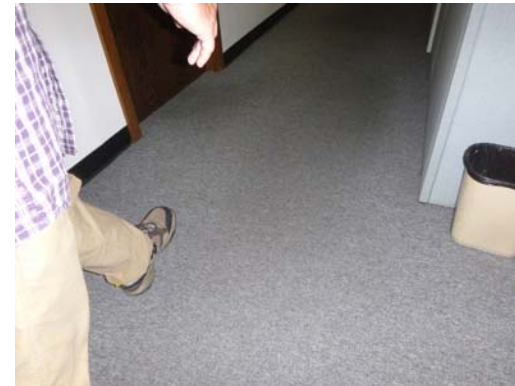
Carpet is showing wear and tear.

Remove and replace with new carpet at 2nd floor and 2/3 of 1st floor..

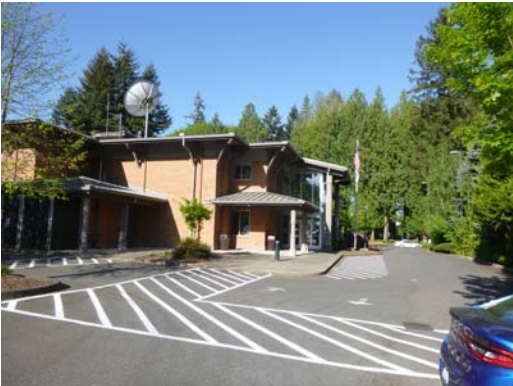
Obsolete HVAC controls with parts no longer available and no remote monitoring or control.

Install new DDC control system with remote monitoring and control capability per County standard (Delta Controls).

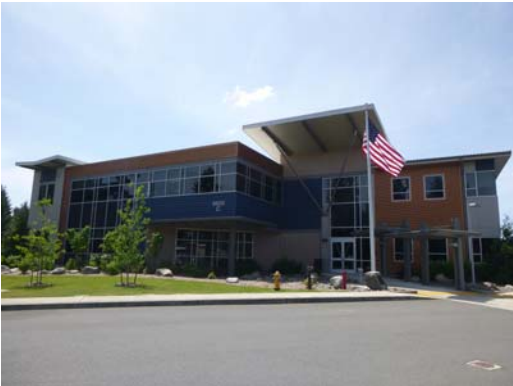
No motorized dampers for building relief louvers  
subjecting building to pressurization issues during windy  
condition and to insect entry when system is not active.

Install DDC controlled motor-operator control for  
barometric relief louvers.

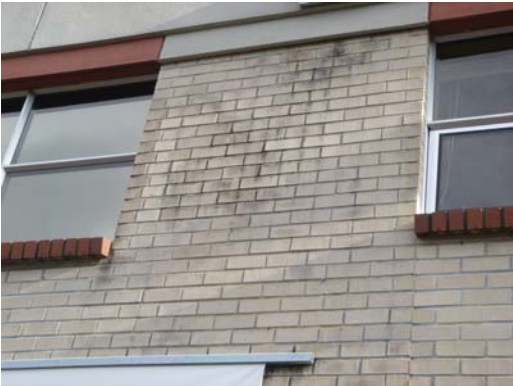
Material	Cond.	Material Useful Life	Survey Year	Condition Notes	Qty	Unit Cost	Unit	Direct Constr. Cost	Marked Up Cost
Deficiency				Action					
Facility:	TwinStar Credit Union Building #5				Total System Deficiency Repair Cost (Undiscounted/Unescalated):				\$18,000
System:	Exterior Closure				Total System Deficiency Repair Cost (Marked Up):				\$43,875
Exterior Walls									
Veneer	4	4	2016		6,000	\$3.00	SF	\$18,000	\$43,875
Brick veneer discolored and moss growth.				Clean and reseal exterior brick veneer.

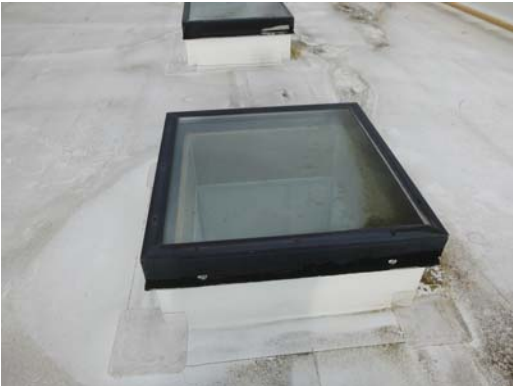
Material	Cond.	Material Useful Life	Survey Year	Condition Notes	Qty	Unit Cost	Unit	Direct Constr. Cost	Marked Up Cost
Deficiency				Action					
Facility:	TwinStar Credit Union Building #5				Total System Deficiency Repair Cost (Undiscounted/Unescalated):				\$29,000
System:	Roofing				Total System Deficiency Repair Cost (Marked Up):				\$70,688
Roof Openings									
Skylights	4	2	2016		10	\$400.00	EA	\$4,000	\$9,750
Skylights have broken seals.				Replace skylight panels with new.

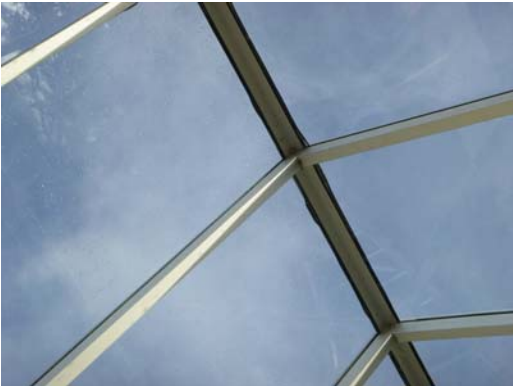
Material	Cond.	Material Useful Life	Survey Year	Condition Notes	Qty	Unit Cost	Unit	Direct Constr. Cost	Marked Up Cost
Deficiency				Action					
Facility:	TwinStar Credit Union Building #5				Total System Deficiency Repair Cost (Undiscounted/Unescalated):				\$29,000
System:	Roofing				Total System Deficiency Repair Cost (Marked Up):				\$70,688
Projections									
Canopy	4	1	2016		1	\$25,000.00	LS	\$25,000	\$60,938
Canopy skylights have broken seals.				Replace skylight panels with new.

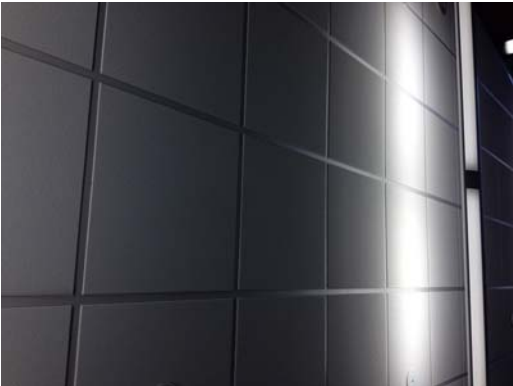
Material	Cond.	Material Useful Life	Survey Year	Condition Notes	Qty	Unit Cost	Unit	Direct Constr. Cost	Marked Up Cost
Deficiency				Action					
Facility: TwinStar Credit Union Building #5					Total System Deficiency Repair Cost (Undiscounted/Unescalated):				\$119,496
System: Fire Protection					Total System Deficiency Repair Cost (Marked Up):				\$291,272
Fire Protection Sprinkler Systems									
Fire Sprinkler	5	0	2016		19,916	\$6.00	SF	\$119,496	\$291,272
No fire sprinkler system.				Install fire sprinkler system.

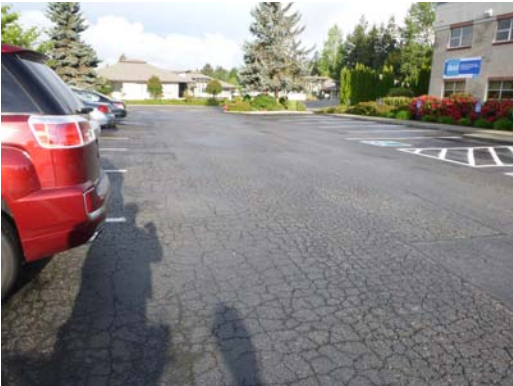
AC paving is cracked at main drive areas and shows surface wear.

Prep, fill cracks and seal coat paving, re-stripe were necessary.
