# **SEISMIC STABILITY EVALUATIONS OF CHESBRO, LENIHAN, STEVENS CREEK, AND UVAS DAMS (SSE2)**

### **LENIHAN DAM**

#### **WORK PLAN FOR SITE INVESTIGATIONS AND LABORATORY TESTING (REPORT No. LN-1)**

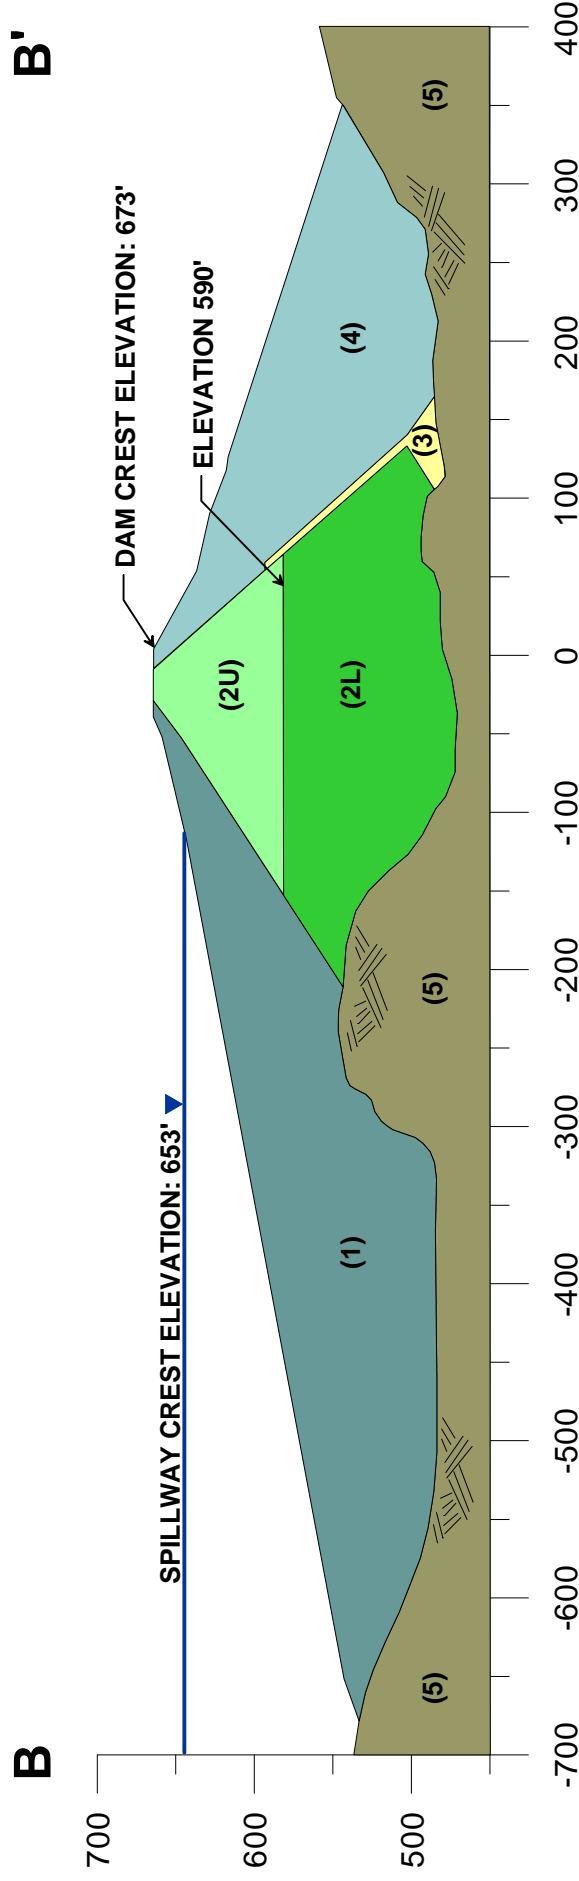
Figure  
5-1

Zone	Color Code	Material Description	Predominant Soil Classification
1		Upstream Shell	Gravely Clayey Sands (SC) to Sandy Clays (CL)
2U		Upper Core (Above El. 590)	Gravely Clayey Sands (SC) to Clayey Gravels (GC)
2L		Lower Core (Below El. 590)	Sandy Highly Plastic Clays (CH) to Silty Sands-Sandy Highly Plastic Silts (SM/MH)
3		Drain	N/A
4		Downstream Shell	Gravely Clayey Sands (SC) to Clayey Gravels (GC)
5		Bedrock	Franciscan Complex

Note: See Figure 2-2A for location of section B-B', see Figure 2-3 for piezometric data.

MAXIMUM CROSS SECTION B-B'  
LENIHAN DAM  
SEISMIC STABILITY EVALUATIONS (SSE2)

The preliminary engineering analyses discussed in Section 6 require the following material properties for the various zones shown on Figure 5-1: unit weight, effective stress friction angle, undrained strength, undrained stress-strain-strength relationship, and dynamic properties (i.e., shear-wave velocity, shear modulus reduction, and damping ratio curves). In addition, the permeability of the various materials is required as initial input to the seepage analyses that will support the engineering analyses of seismic deformations. The following sub-sections describe how material properties were derived from the existing data for all zones except Zone 3. The Zone 3 drain materials should be predominantly sand or sand and gravel mixes but no classification or engineering information is available from previous studies for these materials. For our preliminary engineering analyses of seismic response and permanent displacements, we have assigned the Zone 3 materials the same stiffness and strength as the Zone 4 materials.

supported by trends observed in the available data. There is strong evidence, as discussed in Section 5.4, that all four zones of the embankment are both clayey and over-consolidated. In addition, Zones 1, 2U, and 4 were observed to have very similar PI and  $I_c$  characteristics with Zone 2L being somewhat different as shown by the cumulative distributions of PI and  $I_c$  presented on Figures 5-6 and 5-12, respectively. The CPT data points plotted on the soil behavior type chart in Figure 5-13 have been summarized on another soil behavior type chart (Figure 5-14) by plotting the average normalized cone data for each zone with a range representing one standard deviation of the full body of data. This figure reinforces the observation that the material types of Zones 1, 2U, and 4 can be considered similar with that of Zone 2L being somewhat different.

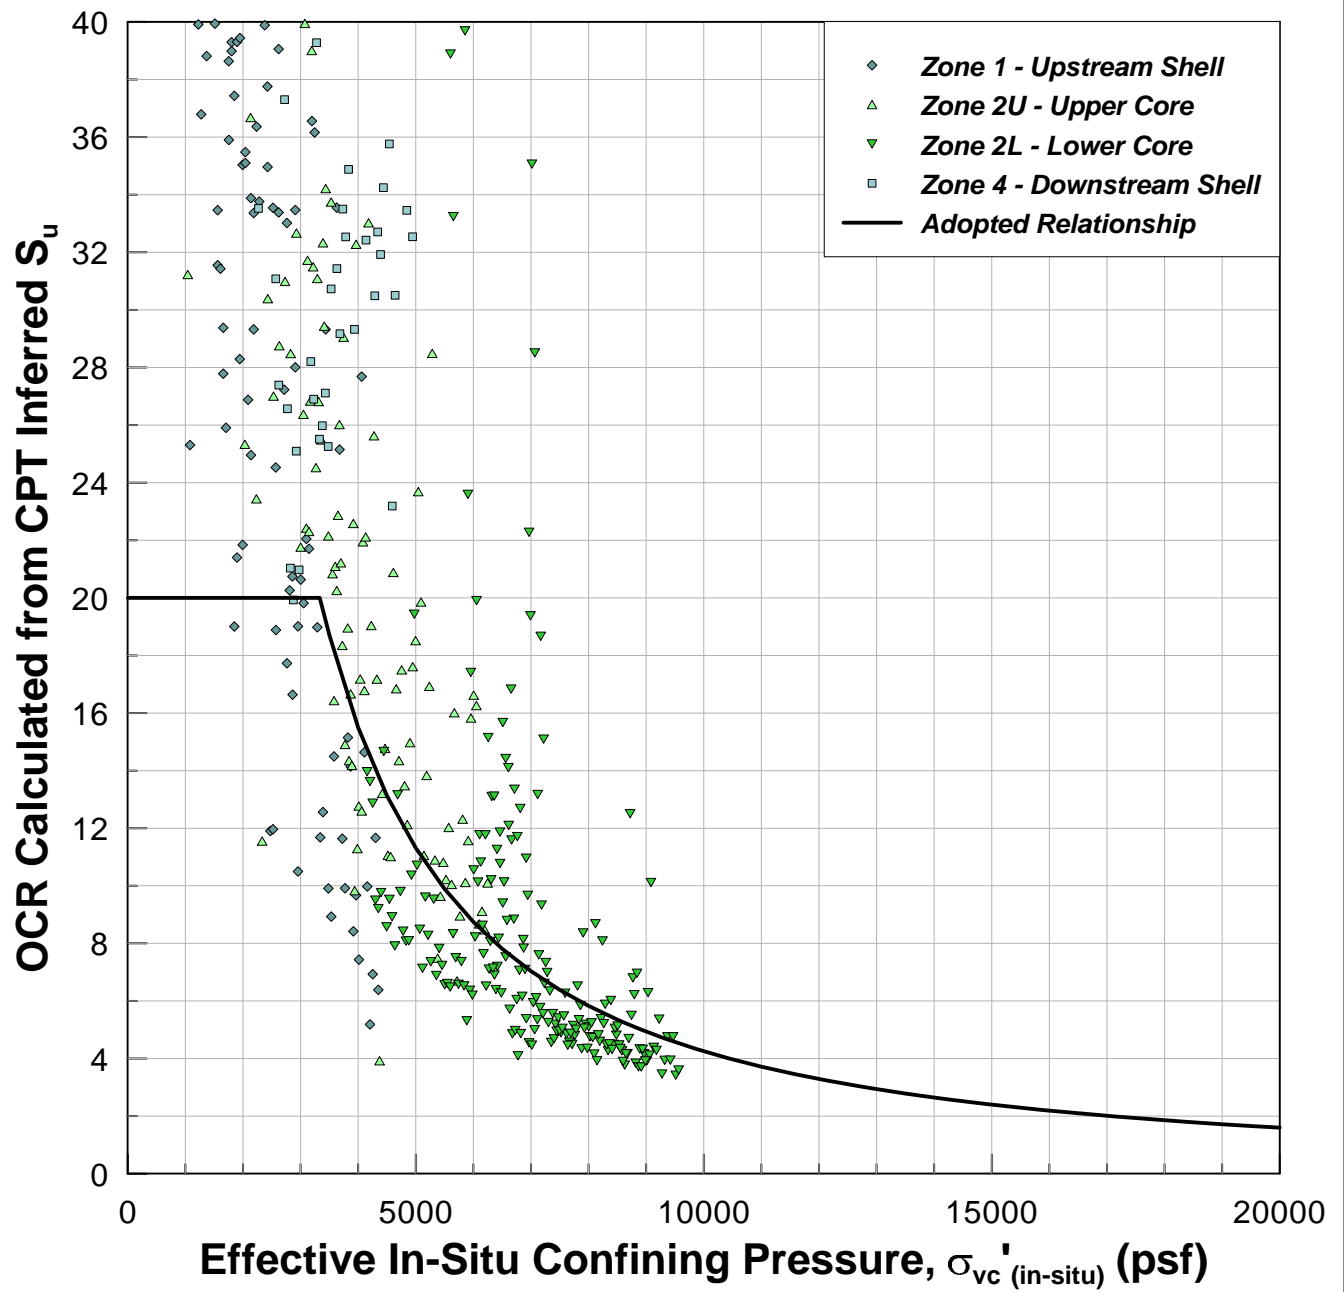
## OCR for All Zones

**Adopted Relationship**

$$\text{OCR} = e^{(-1.41 \cdot \ln(\sigma_{vc}') + 14.44)}$$

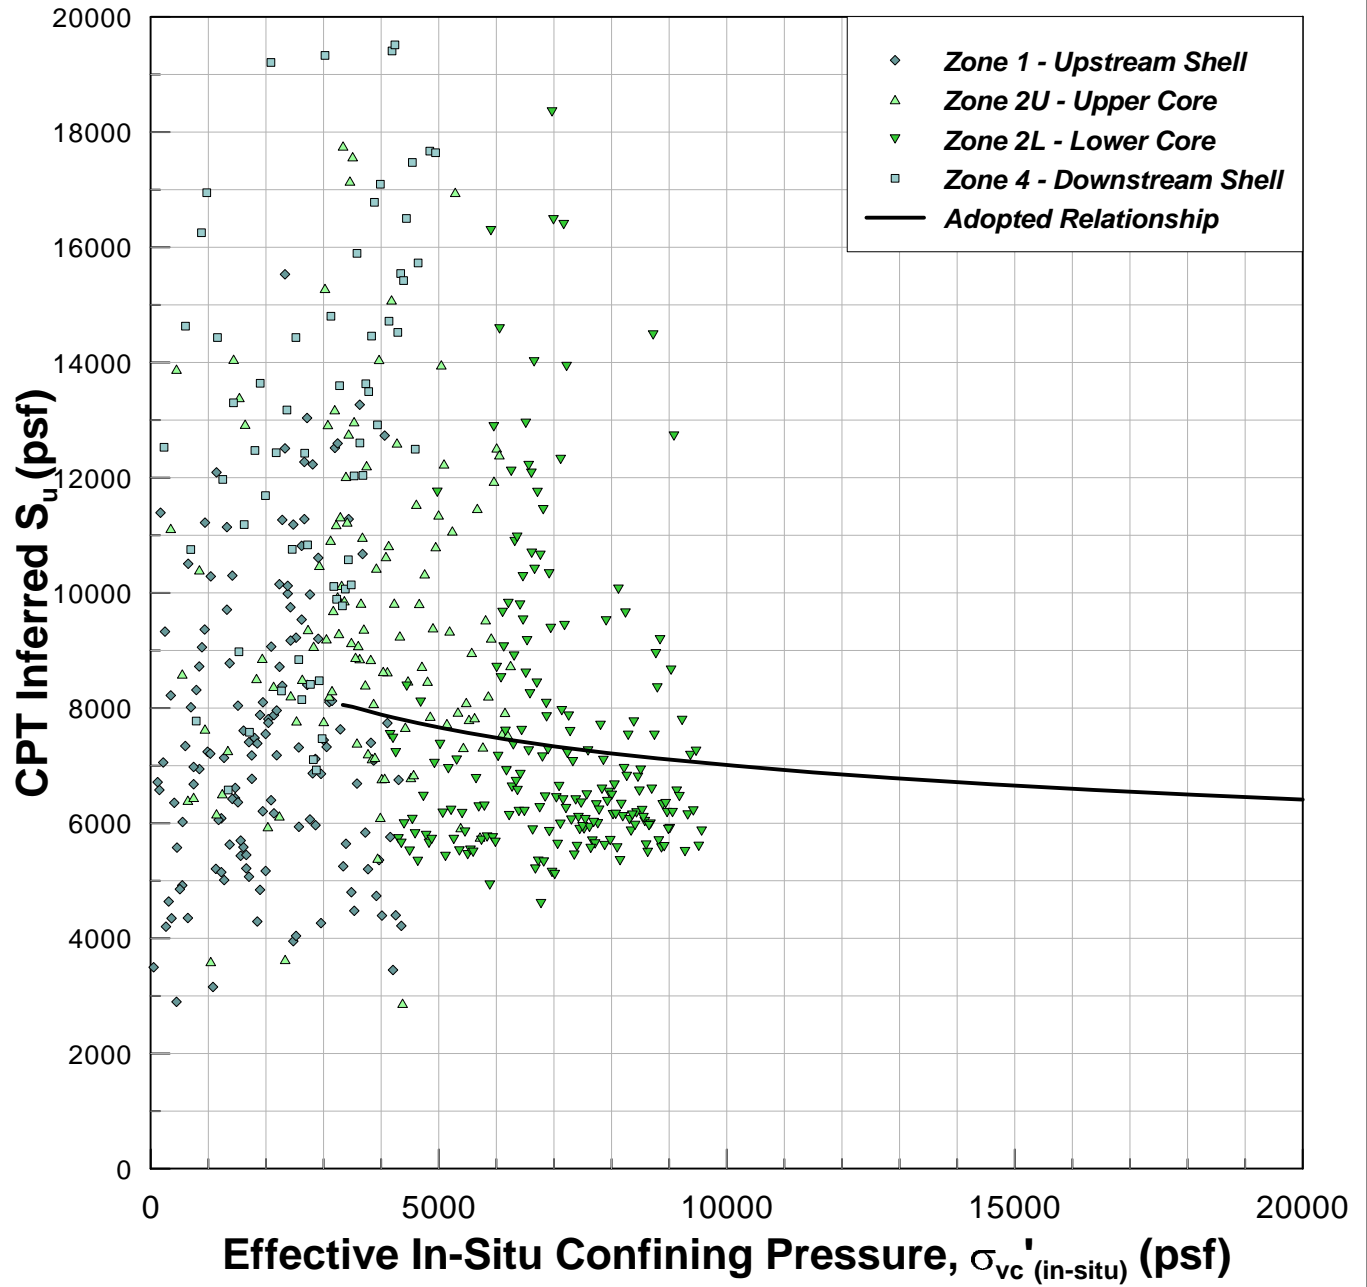
## Undrained Strength Comparison

### Adopted Parameter

$$S_u / \sigma_{vc}' = 0.22 * (OCR)^{0.8}$$

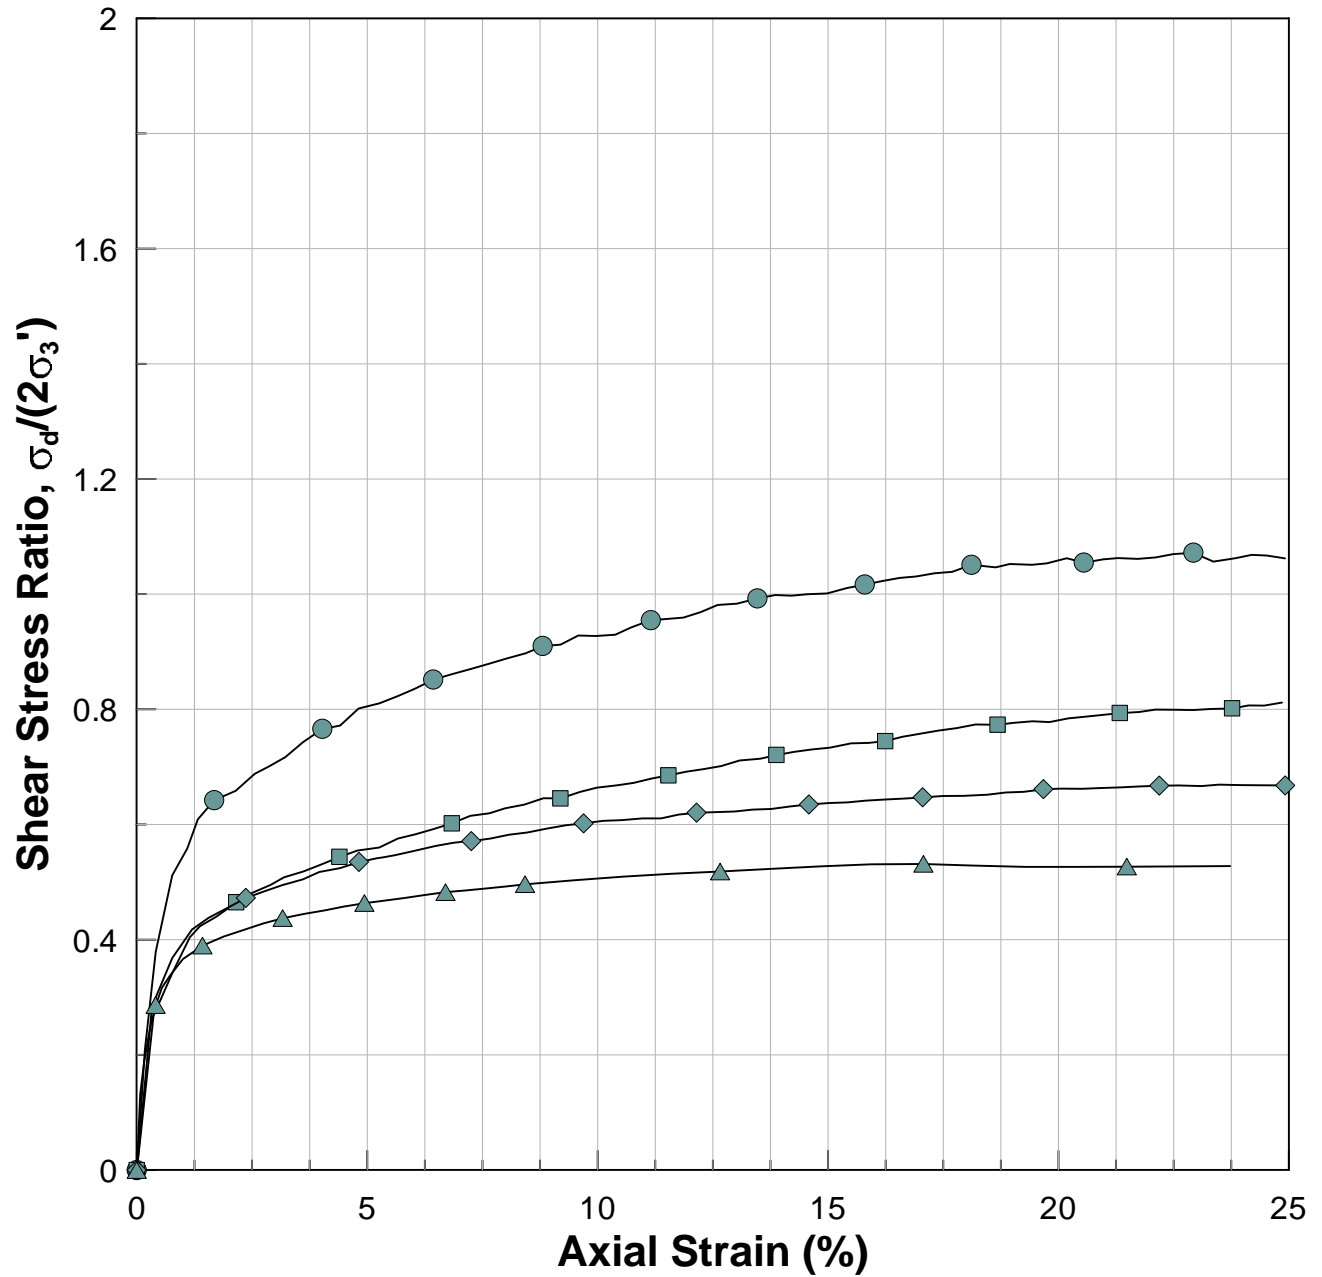
## Strain-Strength Plot for Upstream Shell

- Cons. @ 2 ksf,  $\sigma_{vc}'(\text{tested})/\sigma_{vc}'(\text{in-situ}) \sim 1.1$
- Cons. @ 6 ksf,  $\sigma_{vc}'(\text{tested})/\sigma_{vc}'(\text{in-situ}) \sim 2.6$
- ◆ Cons. @ 10 ksf,  $\sigma_{vc}'(\text{tested})/\sigma_{vc}'(\text{in-situ}) \sim 4.3$
- ▲ Cons. @ 18.2 ksf,  $\sigma_{vc}'(\text{tested})/\sigma_{vc}'(\text{in-situ}) \sim 10.2$

Note: In-situ confining pressure for samples was estimated based on available information, original data was not recoverable.

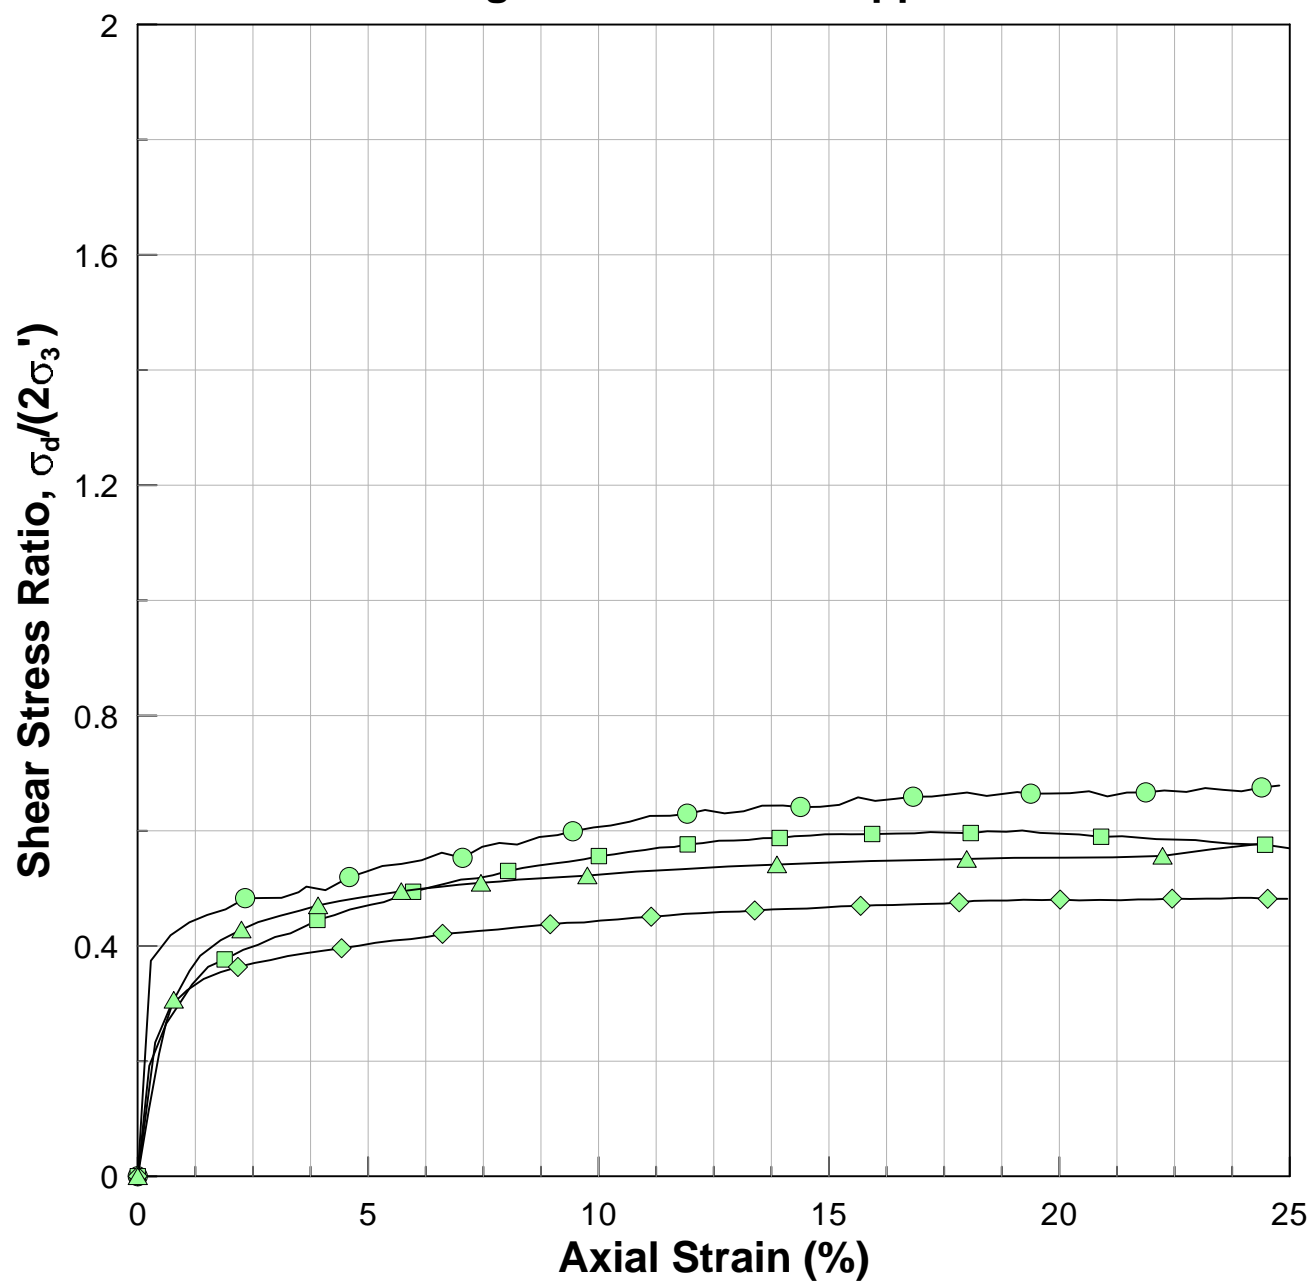
## Strain-Strength Ratio Plot for Upper Core

- Cons. @ 2 ksf,  $\sigma_{vc}'(\text{tested})/\sigma_{vc}'(\text{in-situ}) \sim 0.5$
- Cons. @ 2 ksf,  $\sigma_{vc}'(\text{tested})/\sigma_{vc}'(\text{in-situ}) \sim 1.5$
- ◇— Cons. @ 10 ksf,  $\sigma_{vc}'(\text{tested})/\sigma_{vc}'(\text{in-situ}) \sim 2.5$
- ▲— Cons. @ 15.2 ksf,  $\sigma_{vc}'(\text{tested})/\sigma_{vc}'(\text{in-situ}) \sim 3.9$

Note: In-situ confining pressure for samples was estimated based on available information, original data was not recoverable.

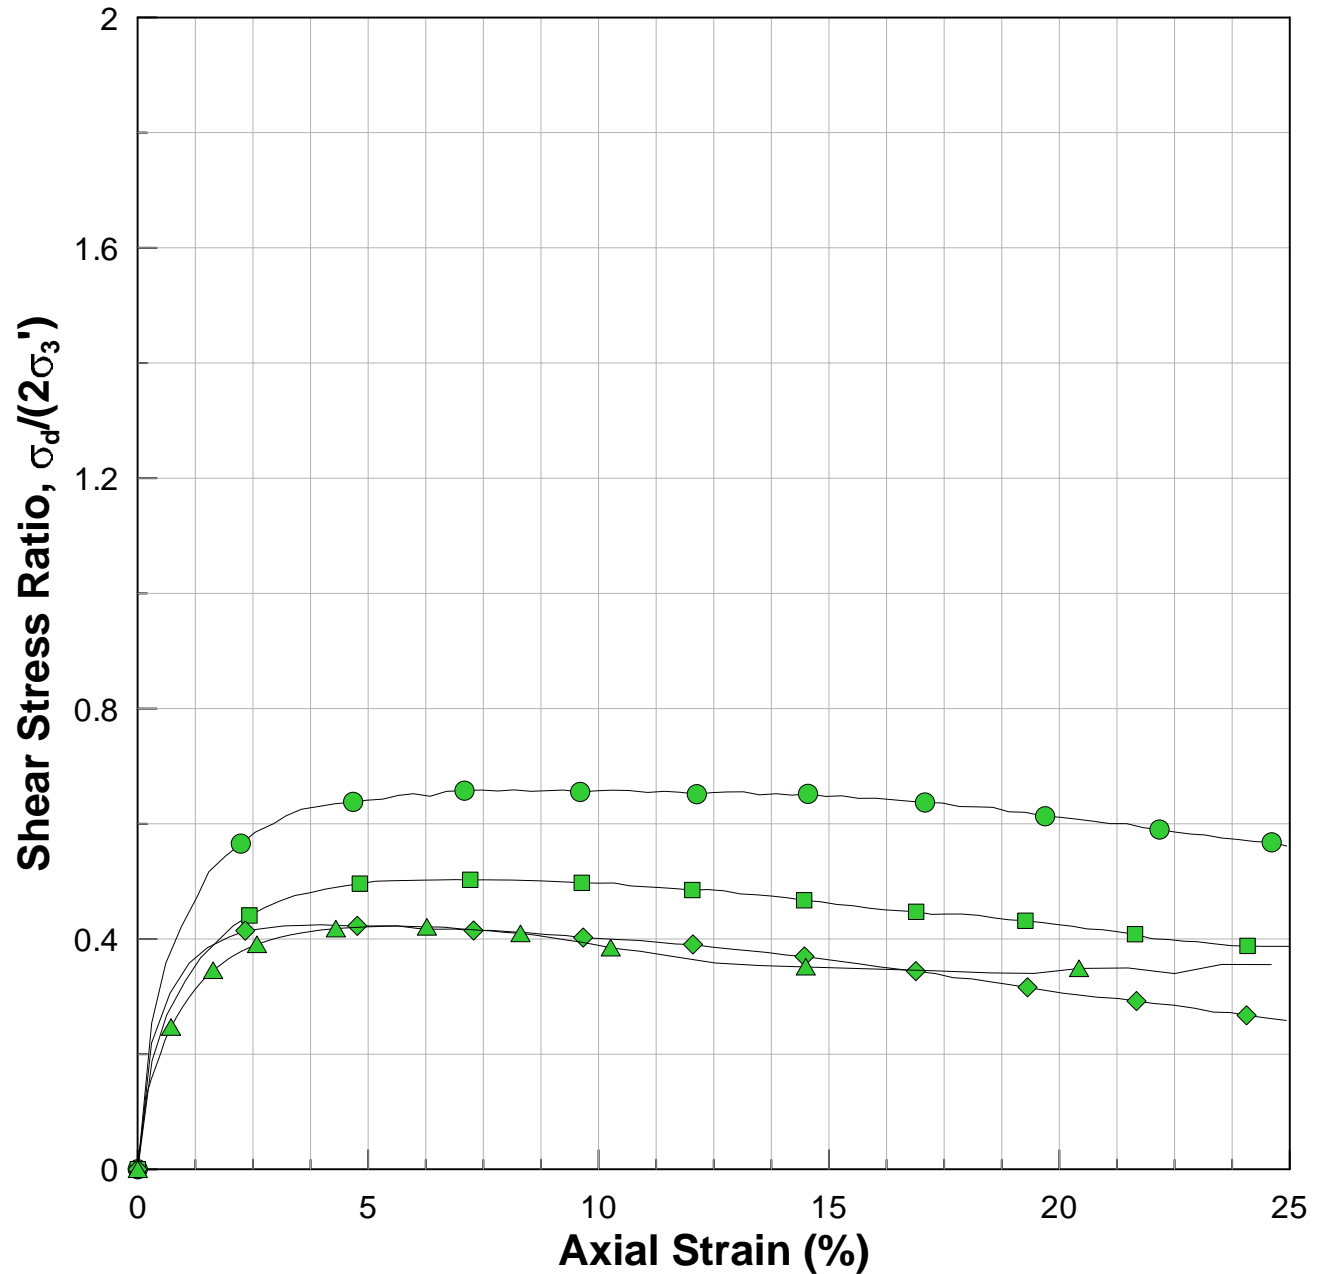
## Strain-Strength Plot for Lower Core

- Cons. @ 4 ksf,  $\sigma_{vc}'(\text{tested})/\sigma_{vc}'(\text{in-situ}) \sim 0.6$
- Cons. @ 8 ksf,  $\sigma_{vc}'(\text{tested})/\sigma_{vc}'(\text{in-situ}) \sim 1.4$
- ◆ Cons. @ 12 ksf,  $\sigma_{vc}'(\text{tested})/\sigma_{vc}'(\text{in-situ}) \sim 2.3$
- ▲ Cons. @ 16.8 ksf,  $\sigma_{vc}'(\text{tested})/\sigma_{vc}'(\text{in-situ}) \sim 2.5$

Note: In-situ confining pressure for samples was estimated based on available information, original data was not recoverable.

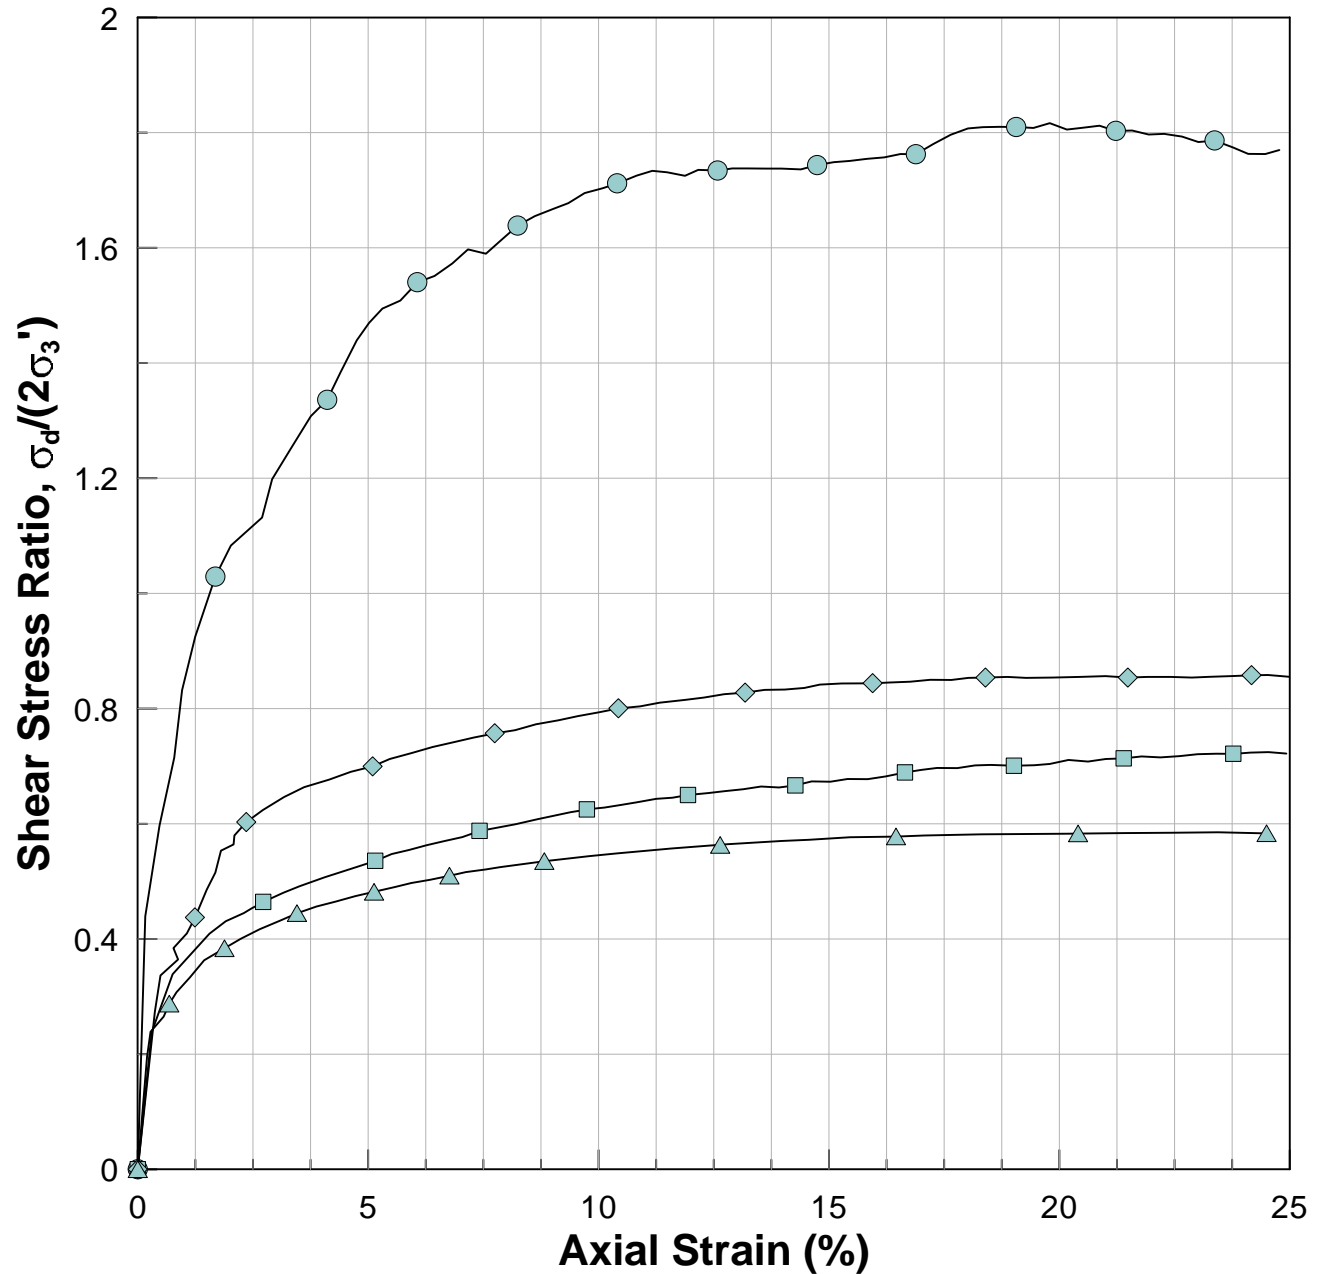
## Strain-Strength Ratio Plot for Downstream Shell

- **Cons. @ 2 ksf,  $\sigma_{vc}'(\text{tested})/\sigma_{vc}'(\text{in-situ}) \sim 0.4$**
- **Cons. @ 6 ksf,  $\sigma_{vc}'(\text{tested})/\sigma_{vc}'(\text{in-situ}) \sim 1.0$**
- ◆— **Cons. @ 10 ksf,  $\sigma_{vc}'(\text{tested})/\sigma_{vc}'(\text{in-situ}) \sim 1.7$**
- ▲— **Cons. @ 14.4 ksf,  $\sigma_{vc}'(\text{tested})/\sigma_{vc}'(\text{in-situ}) \sim 2.7$**

Note: In-situ confining pressure for samples was estimated based on available information, original data was not recoverable.

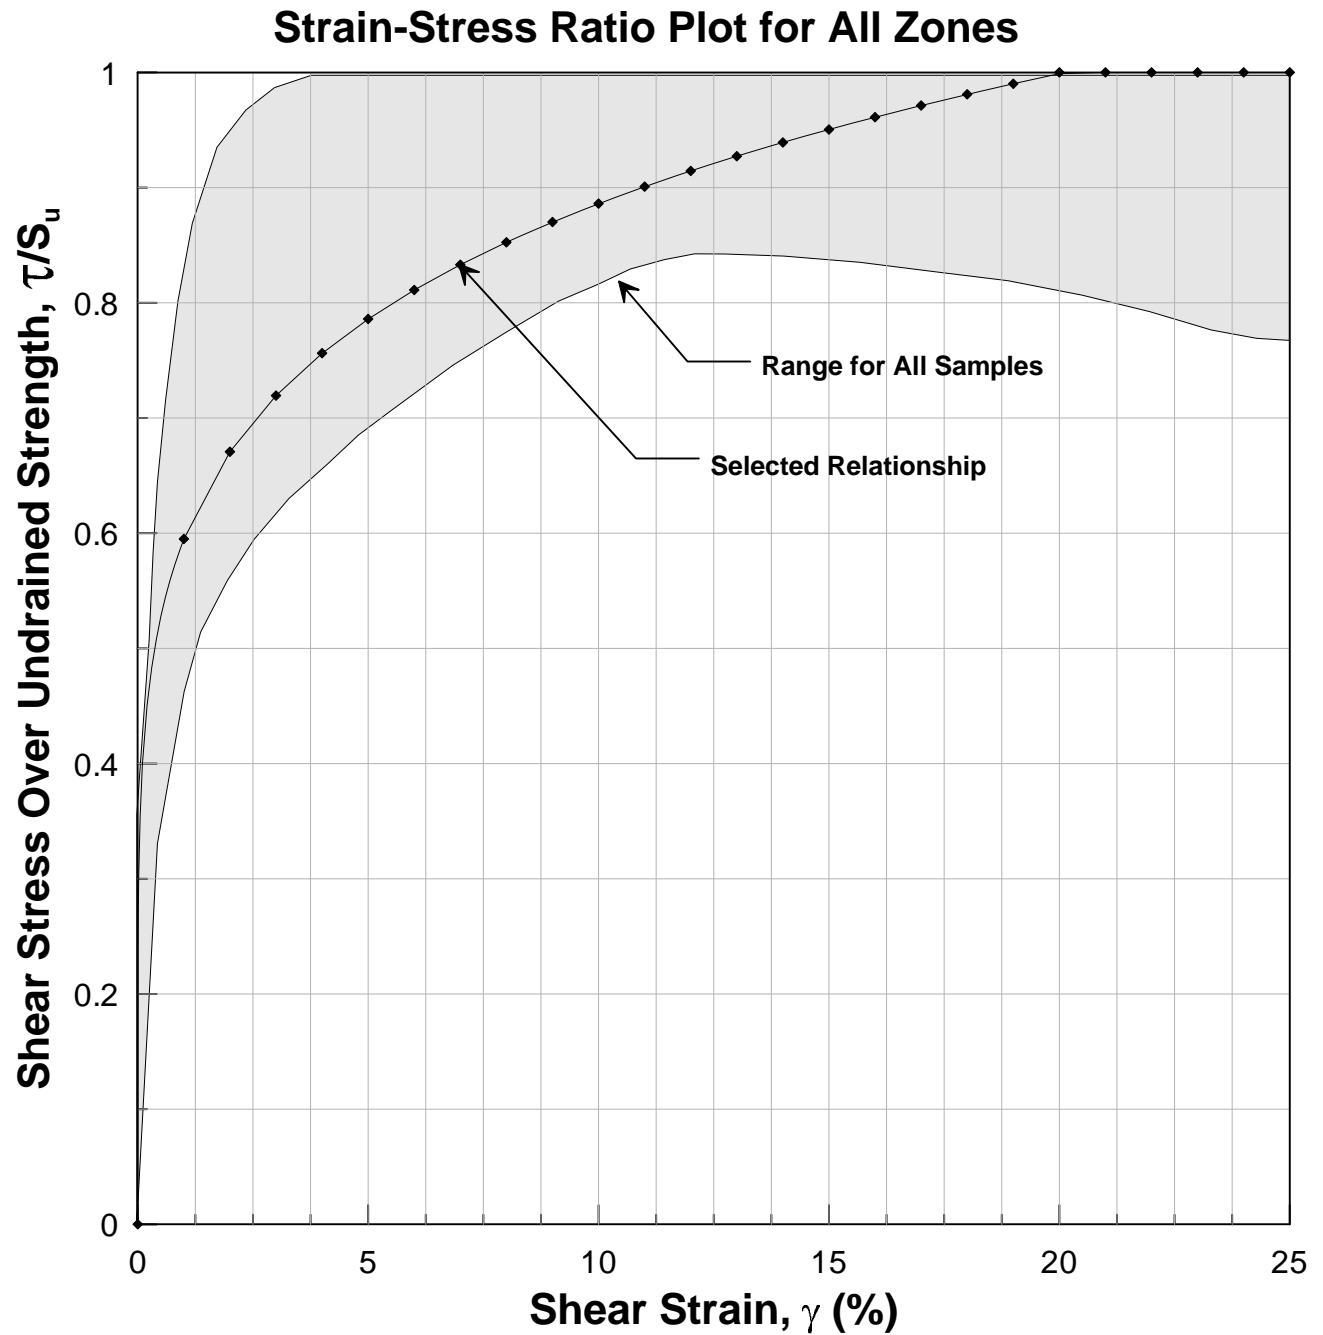
**Adopted Relationship**

$$\tau = S_u * e^{(0.17 * \ln(\gamma) - 0.52)}$$

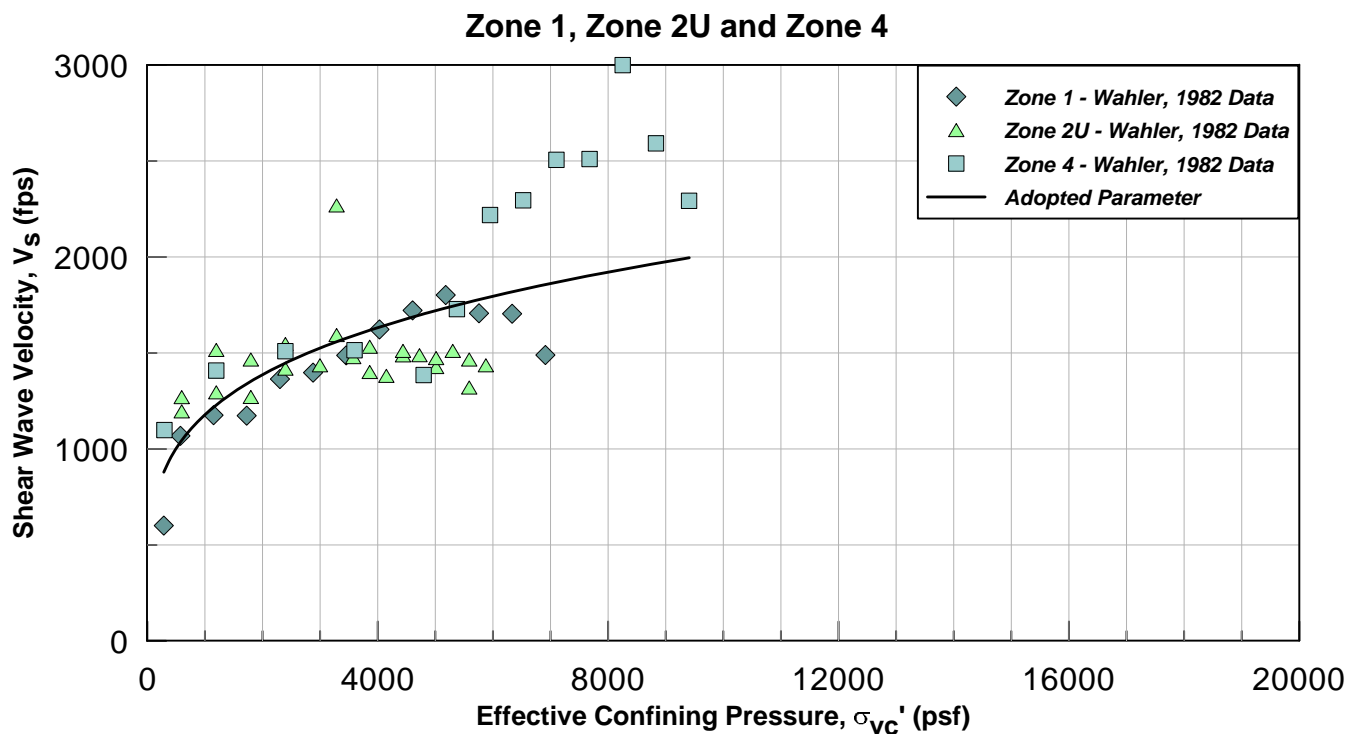
**Zone 1, 2U, 4 - Adopted Parameter:  $V_s = e^{(0.24 \cdot \ln(\sigma_{vc}') + 5.4)}$**

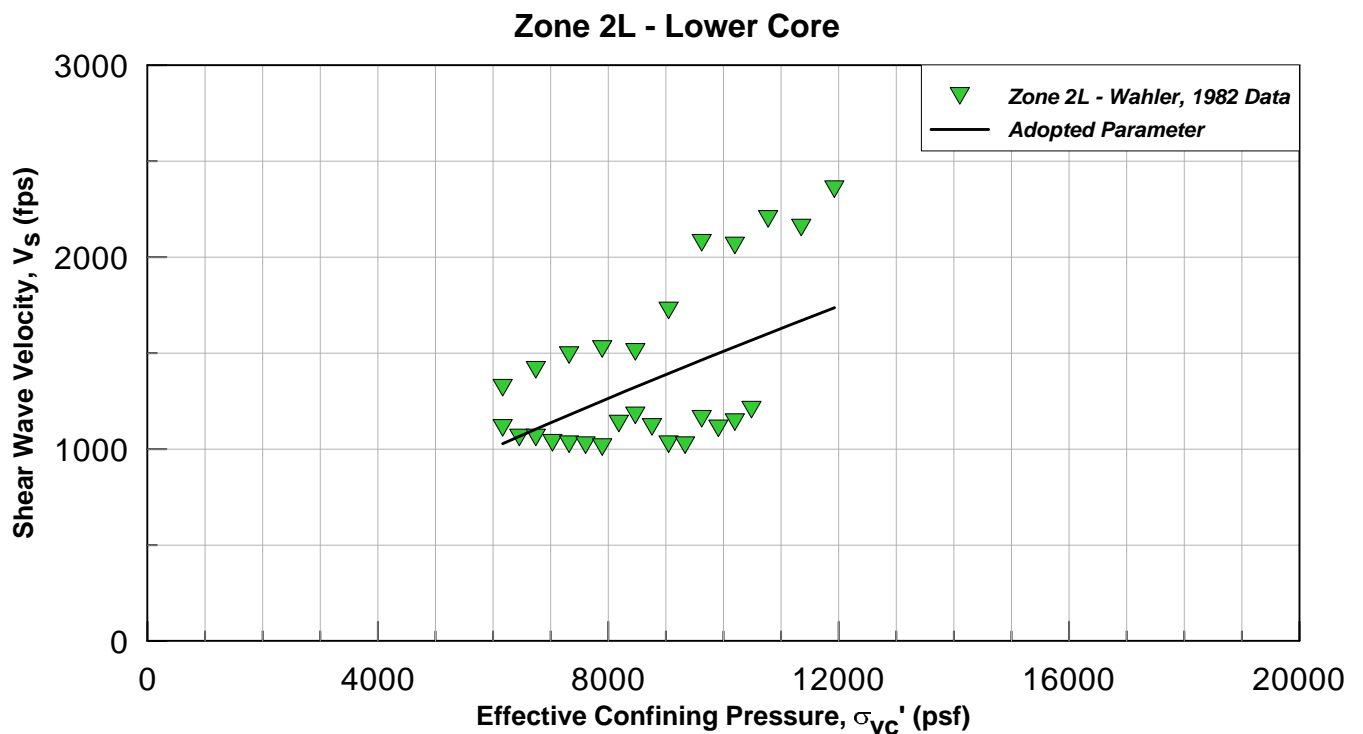
**Zone 2L - Adopted Parameter:  $V_s = e^{(0.79 \cdot \ln(\sigma_{vc}') + 5.4)}$**

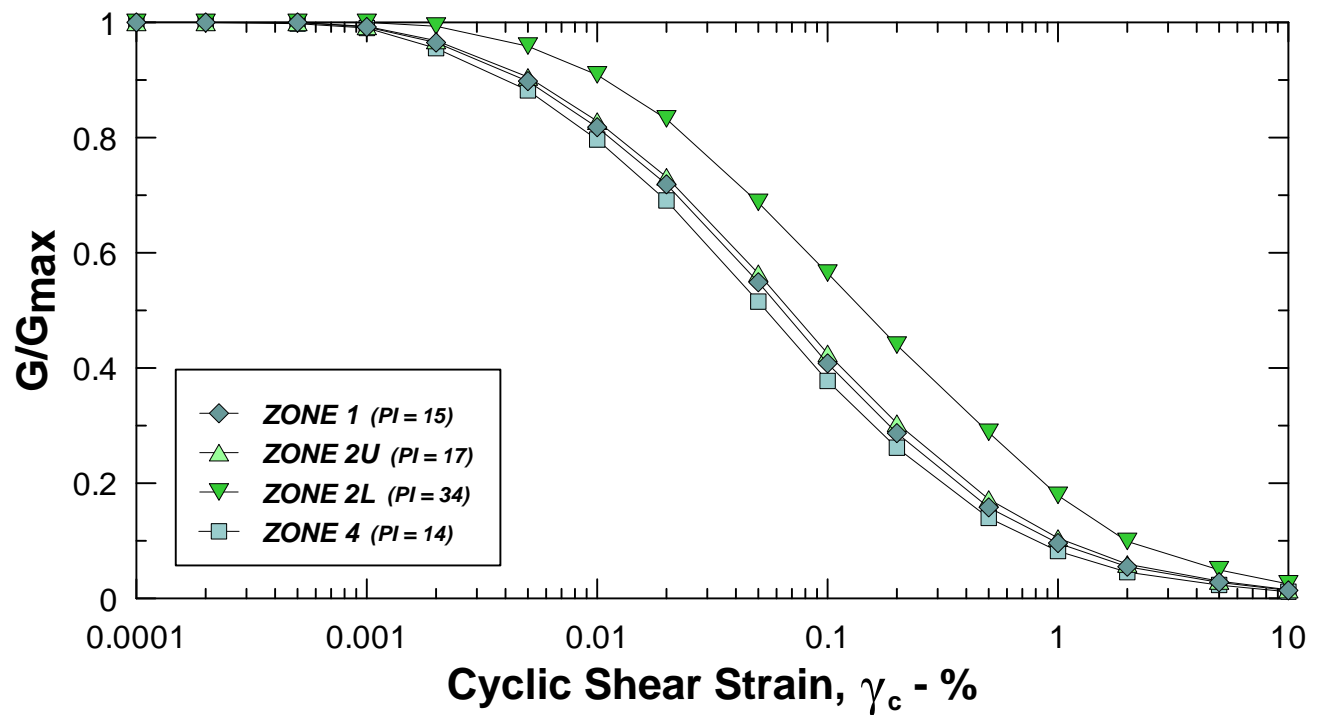
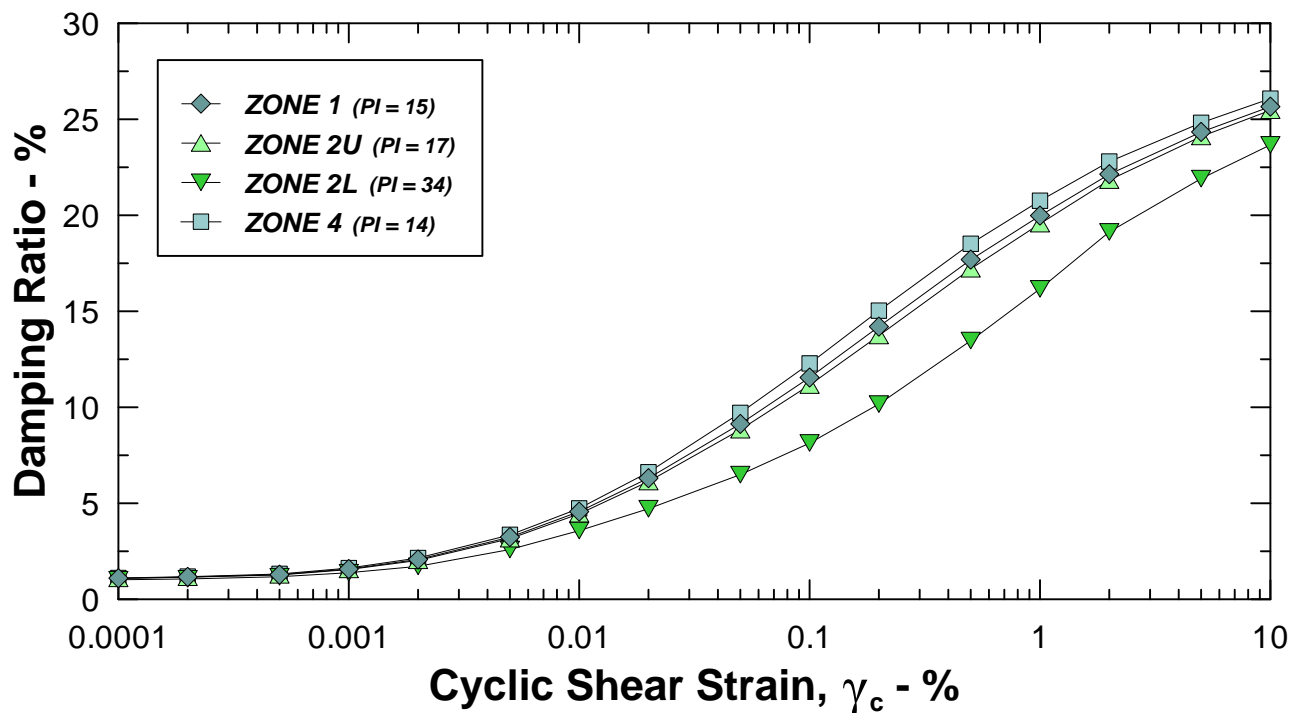
Note: Modulus reduction and damping ratio curves are based on Vucetic and Dobry, 1991

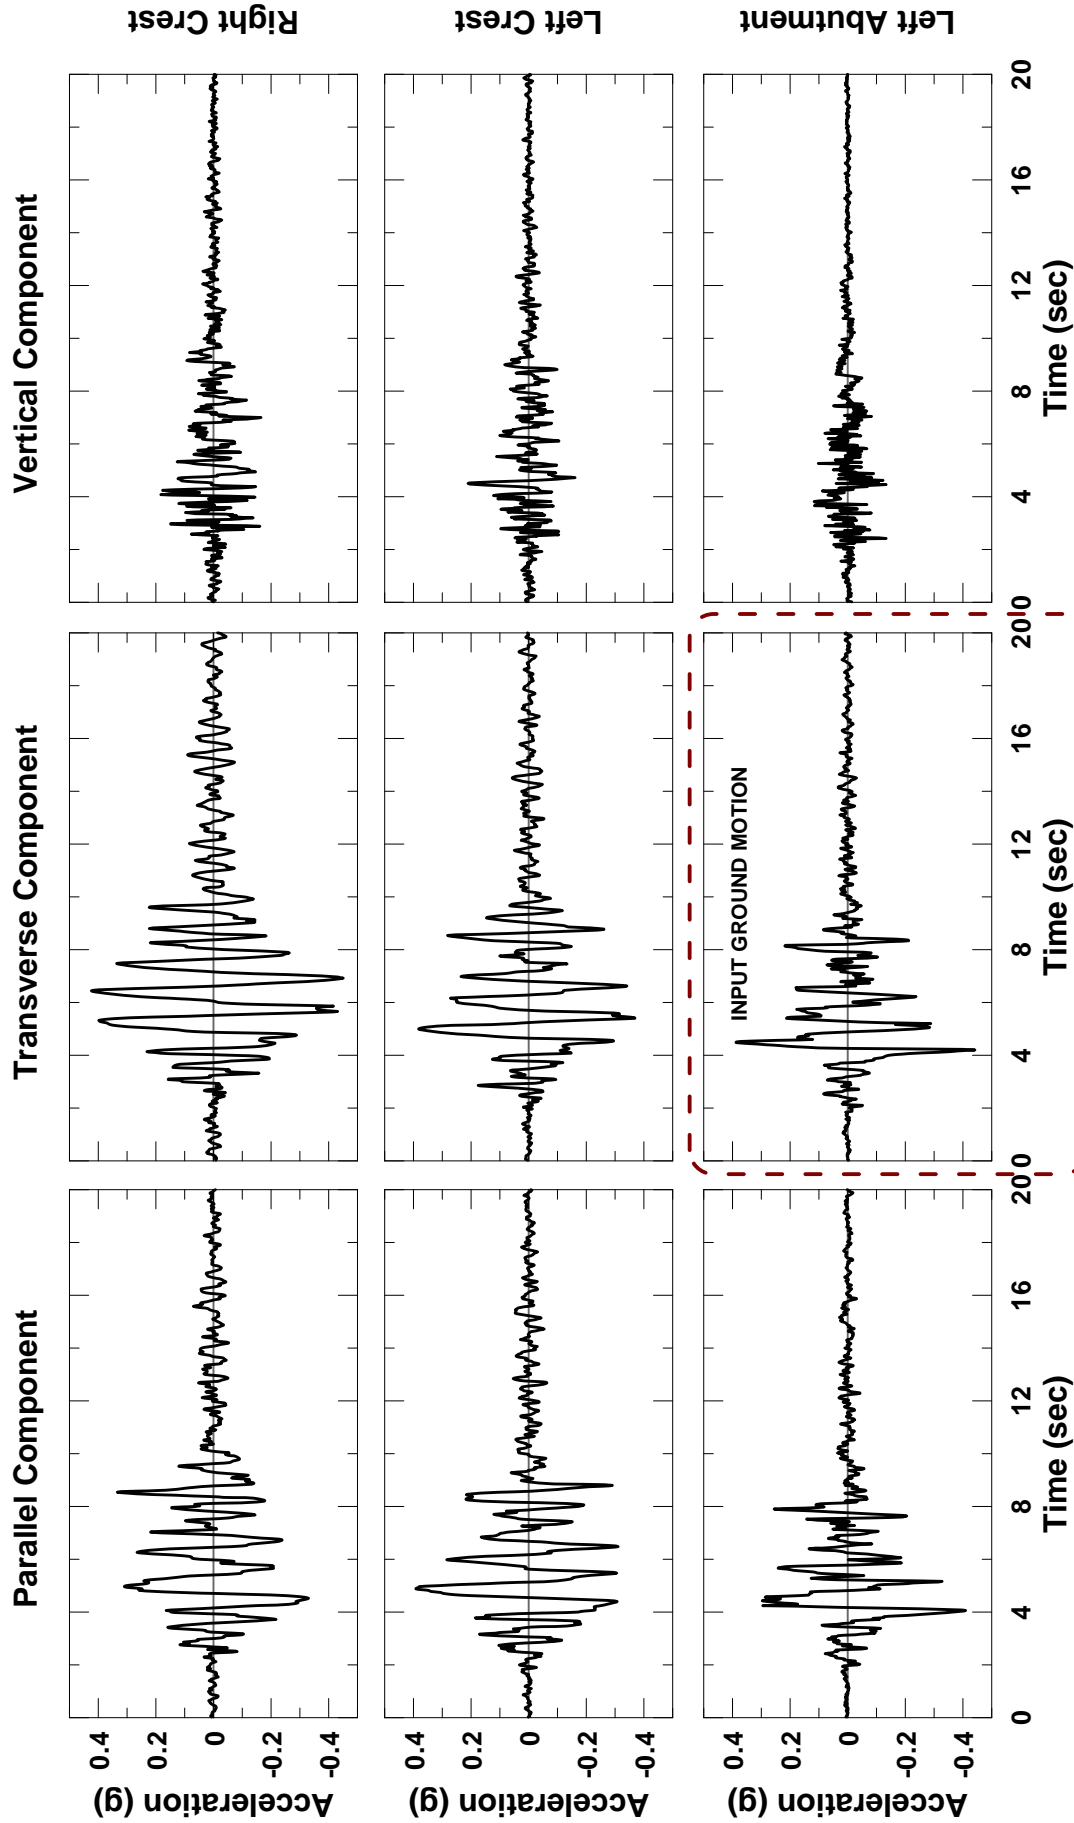
Acceleration Time Histories of  
Loma Prieta Recordings from CGS Strong Motion Center Database

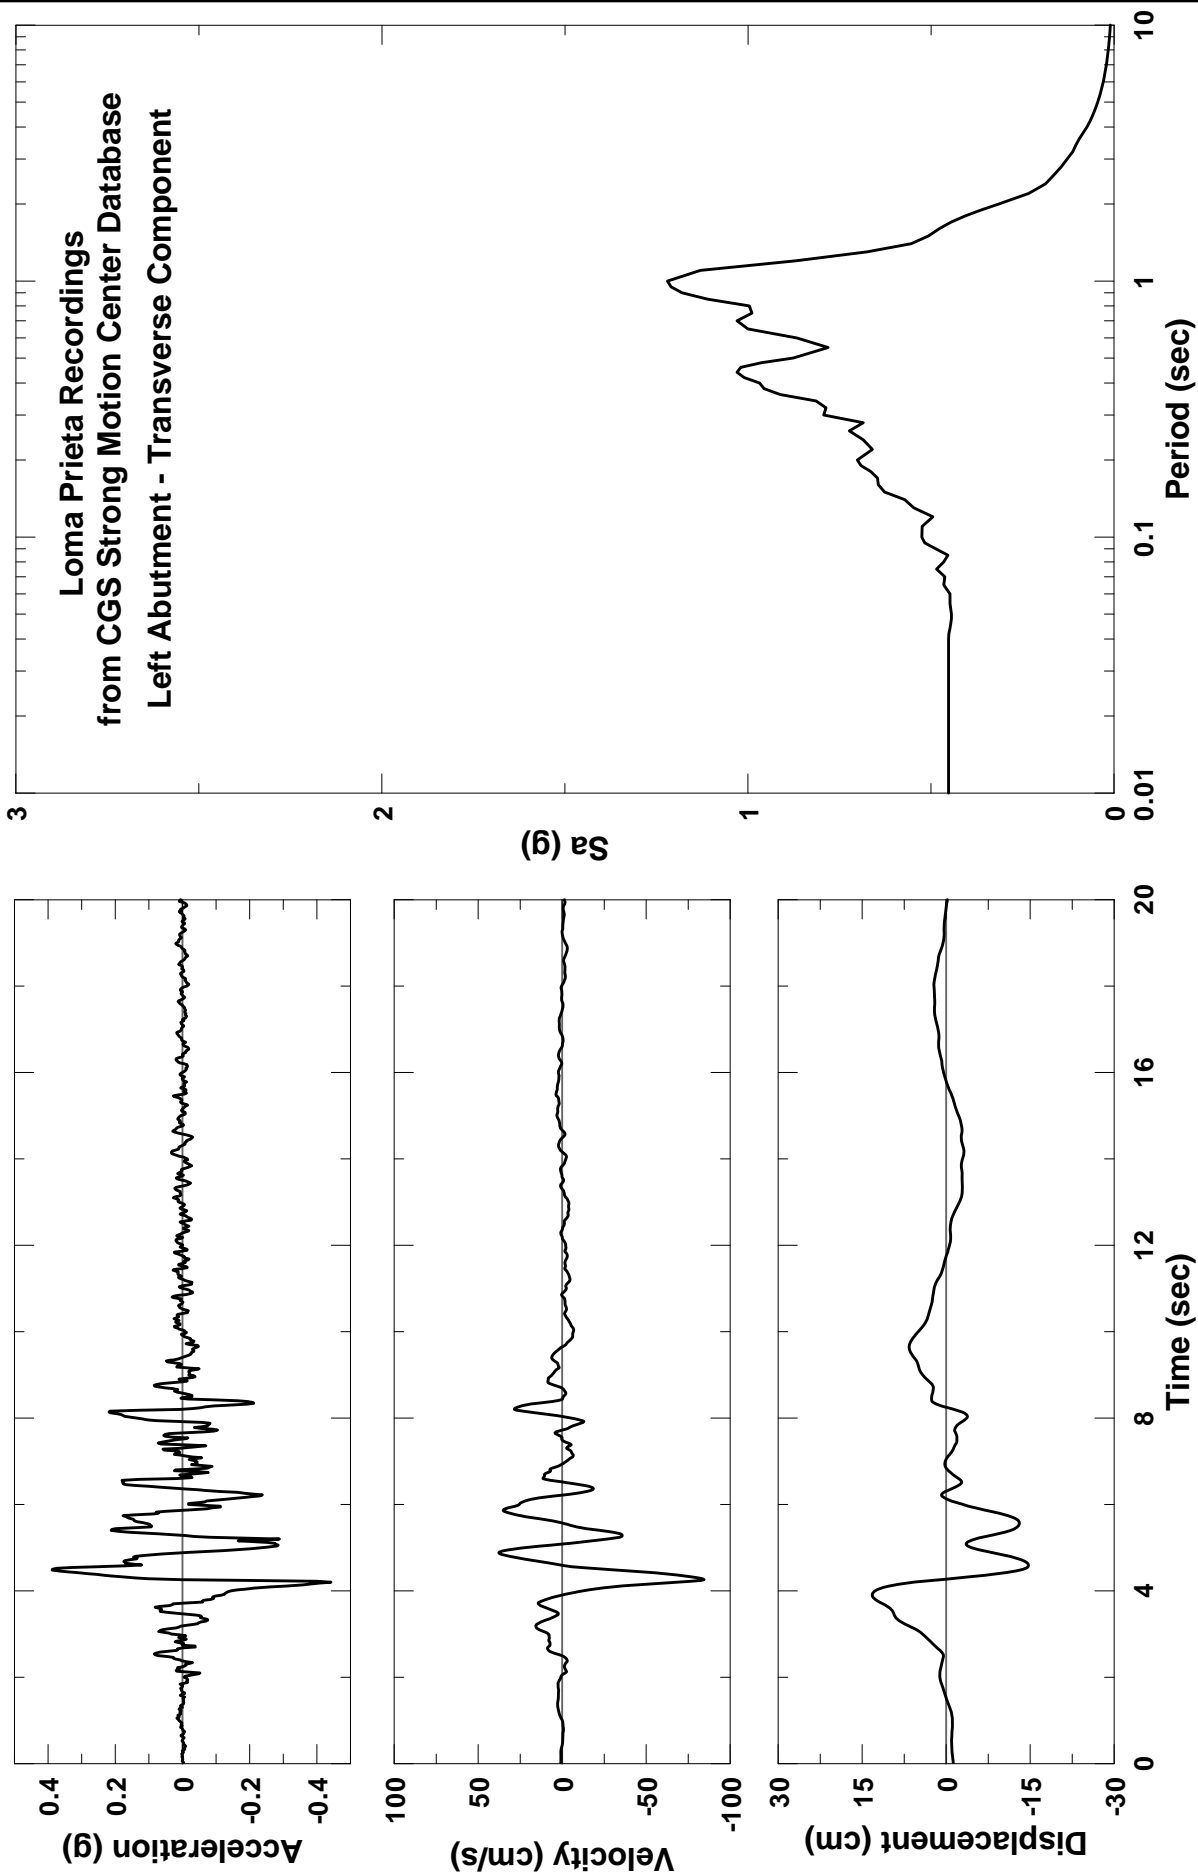
<b>TERRA / GeoPentech</b> a Joint Venture	<b>INPUT MOTION FOR FLAC ANALYSES LENIHAN DAM SEISMIC STABILITY EVALUATIONS (SSE2)</b>	<b>Figure 6-7</b>
---	--	-----------------------
