# **SEISMIC STABILITY EVALUATIONS OF CHESBRO, LENIHAN, STEVENS CREEK, AND UVAS DAMS (SSE2)**

### **LENIHAN DAM**

#### **WORK PLAN FOR SITE INVESTIGATIONS AND LABORATORY TESTING (REPORT No. LN-1)**

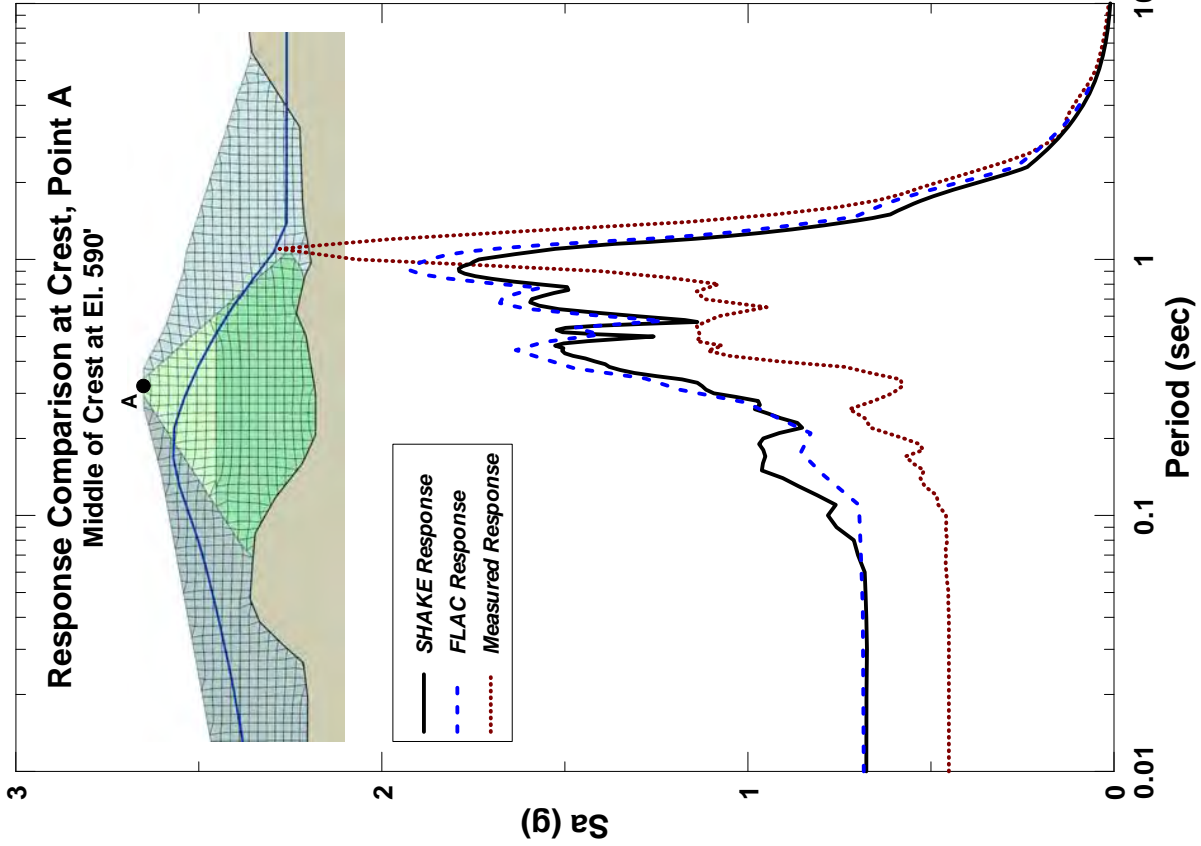
Figure  
6-8

COMPARISON OF FLAC AND SHAKE  
RESPONSE SPECTRA - LENIHAN DAM  
SEISMIC STABILITY EVALUATIONS (SSE2)

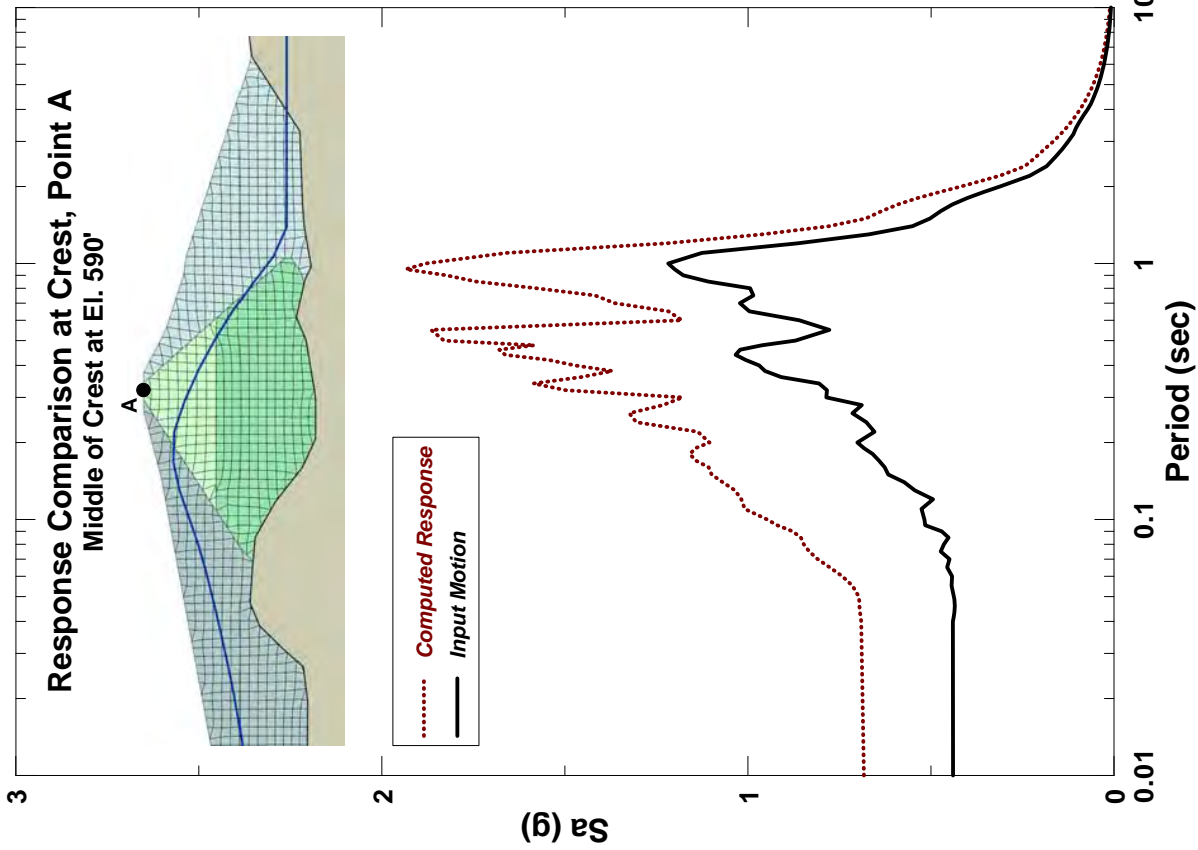
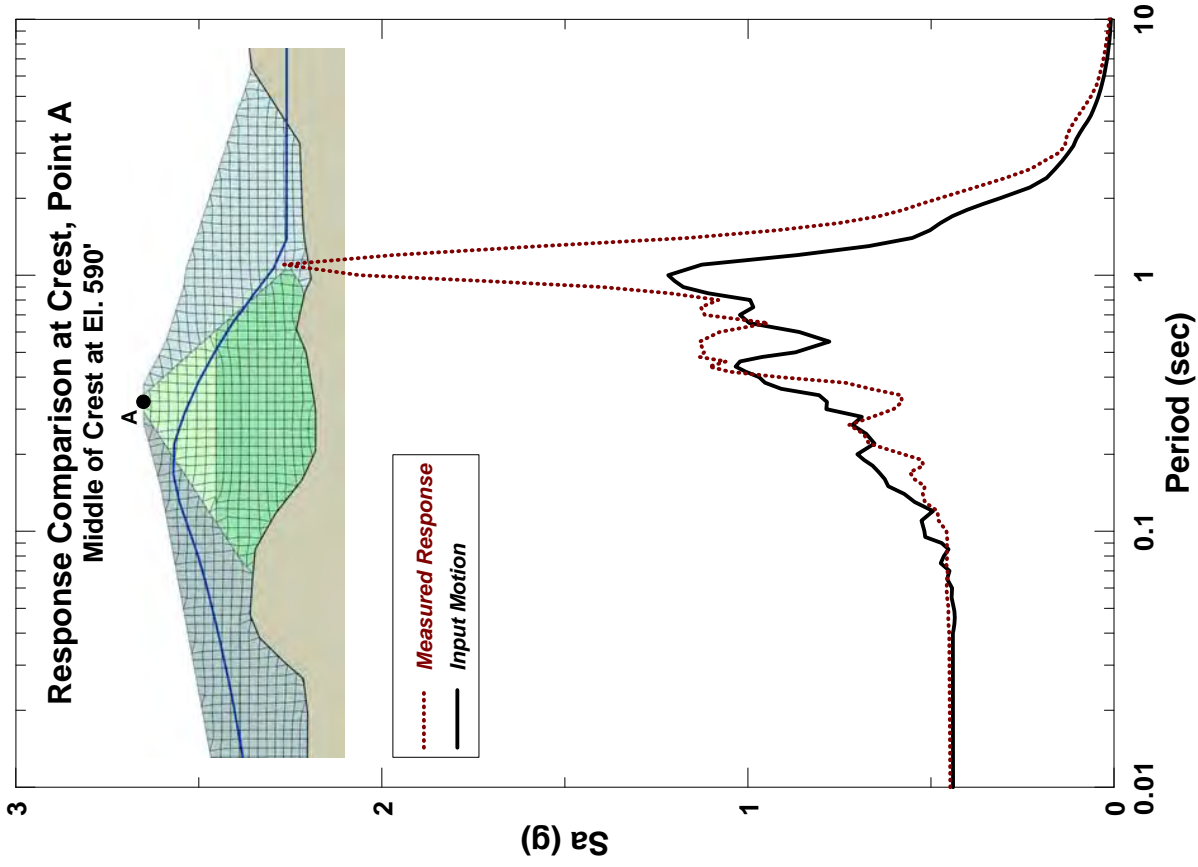
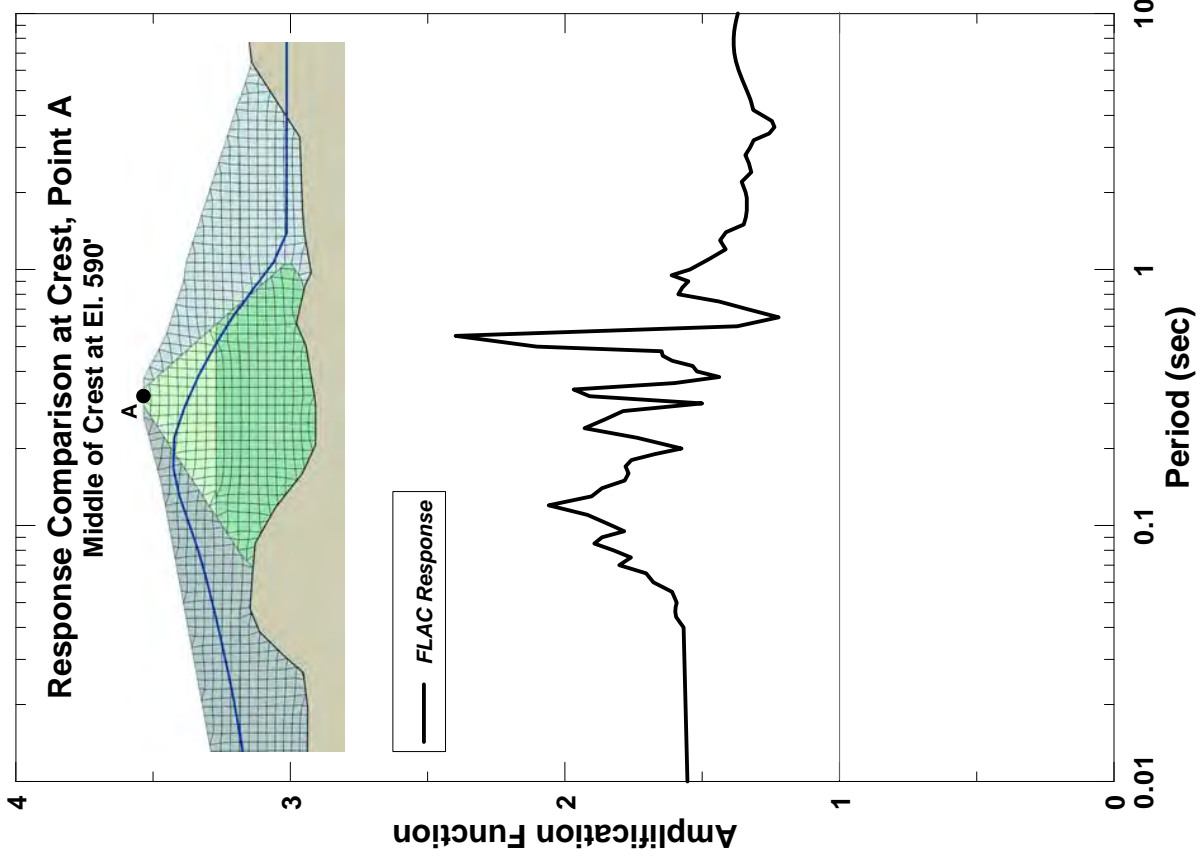
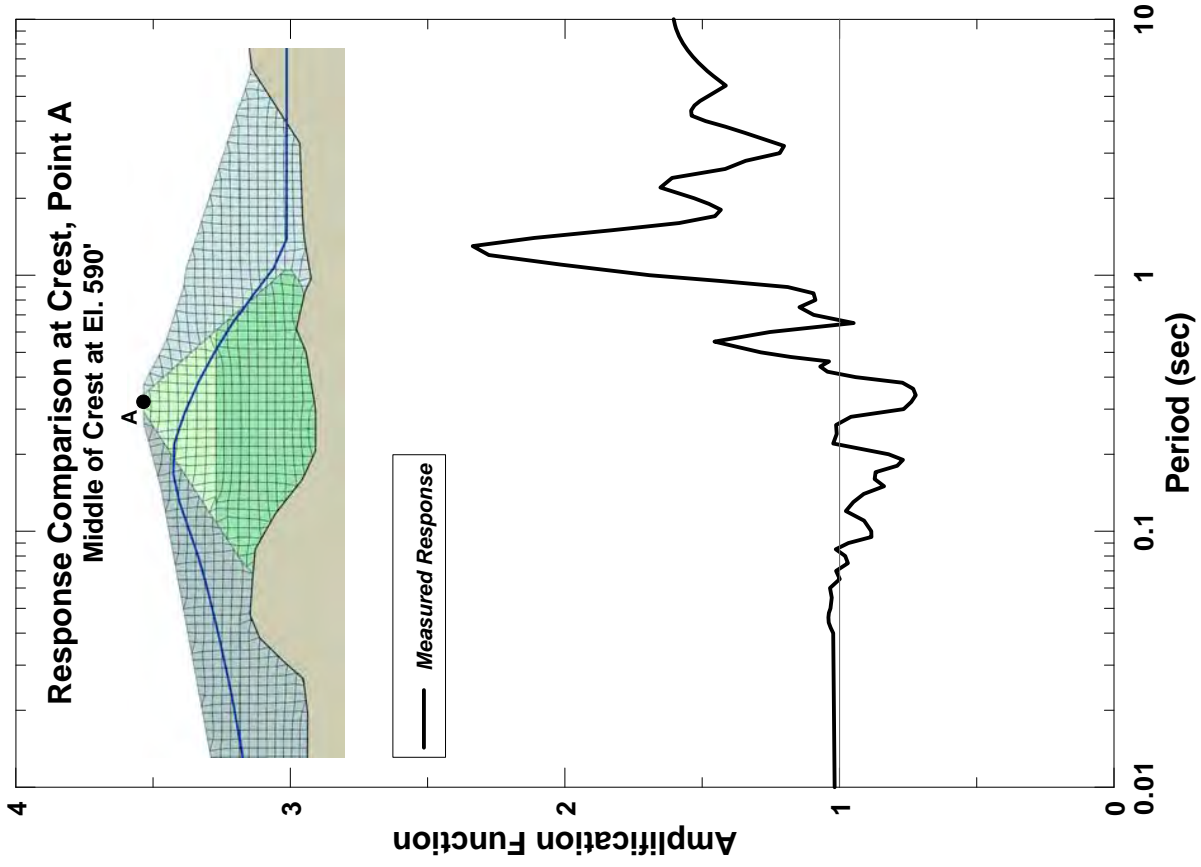
COMPARISON OF COMPUTED  
AMPLIFICATION FUNCTIONS - LENIHAN DAM  
SEISMIC STABILITY EVALUATIONS (SSE2)

The amplification function in the left portion on Figure 6-11 reflects primarily the uncertainties in the input motion and the dynamic properties used in the analysis, as well as the uncertainty inherent to the FLAC model. The amplification function in the right portion of the figure reflects mainly the uncertainty in the input motion. These amplification functions probably are not reliable beyond a period of a few seconds.

There is no easy way of discerning in any quantitative manner what is contributing to what in these amplification functions. However, the values and shape of the "recorded" amplification function in the right portion on Figure 6-11 (no amplification to negative amplification up to about 0.4 second and a high peak slightly above a period of 1 second) indicate some uncertainty in the input motion is likely present throughout the period range; i.e., not just at the peak near a period of 1 second (Figure 6-7). In reviewing the proximity of the abutment recording location relative to the dam (Figure 6-2) it appears unlikely that the presence of the dam had any measureable impact on the abutment ground motions. However, trying to reduce the uncertainty in the input motion from the Loma Prieta event for the purpose of the seismic deformation analyses would not be fruitful because additional data on input motions are not available and because of issues related to variable bedrock and incoming seismic energy. Nevertheless, one could speculate that the appropriate amplification function for the two-dimensional analyses discussed herein would likely exhibit attributes of the two amplification functions shown on Figure 6-11.

Assuming that the uncertainty in the input motion cannot be quantified, the analysis amplification function in the left portion on Figure 6-11 may be open for refinement. The main parameters that contribute to the analysis amplification functions for a given shaking level are shear wave velocity (values and distribution) and shear modulus reduction and damping ratio curves. The shear modulus reduction and damping ratio curves presented in Figure 5-22 are considered reasonably robust (with respect to shear wave velocity) and may require extensive efforts to refine. On the other hand, shear wave velocity values and distribution are considered less robust (with respect to reduction and damping ratio curves) and are amenable to refinement at a more manageable level of effort.

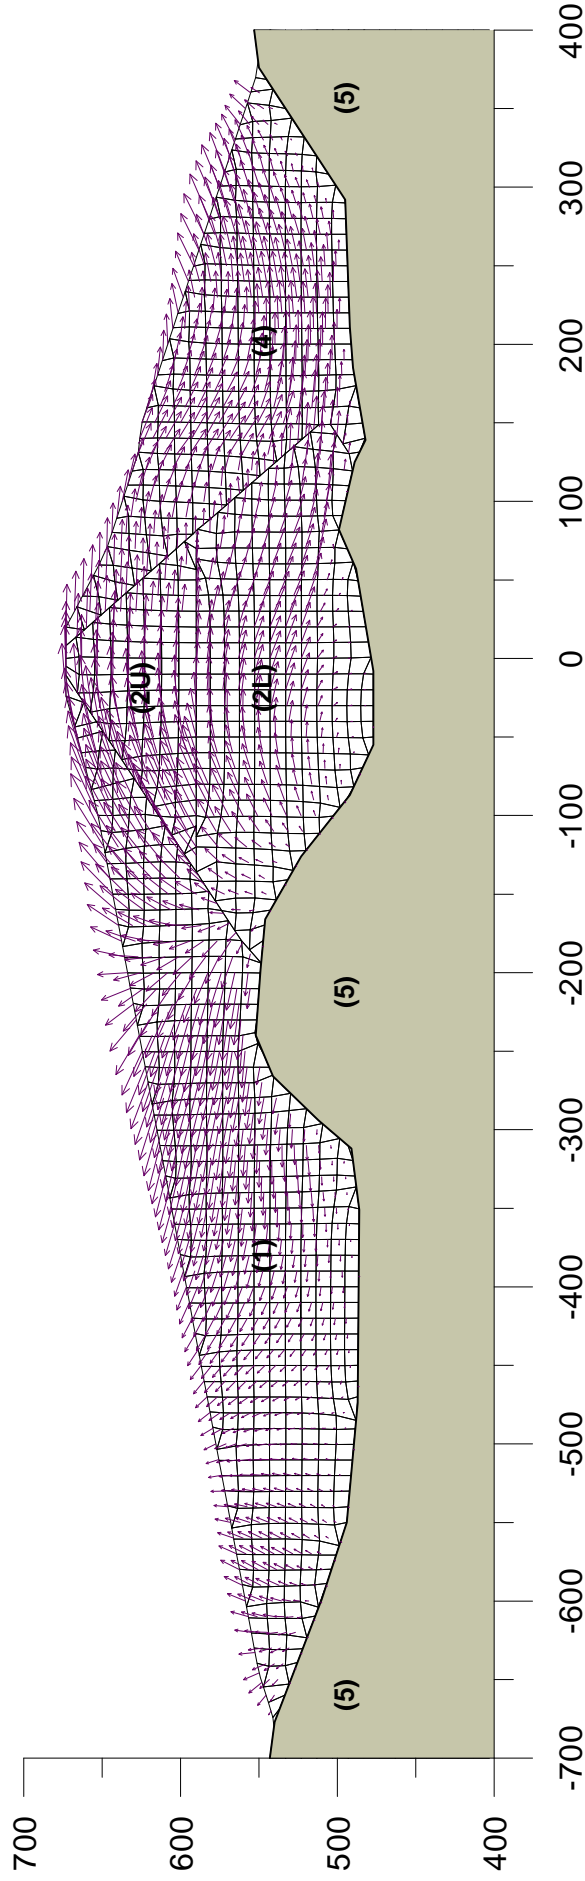
### CASE 1 - Undrained Strength Below & Effective Strength Above WT

CASE 1 COMPUTED DISPLACEMENT  
VECTORS - LENIHAN DAM  
SEISMIC STABILITY EVALUATIONS (SSE2)

Figures 6-12A, 6-12B, and 6-12C document the results of the FLAC analysis for Case 1. Figure 6-12A shows the seismic displacement contours in the embankment at the end of shaking. The computed vertical and horizontal seismic displacement values and directions at the crest of the dam are shown as vector components near the crest. Figure 6-12B shows the end-of-shaking seismic displacement vectors, describing the general pattern of seismic deformations. Figure 6-12B should be considered for seismic deformation patterns only; an exaggerated scale is used to plot the displacement vectors for clarity of presentation and that exaggerated scale provides a somewhat unrealistic sense of the calculated overall seismic deformations which are very small. Figure 6-12C shows color-coded contour intervals of computed shear strains at the end of shaking. Most of the embankment has shear strains between 0.00 and 0.01 and this contour interval is "colored" white. The areas where the shear strains are greater than 0.01 are shown in blue.

It is interesting to note that the pattern of deformations shown on Figure 6-14B suggests that the upstream shell of the dam in the general area above the bedrock knob is in a tensile state relative to the pre-earthquake conditions; this is the same general area where ground cracks were observed after the Loma Prieta earthquake (Figure 6-1). Figure 6-14C indicates that much of the shearing is taking place at depth. The same patterns, but to a lesser extent, can be seen on Figures 6-12B and 6-12C and on Figures 6-13B and 6-13C for Cases 1 and 2, respectively.

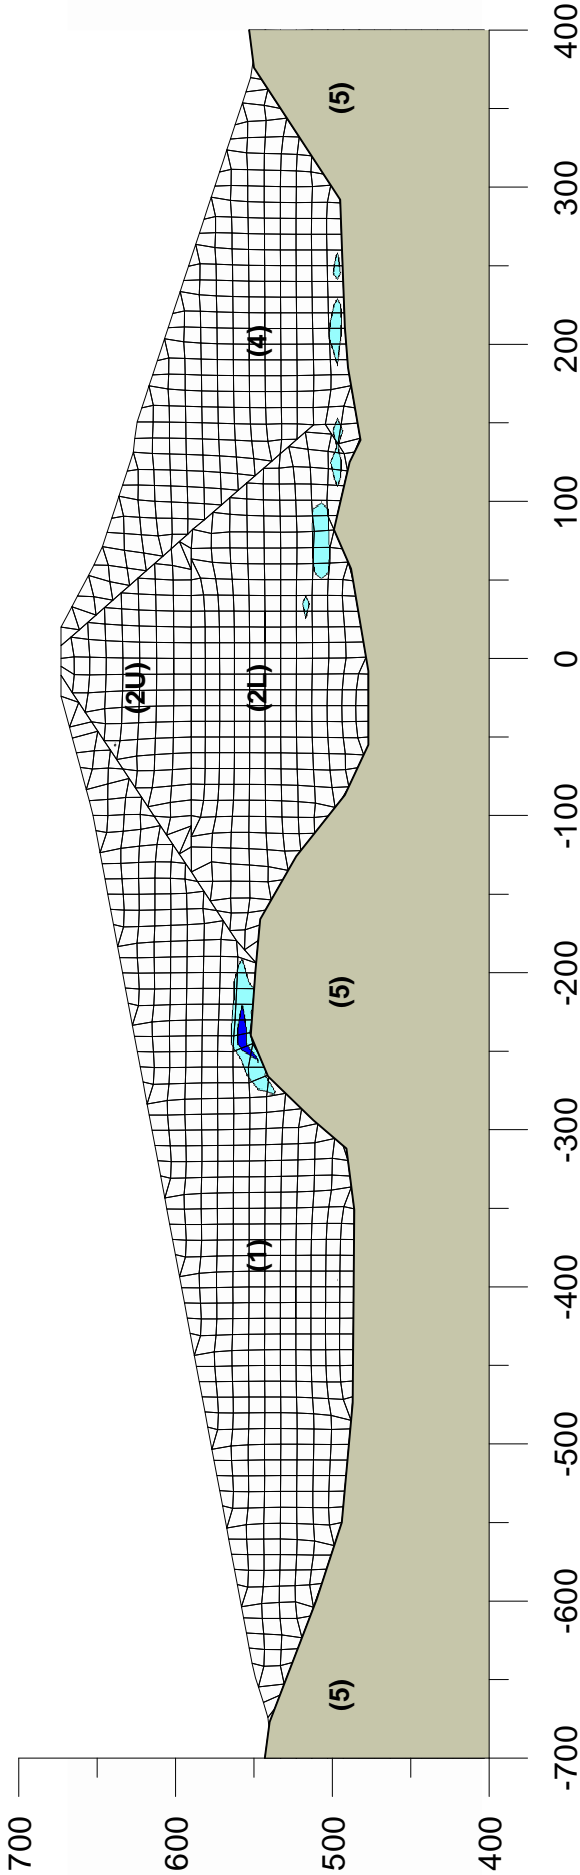
Figure  
6-12C

**CASE 1 - Undrained Strength Below & Effective Strength Above WT**

CASE 1 COMPUTED SHEAR STRAIN  
CONTOURS - LENIHAN DAM  
SEISMIC STABILITY EVALUATIONS (SSE2)

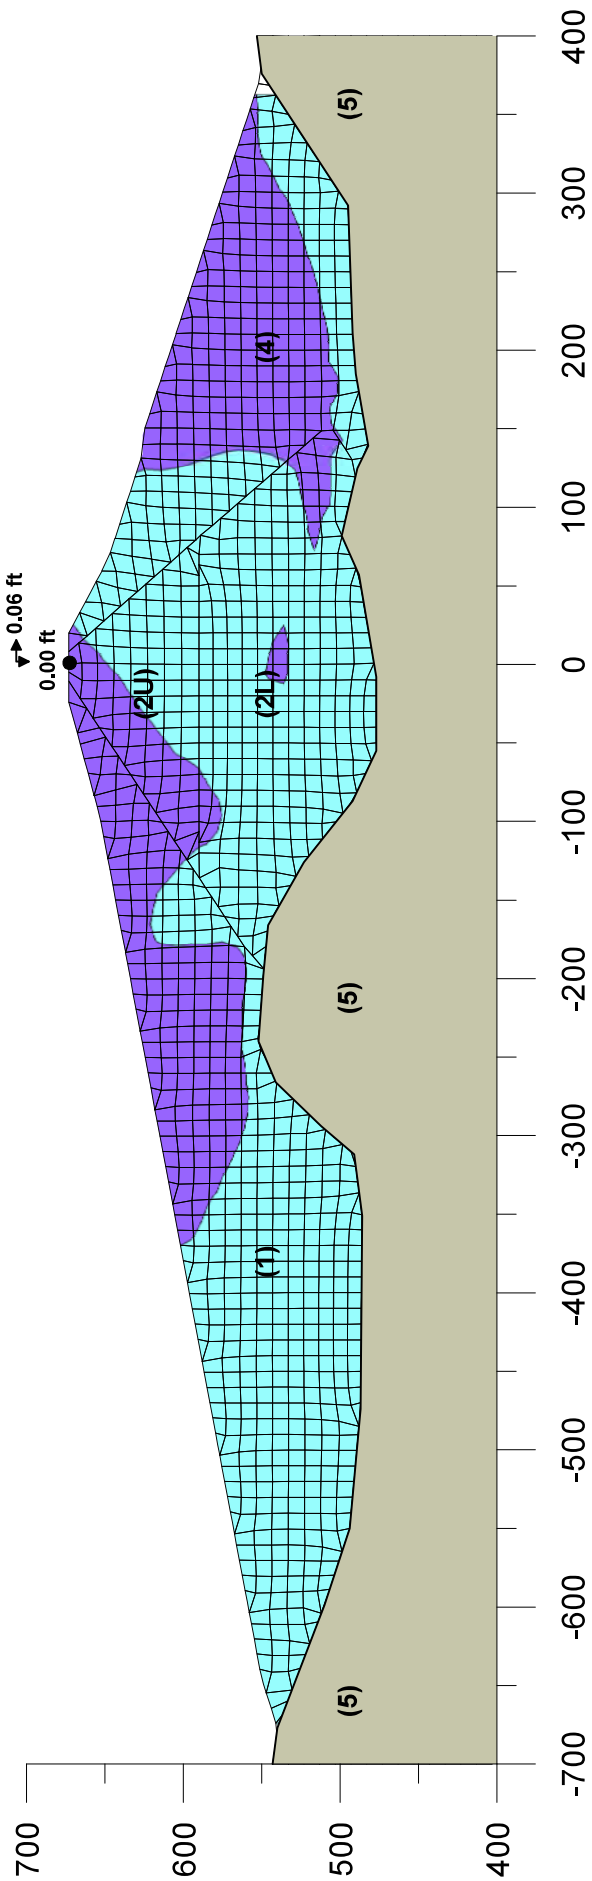
Figure  
6-13A

CASE 2 - Undrained Strength Throughout

Figures 6-13A, 6-13B, and 6-13C document the results of Case 2. Although the shear strength used in Case 2 is considered more appropriate than that of Case 1 because of the clayey nature of the embankment materials, the results from Case 2 do not appear that different from those of Case 1.

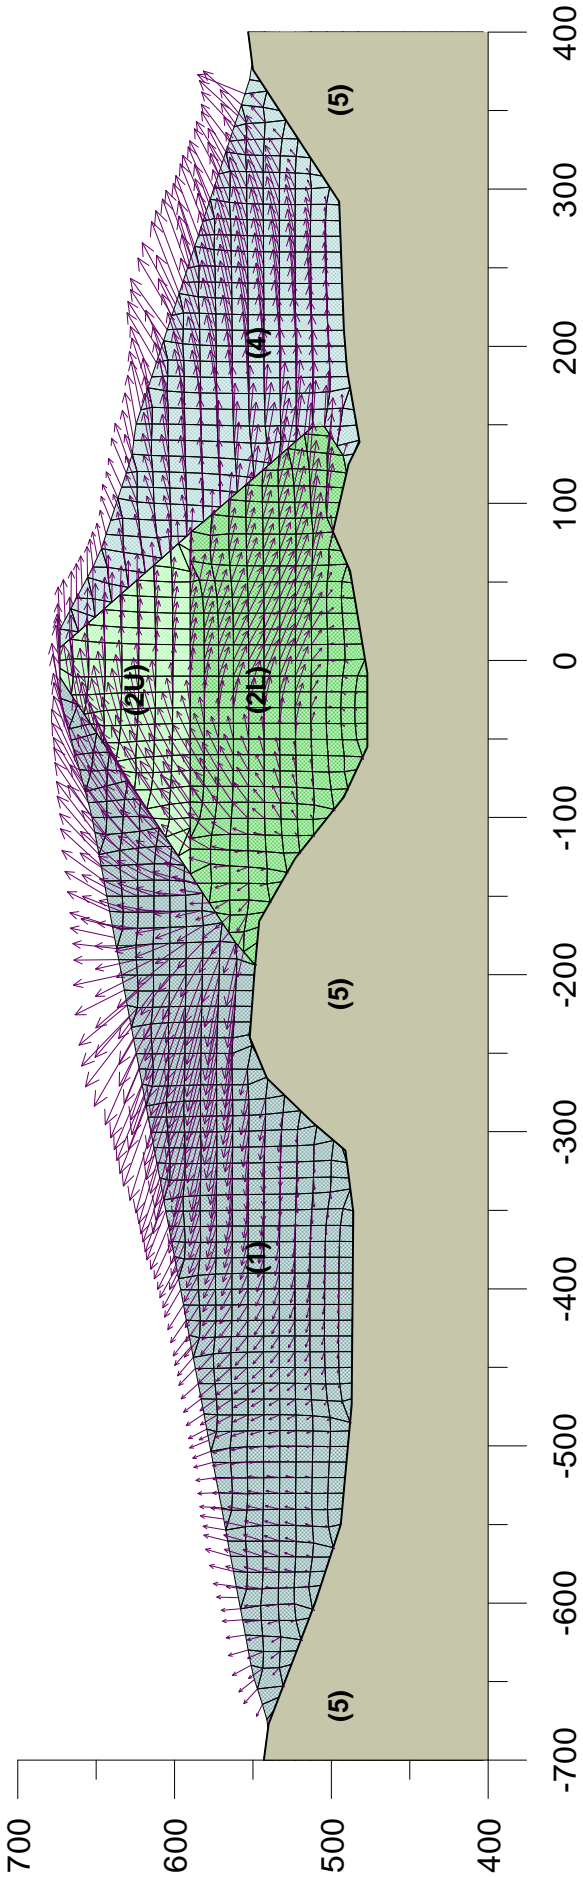
Figure  
6-13B

CASE 2 - Undrained Strength Throughout

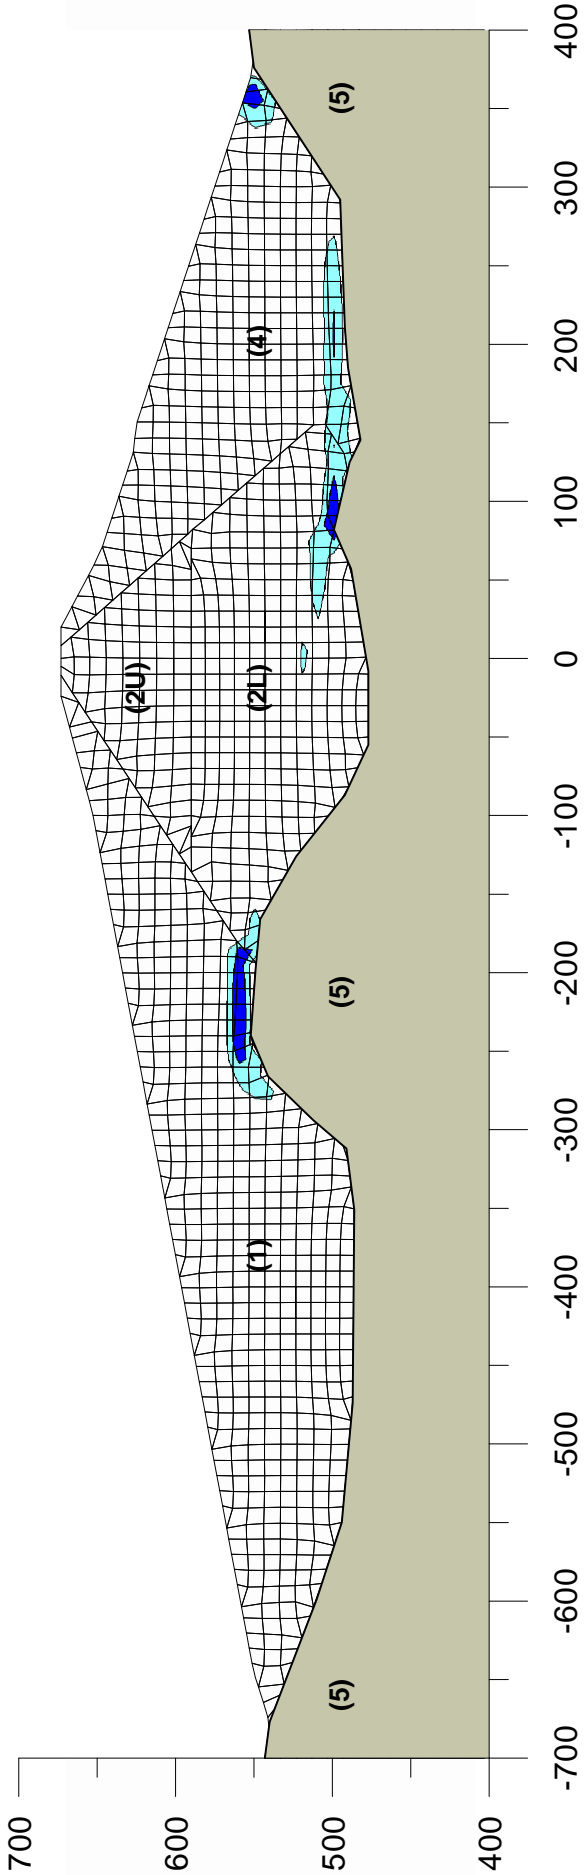
Figure  
6-13C

CASE 2 - Undrained Strength Throughout

CASE 2 COMPUTED SHEAR STRAIN  
CONTOURS - LENIHAN DAM  
SEISMIC STABILITY EVALUATIONS (SSE2)

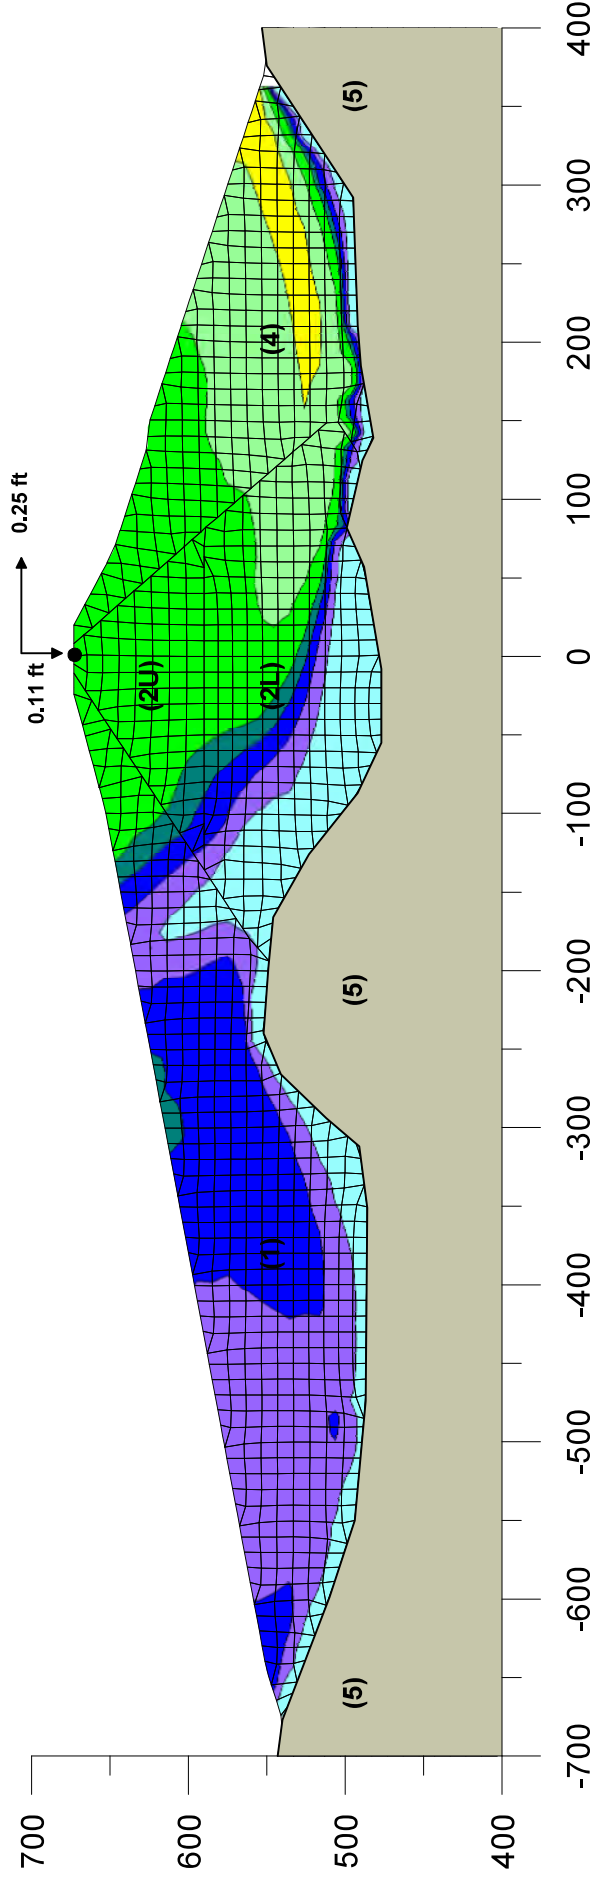
Figure  
6-14A

## CASE 3 - Undrained Strength Throughout with 30% Reduction

CASE 3 COMPUTED DISPLACEMENT  
CONTOURS - LENIHAN DAM  
SEISMIC STABILITY EVALUATIONS (SSE2)

Figures 6-14A, 6-14B, and 6-14C present the results of Case 3, where the shear strength used in Case 2 has been reduced by 30 percent. As can be seen on Figure 6-14A, the calculated seismic displacements are much greater than for the other two cases analyzed. The calculated lateral displacement at the crest is of the same order of magnitude as the displacement observed after the Loma Prieta earthquake, but the calculated vertical displacement remains significantly less than that observed. Unlike the observed seismic displacement values, the computed values show higher horizontal movement than vertical settlement; this may be caused in part by the undrained strength values and distribution reported in the interim site characterization report and used for this evaluation.

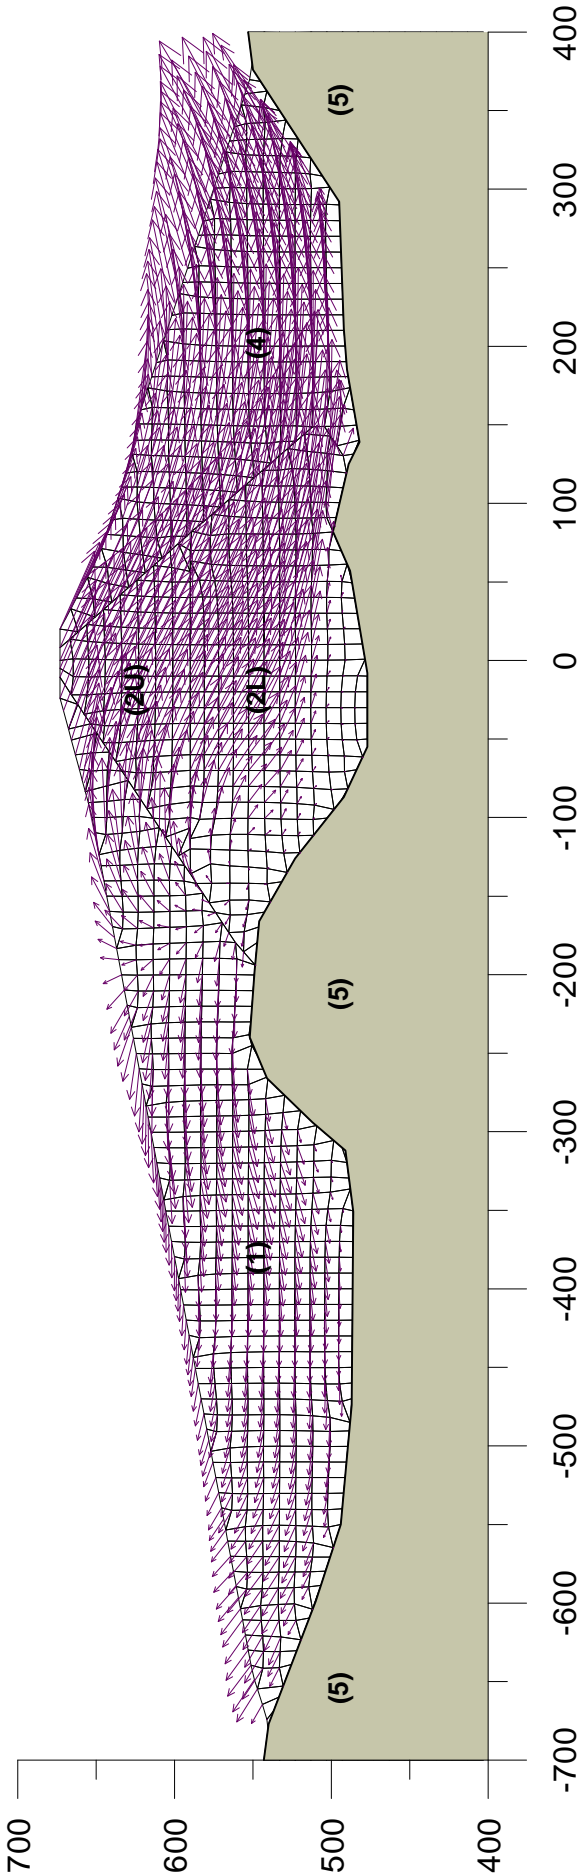
Figure  
6-14B

CASE 3 - Undrained Strength Throughout with 30% Reduction

CASE 3 COMPUTED DISPLACEMENT  
VECTORS - LENIHAN DAM  
SEISMIC STABILITY EVALUATIONS (SSE2)
