APMT FENDER REPAIR PROJECT NO. 101068.01 CONTRACT NO. 070444

6562	G1.0	SH 01 OF 10	CONT/CONS: 070444	M. ID: 101068.01	PHASE: CONSTRUCTION	DRAWING SCALE: AS NOTED	TOWNSHIP: 21N	RANGE: 3E	SECTION: 27	VERT: 1-5	PARCEL:	APMT TERMINAL FENDER REPAIRS COVER SHEET	APPROVED:	SEK	5/16/17	CHECKED BY	DATE
														AWB	5/16/17	PROJ. ENGR	DATE
													PRINTED BY: ilemons May 17, 2017	5/16/17	5/16/17	DATE	DATE
													PORT ADDRESS: ONE SITCUM PLAZA	TACOMA WA 98401-1837			
													MARK:	REVISION:	BY:	APPR:	DATE:

SHEET NO.	DRAWING LIST
G1.0	COVER SHEET
S1.0	GENERAL NOTES
S1.1	SITE PLAN
S2.0	FENDER REPAIR PLAN – 1 OF 3
S2.1	FENDER REPAIR PLAN – 2 OF 3
S2.2	FENDER REPAIR PLAN – 3 OF 3
S3.0	TYPICAL FENDER SYSTEM CONFIGURATION DETAILS – 1 OF 2
S3.1	TYPICAL FENDER SYSTEM CONFIGURATION DETAILS – 2 OF 2
S4.0	FENDER SYSTEM REPAIR NOTES – 1 OF 2
S4.1	FENDER SYSTEM REPAIR NOTES – 2 OF 2

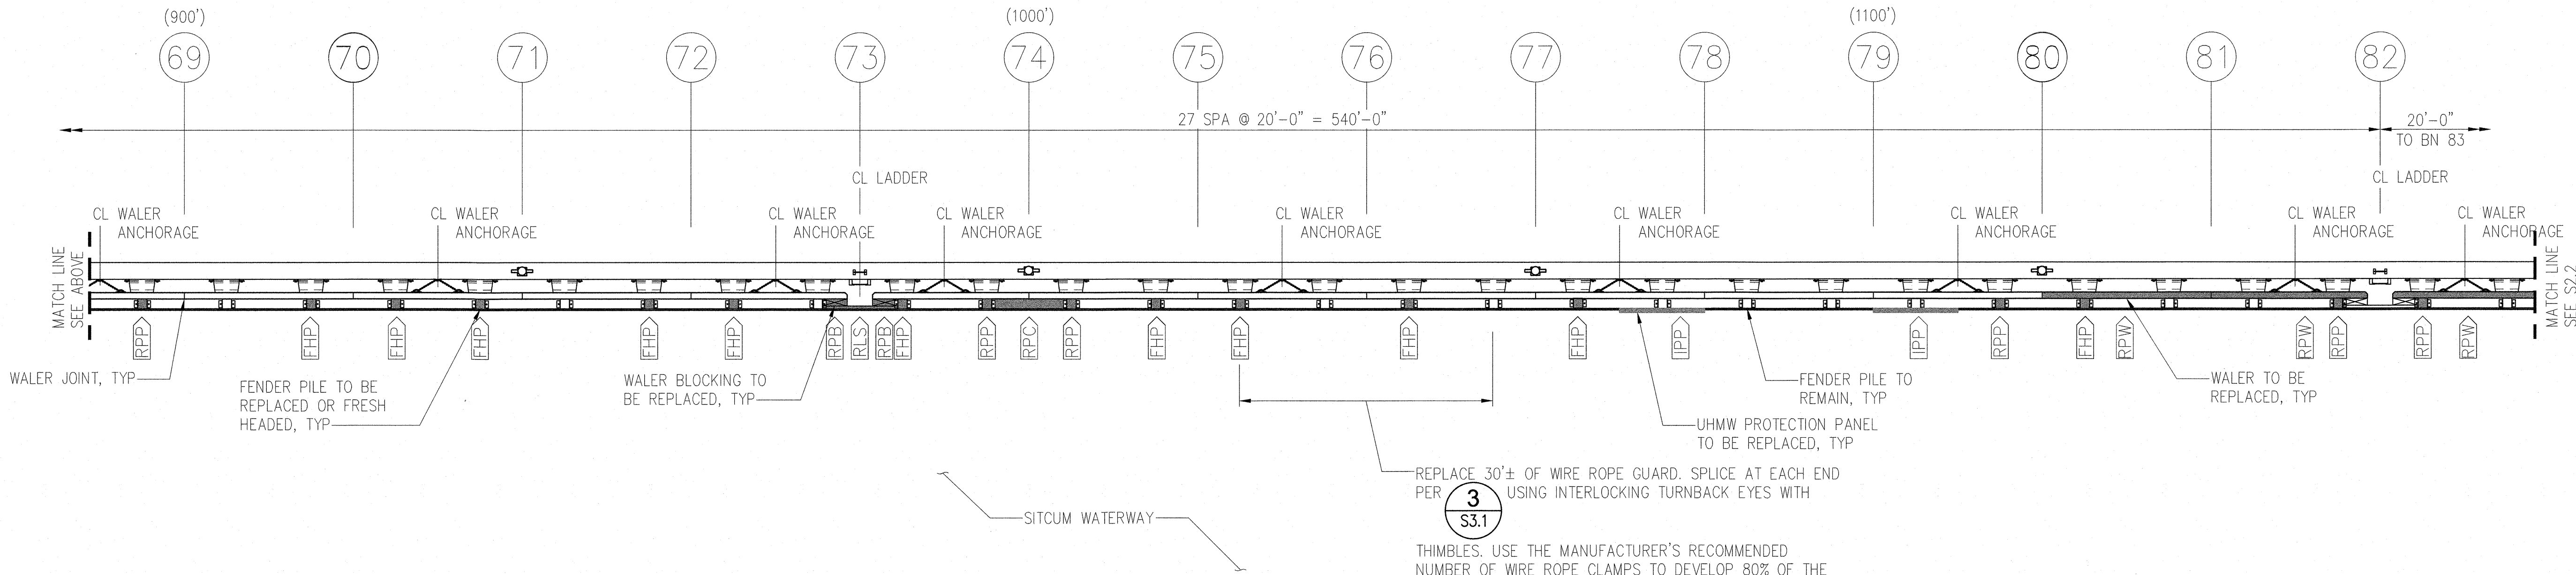
2 FENDER REPAIR PLAN
SCALE: 3/32" = 1'-0"

3
S3.1
THIMBLES. USE THE MANUFACTURER'S RECOMMENDED NUMBER OF WIRE ROPE CLAMPS TO DEVELOP 80% OF THE ROPE'S CAPACITY. ACTUAL SPLICE LENGTH WILL DEPEND ON THE LENGTH OF THE TURNBACK EYES. CONTRACTOR SHALL DETERMINE WIRE ROPE DIAMETER IN THE FIELD. FOR DETAILS SEE **A** S3.0 AND **2** S3.1

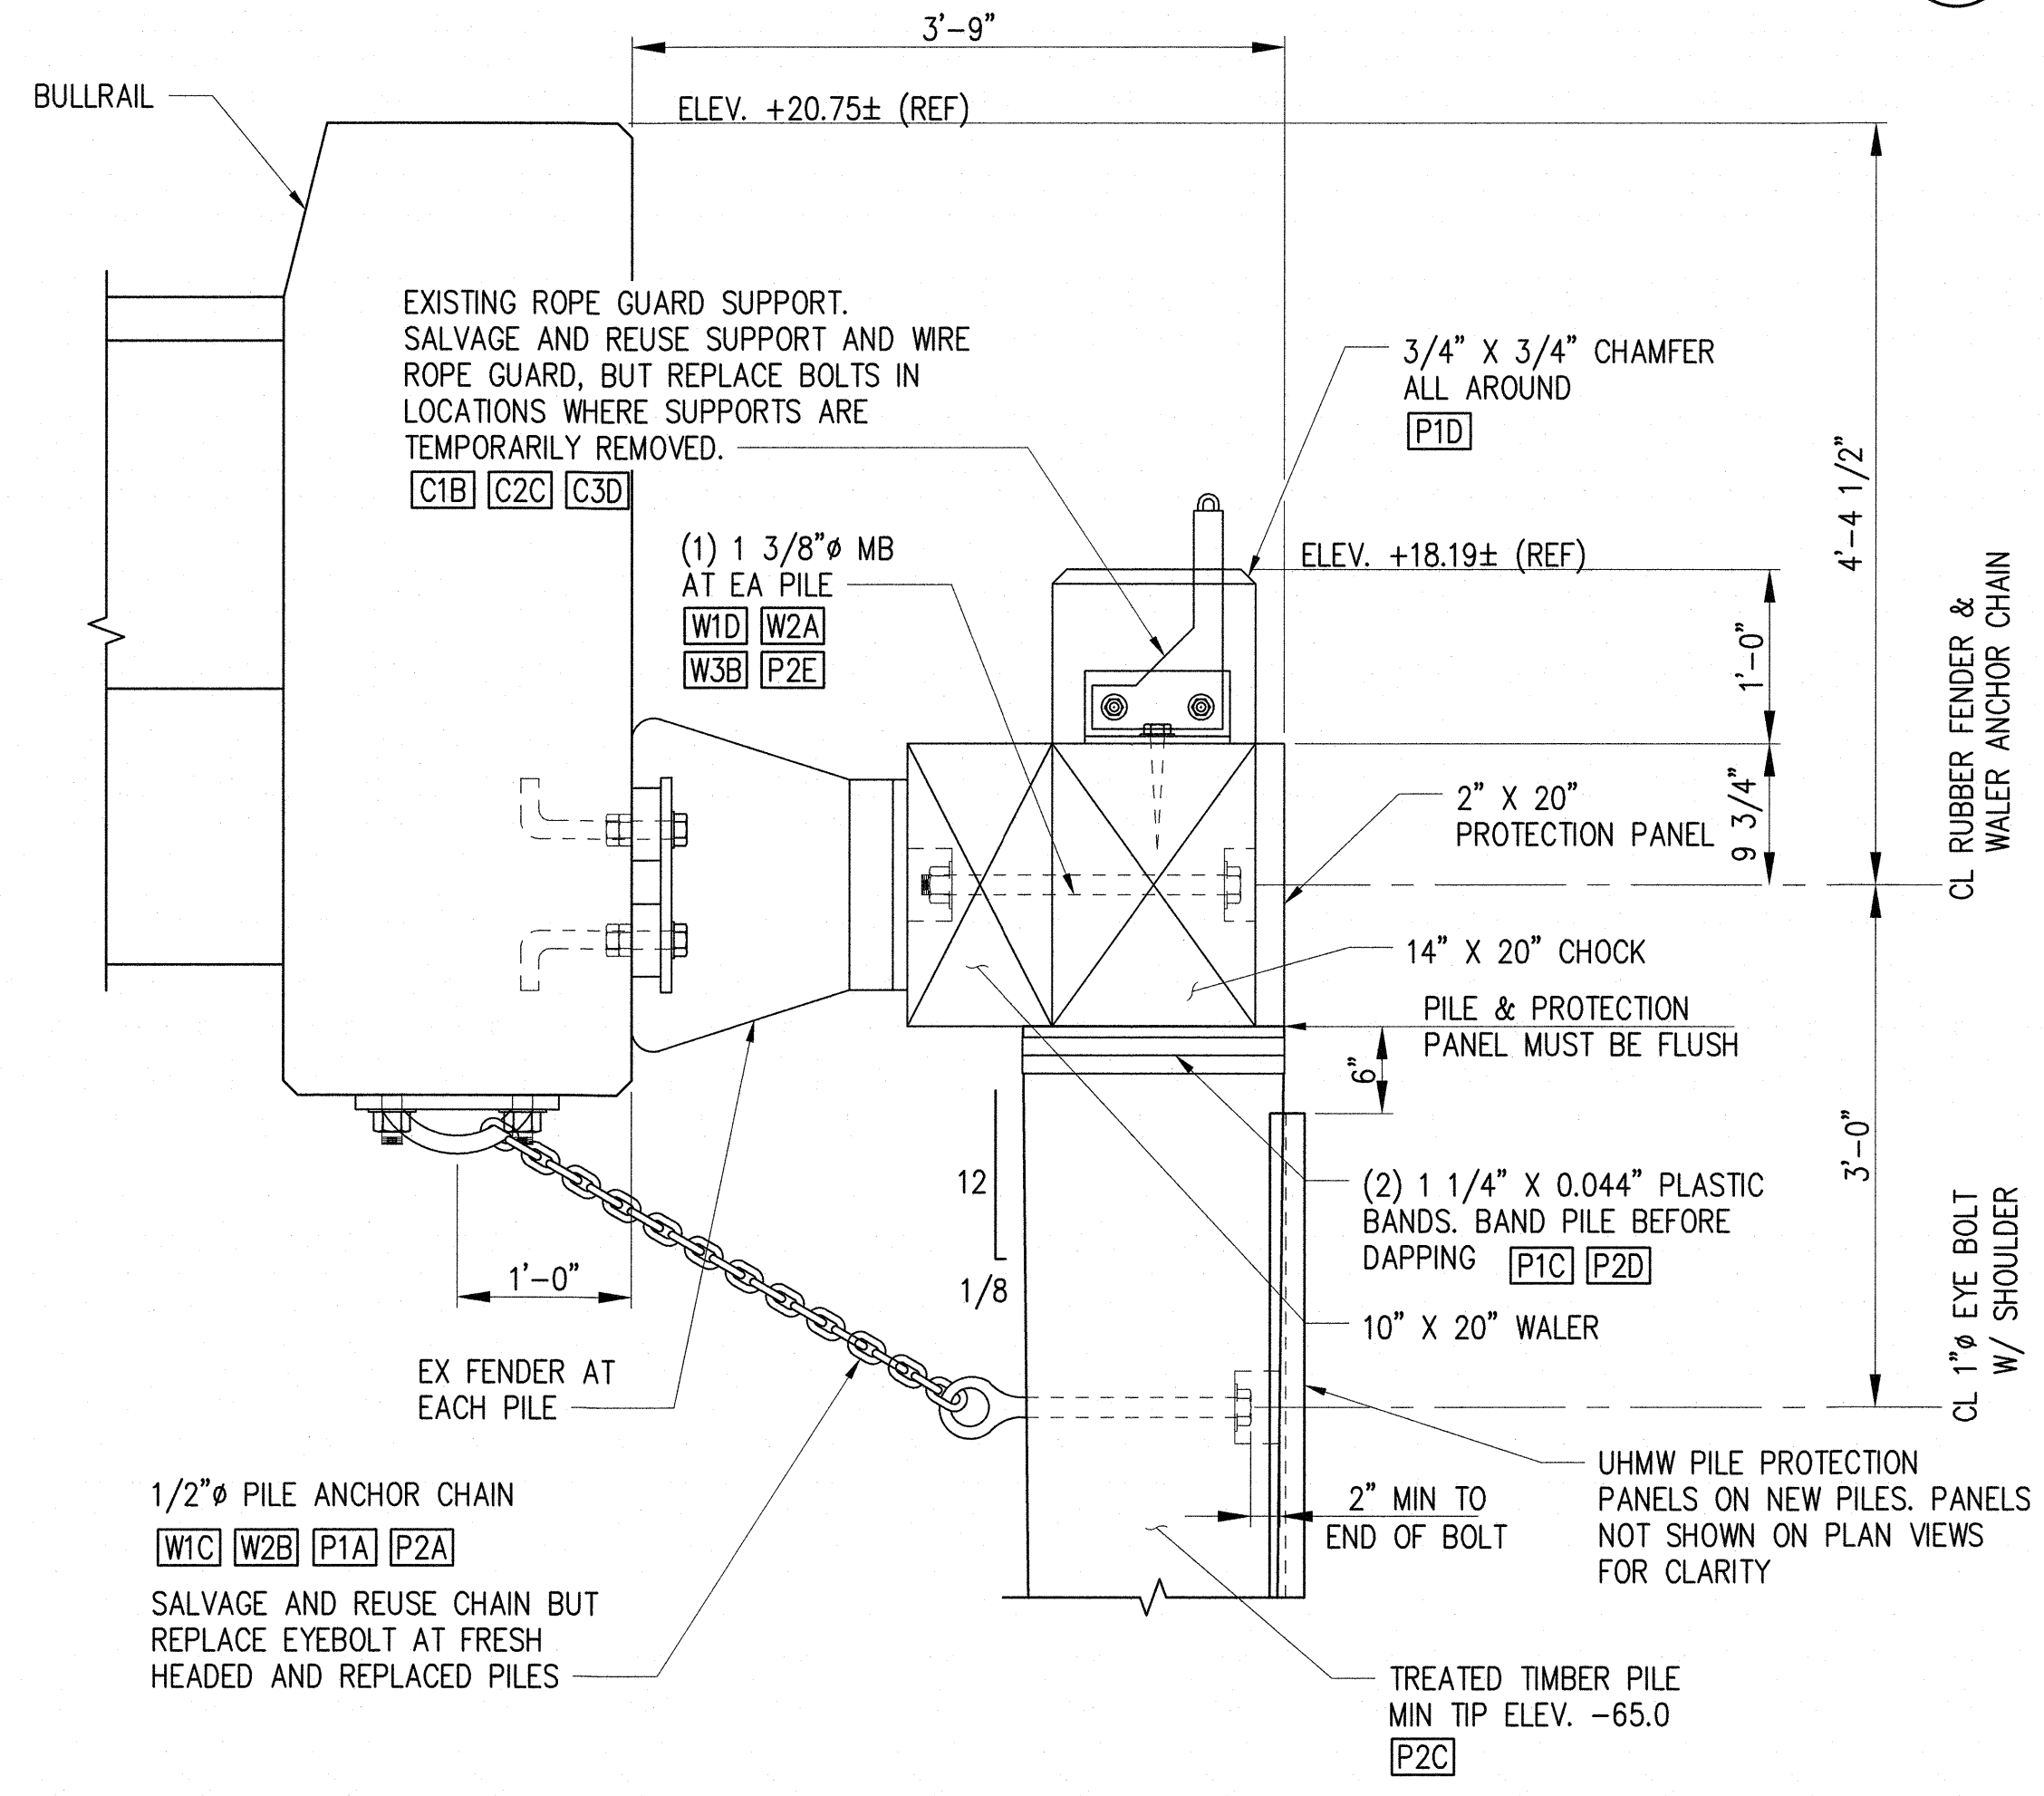
A SECTION
S2.0, S3.0, S3.1, S4.0, S4.1 SCALE: 1" = 1'-0"

- NOTES:
1. THESE DETAILS ARE REPRODUCED FROM PORT RECORD DRAWINGS AND HAVE ONLY BEEN GENERALLY VERIFIED. THE CONTRACTOR SHALL VERIFY ALL FIELD DIMENSIONS AT EACH SPECIFIC LOCATION PRIOR TO CUTTING OR DRILLING MATERIALS.
 2. SEE SHEETS S4.0 AND S4.1 FOR REPAIR NOTES. [XXX]
