# Phase I Environmental Site Assessment Report for Selected Parcels along Upper Llagas Creek Reach 8 Morgan Hill, California

PIERS Environmental Services, Inc. 1330 S. Bascom Avenue, Suite F San Jose, CA 95128

April 21, 2003

## Phase I Environmental Site Assessment Selected Parcels Along Upper Llagas Creek, Reach 8 Morgan Hill, Santa Clara County, CA

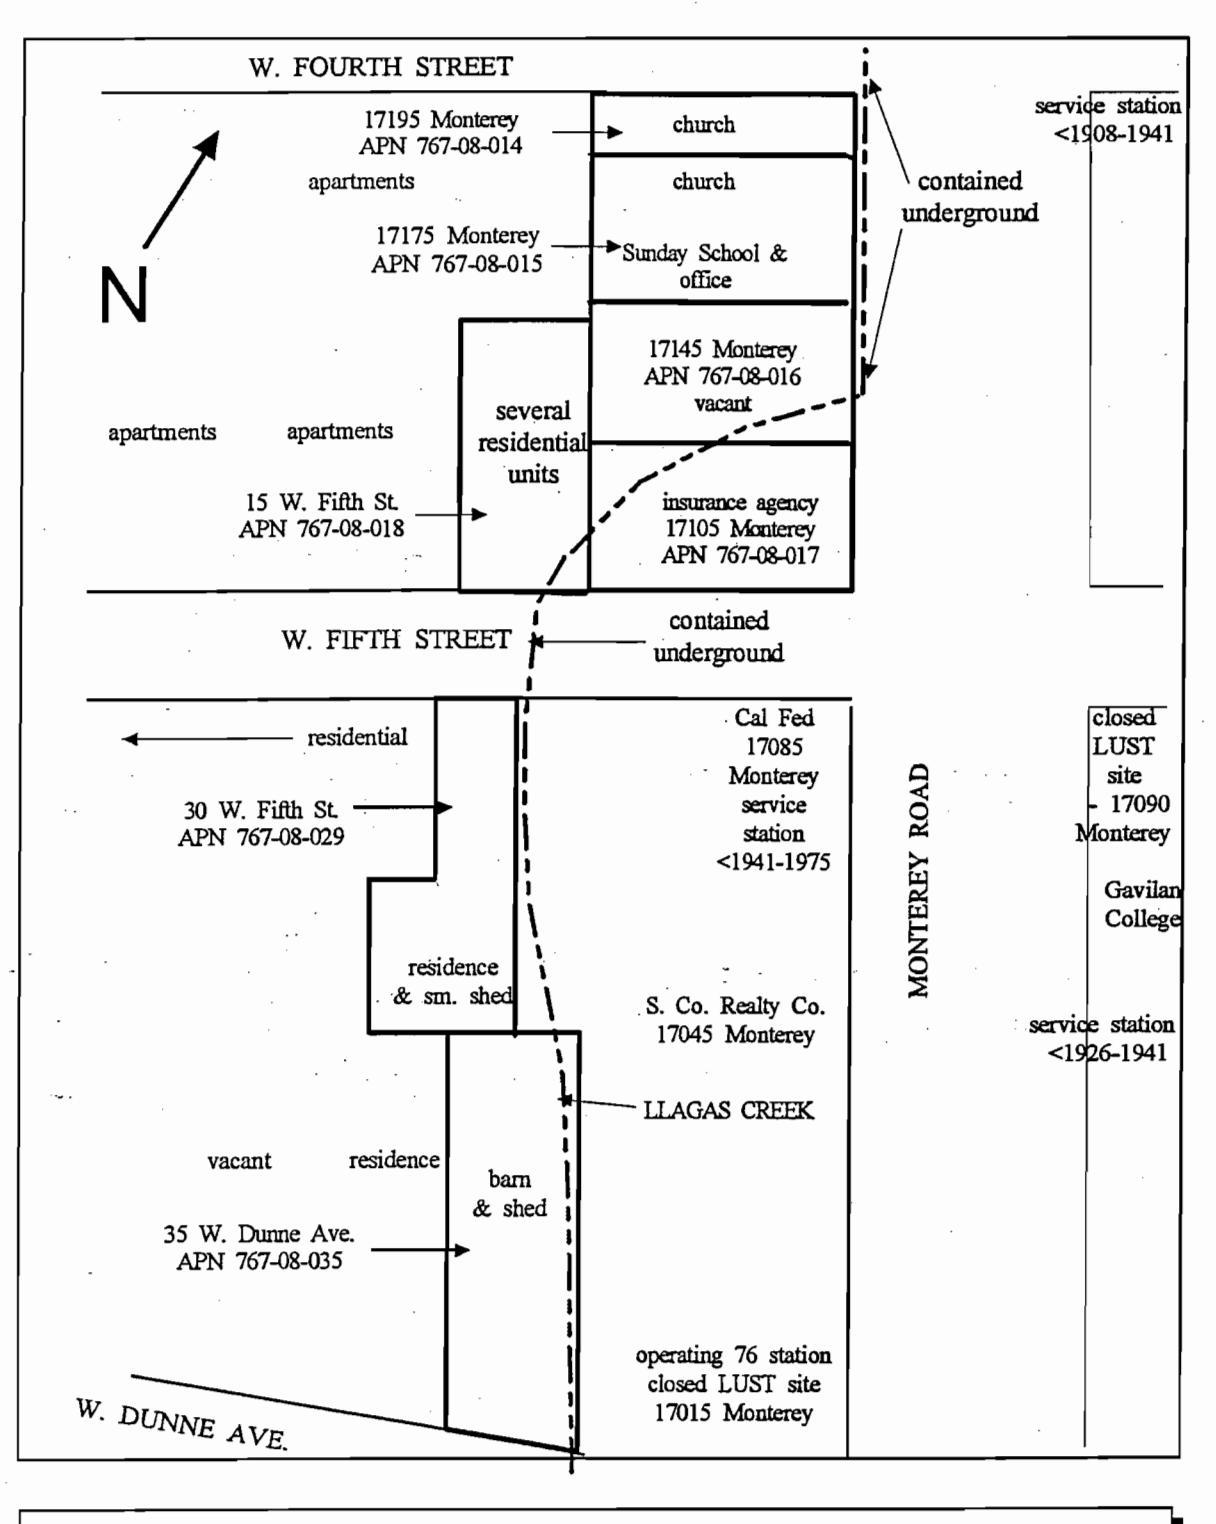
### FIGURE 2 - PROPERTY SITE PLAN

35 W. DUNNE AVENUE, 15 & 30 W. FIFTH STREET, 17105, 17145, 17175 & 17195 MONTEREY STREET REACH 8, MORGAN HILL, CALIFORNIA

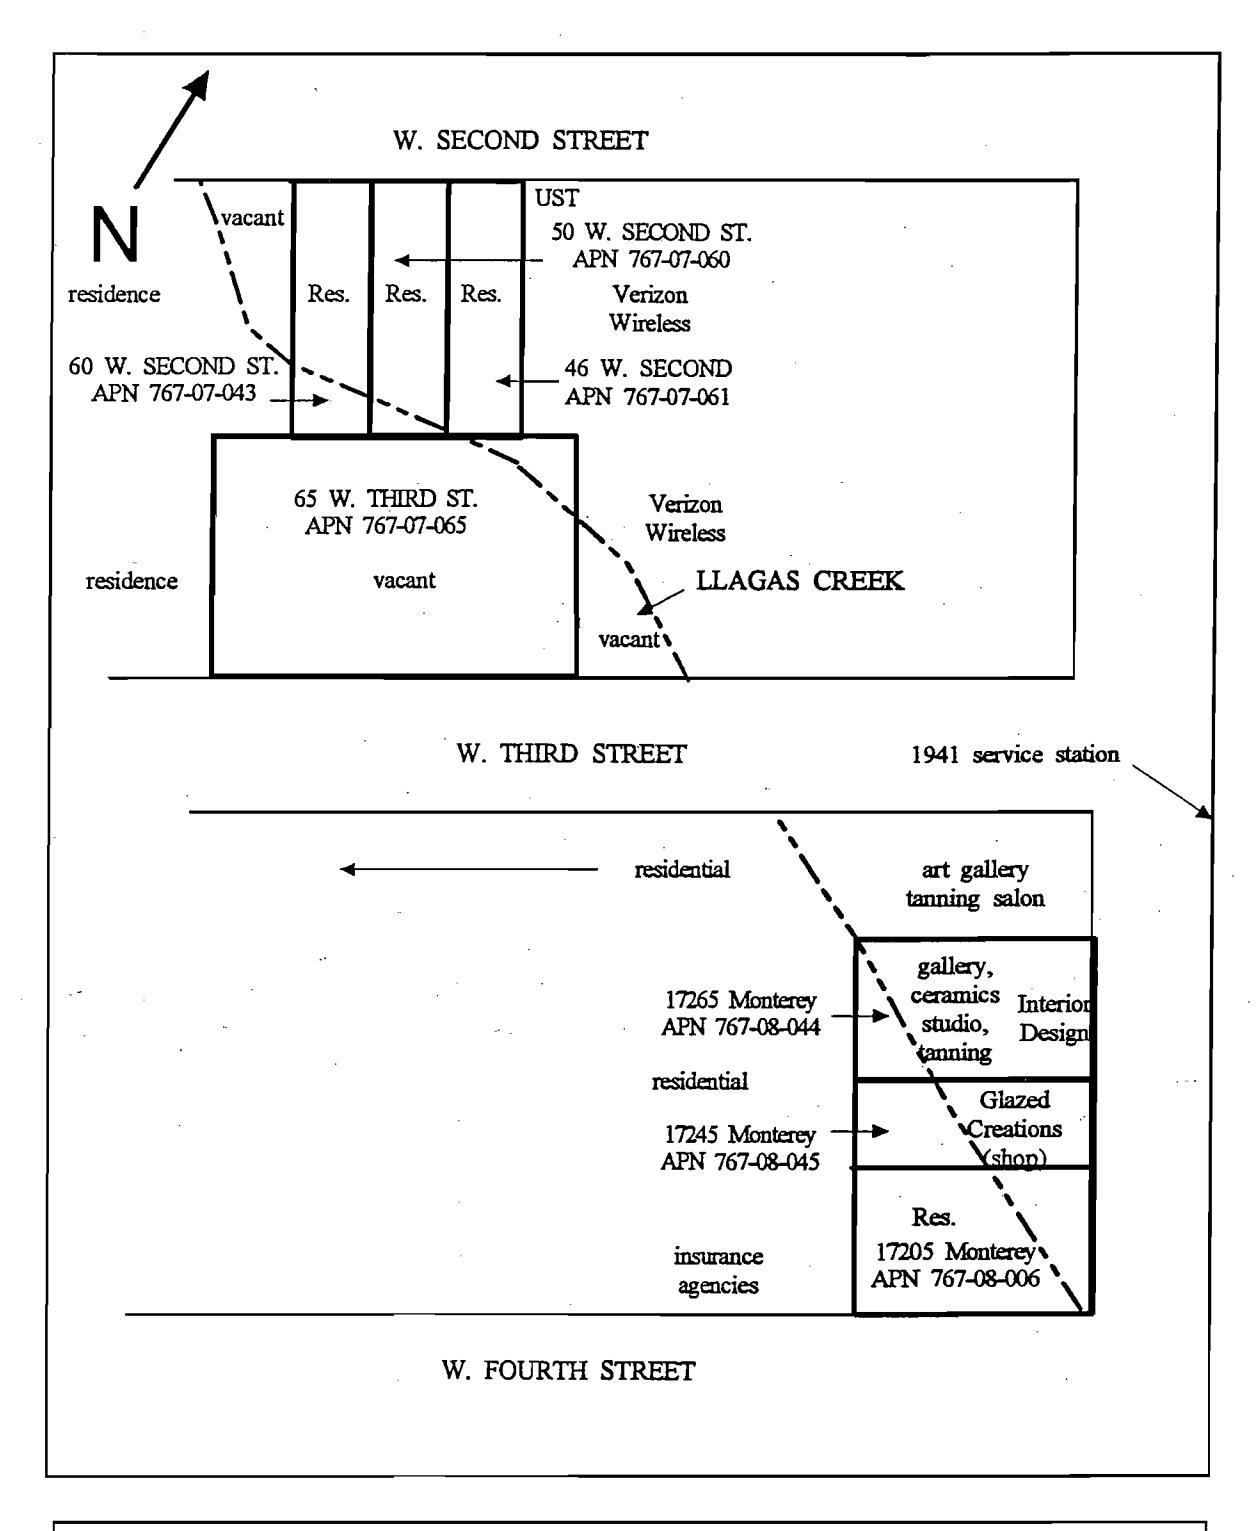
#### FIGURE 3 - PROPERTY SITE PLAN

17205, 17245, & 17265 MONTEREY STREET, 65 W. THIRD STREET, 46 - 60 W. SECOND STREET REACH 8, MORGAN HILL, CALIFORNIA

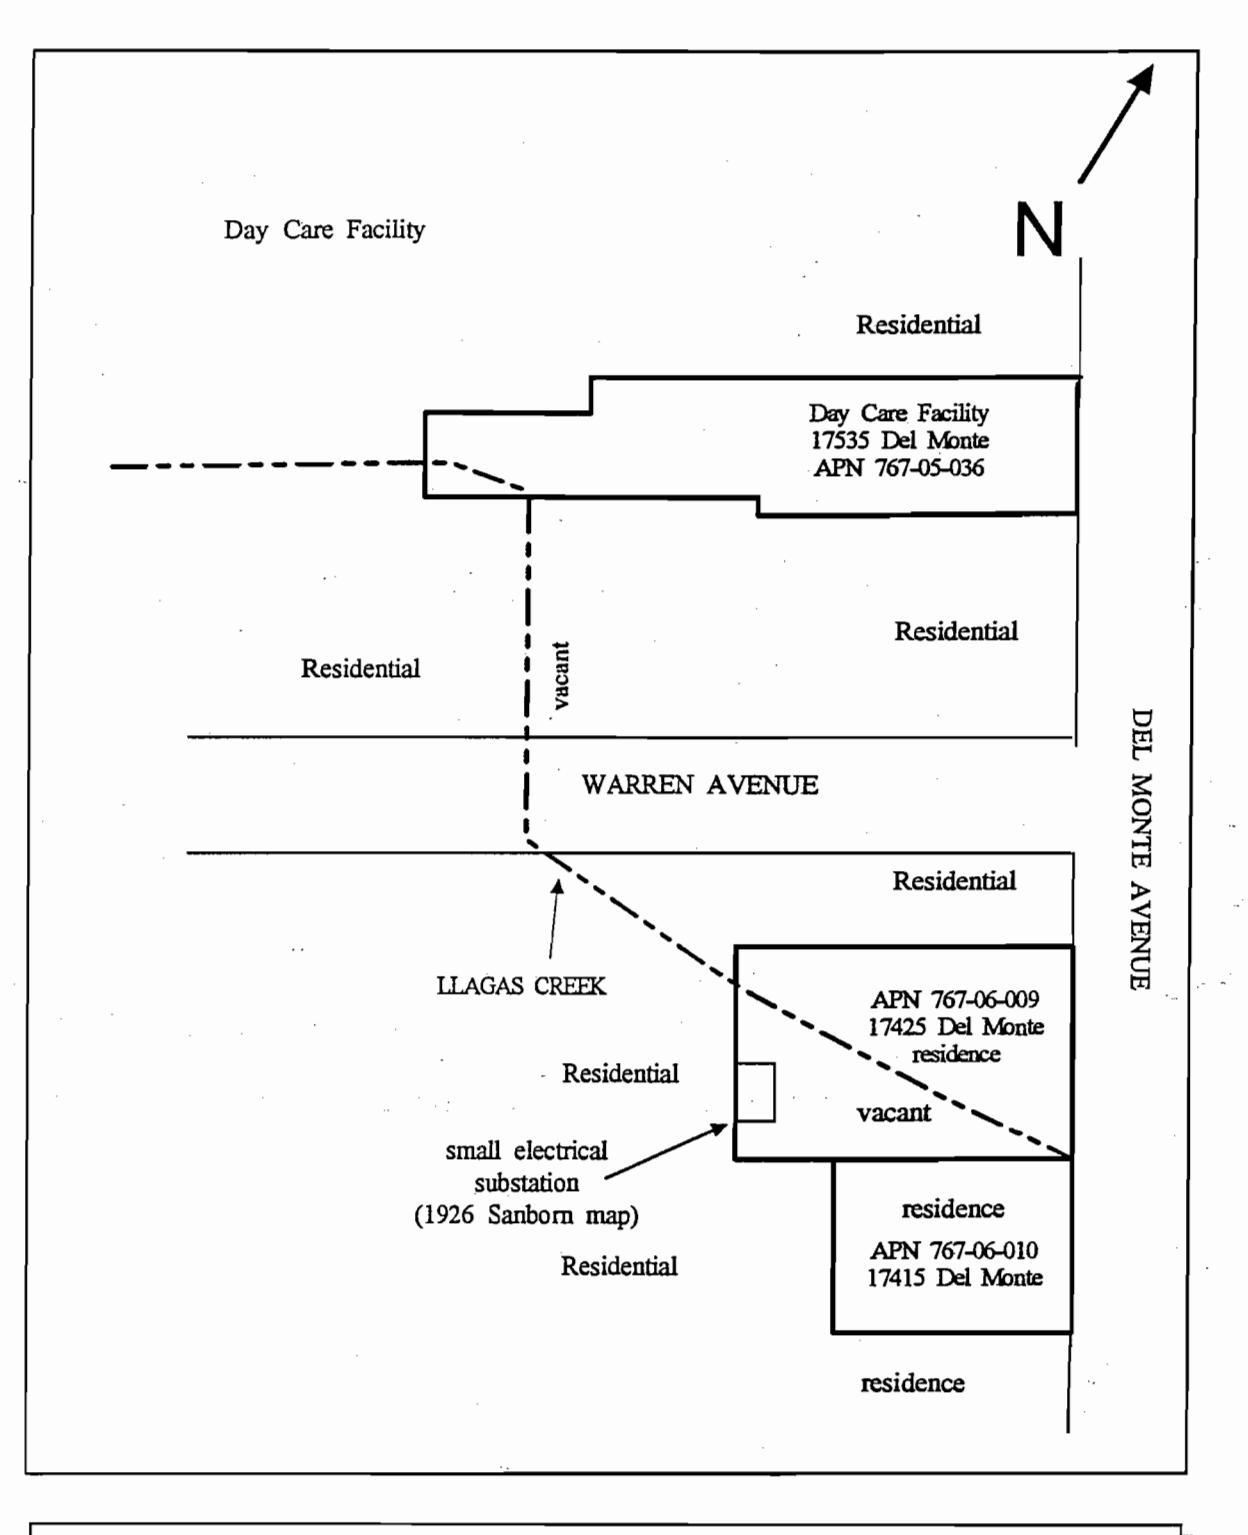
#### FIGURE 4 - PROPERTY SITE PLAN

17425 & 17535 DEL MONTE AVENUE REACH 8, MORGAN HILL, CALIFORNIA

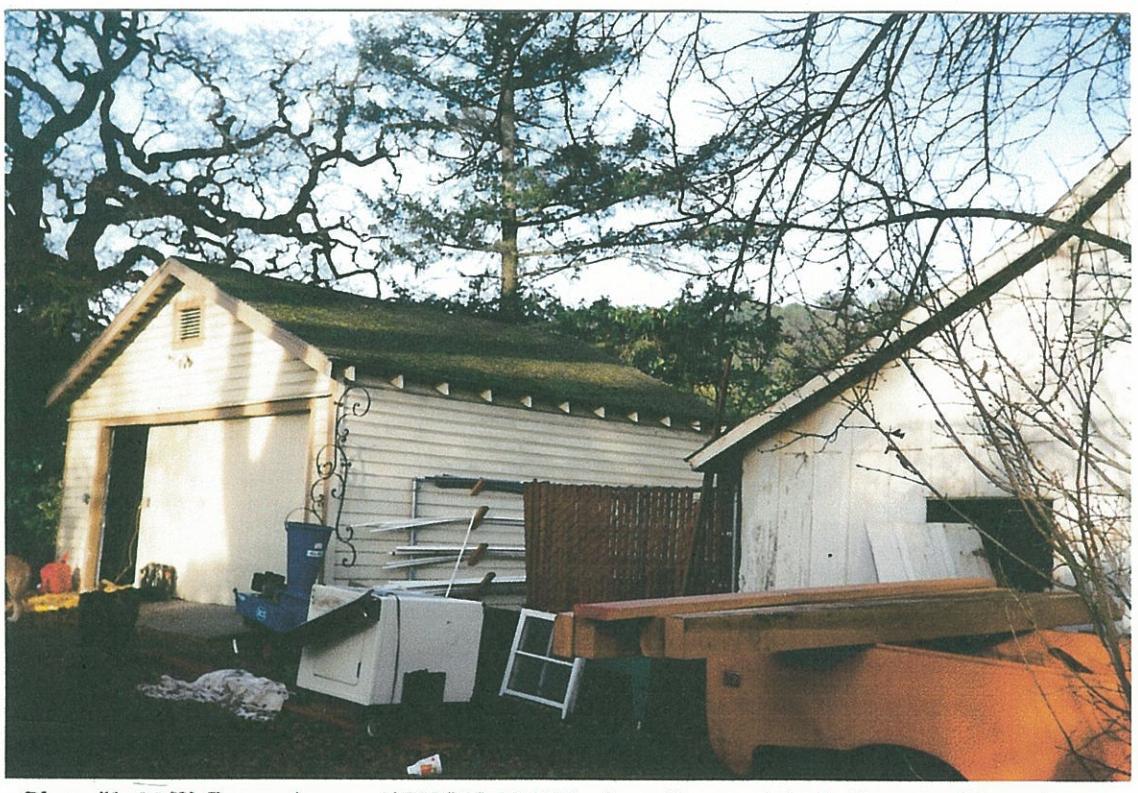
Photo #1: 35 W. Dunne Avenue (APN 767-08-035), view of barn and shed adjacent to Llagas Creek.

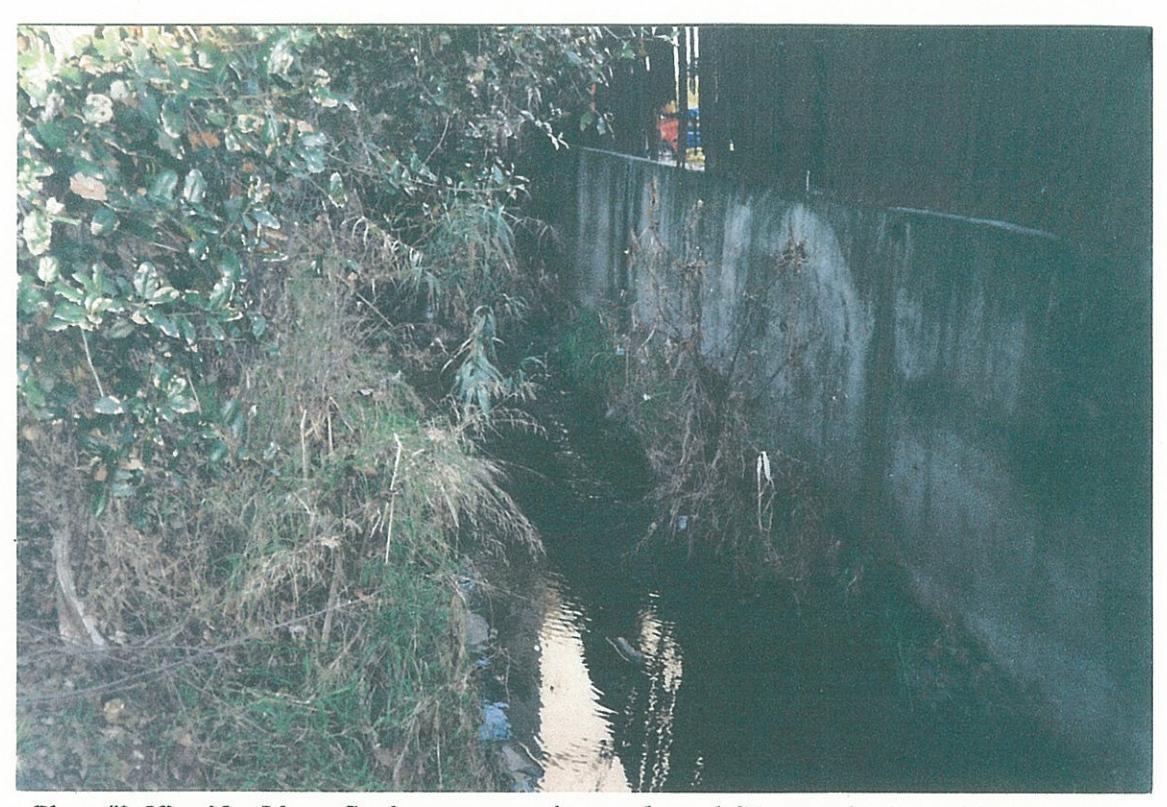
Photo #2: View N at Llagas Creek at eastern perimeter of parcel, 76 gas station beyond fence to right.

There is a potential risk of impacts to groundwater beneath the parcel from future releases from the adjacent Union 76 service station across Llagas Creek from 35 W. Dunne Avenue. PIERS recommends that the regulatory agency databases be checked again prior to any District activities at the parcel, to determine if any releases have occurred.

As the Unocal 76 station is an operating facility, PIERS recommends that prior to any District activities at the 35 W. Dunne Avenue parcel, that the regulatory agency databases be again checked to see if any releases have been documented from this potential source.

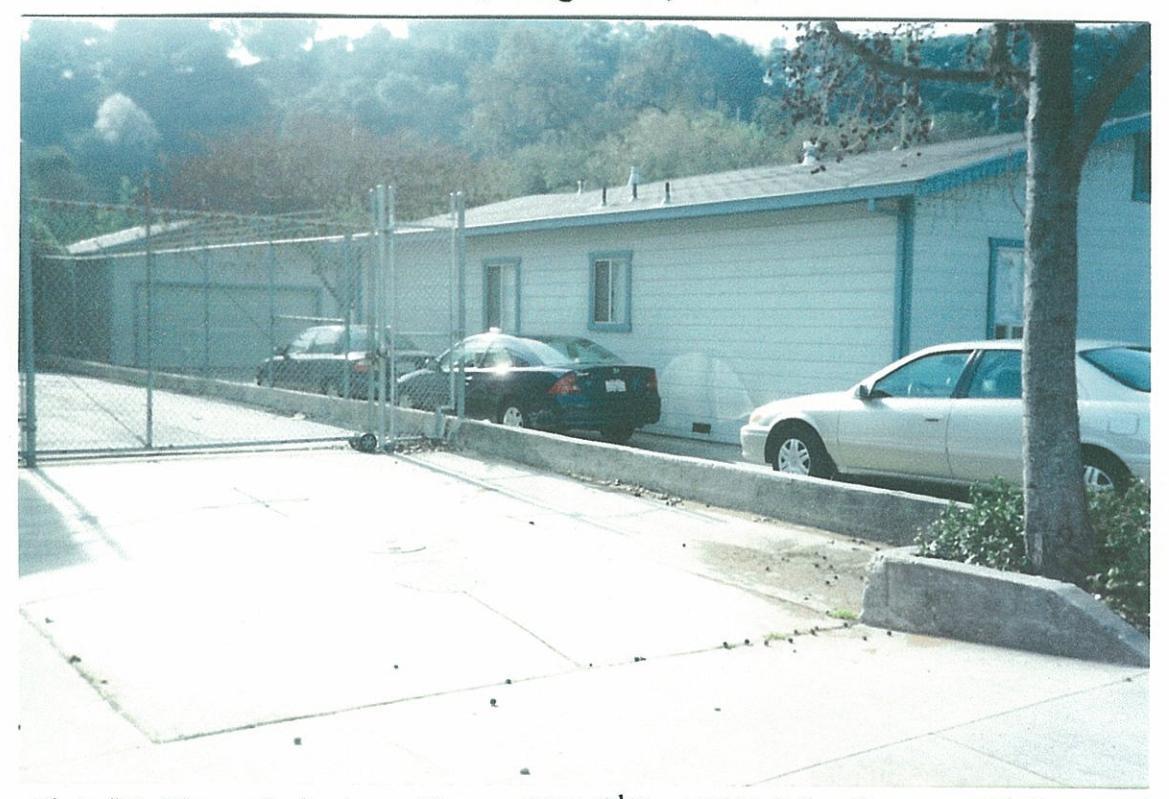
Photo #23: View south showing residence at 46 W. 2<sup>nd</sup> Street, UST pit for adjacent parcel in foreground.

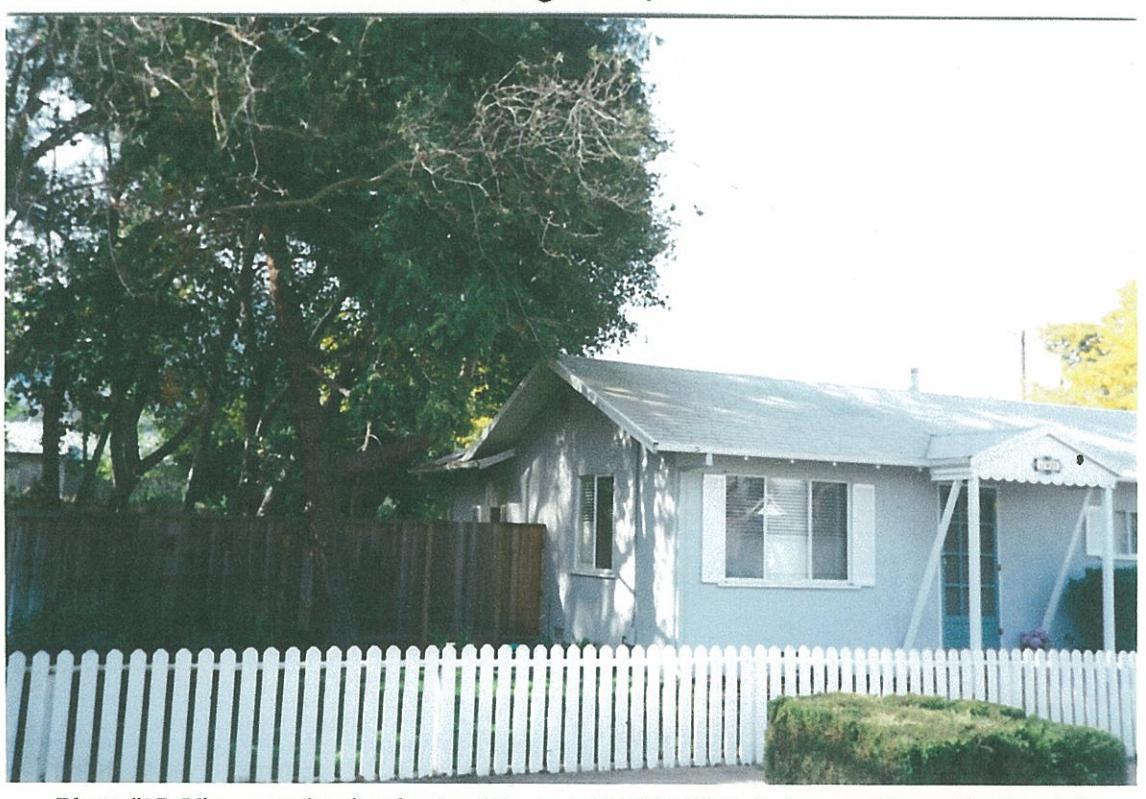
Photo #27: View east showing front residence at 17425 Del Monte Avenue, Llagas Creek to left.

Further investigation of one portion of the parcel at 17245 Del Monte Avenue (APN 767-06-009) is recommended due to prior use as an electrical substation. No evidence of the structure or any evidence of impacts was observed during PIERS' reconnaissance. At this location, if the District's activities will include the area of the former substation (rear southern corner of the parcel), the former substation should be located based on the available maps, and a soil sample should be collected and analyzed for the presence of PCB's (EPA Method 8082). If PCBs are present above risk-based screening levels, additional sampling and analysis should be conducted to define the degree and extent of contamination.

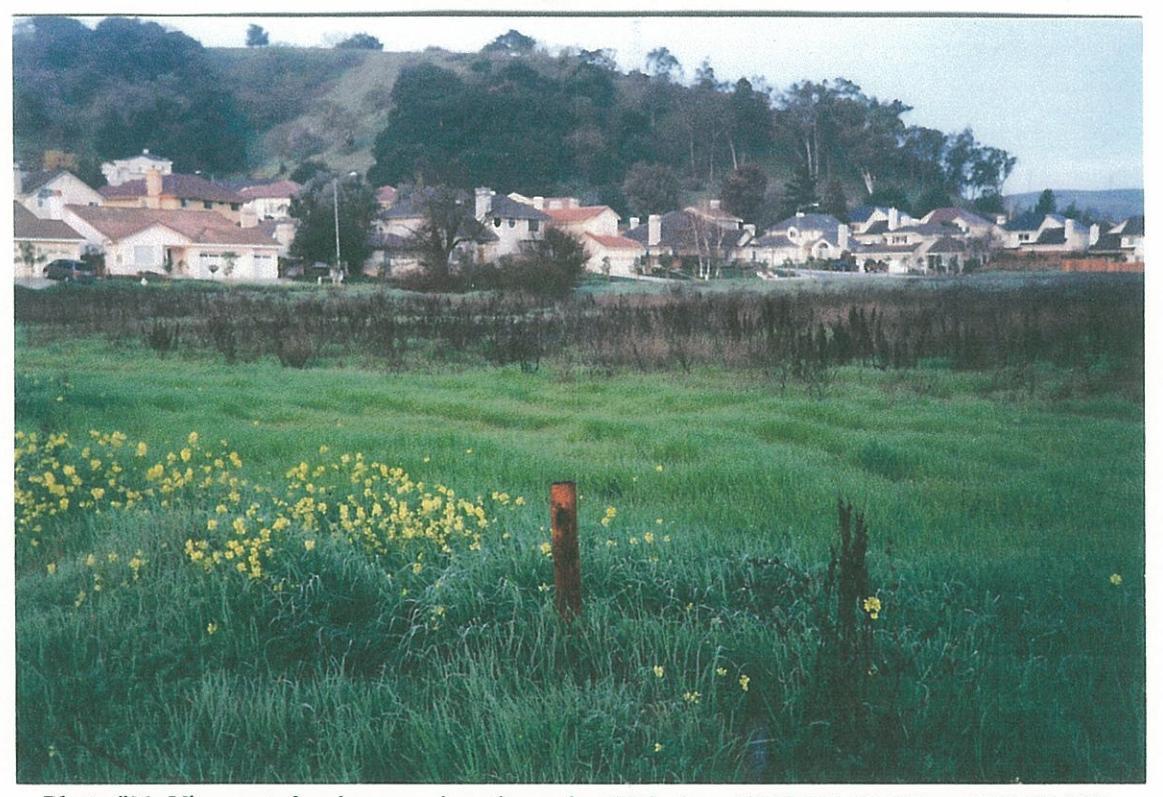
Photo #31: View east showing a portion of parcels at Hale Ave. (APN 764-32-017 and 764-32-018).

Further investigation of two parcels in Reach 8 (764-32-017 and 764-32-018, Hale Avenue) with previous agricultural use is recommended by PIERS due to the potential for residual pesticides and fertilizers in soil. At these locations, soil samples should be collected and analyzed for the presence of pesticides and fertilizers (EPA Method 8081). The soil sampling should be performed in those areas where human exposure is likely to occur, prior to construction activities. Any residual concentrations, if present, are the result of area spraying of pesticides and/or herbicides, and not the result of point sources, and the sampling should be conducted randomly within the area where human exposure would occur. One sample per potentially affected parcel is recommended. If the analytical results of the sample indicate concentrations above riskbased screening levels, additional sampling should be conducted to define the degree and extent of contamination.

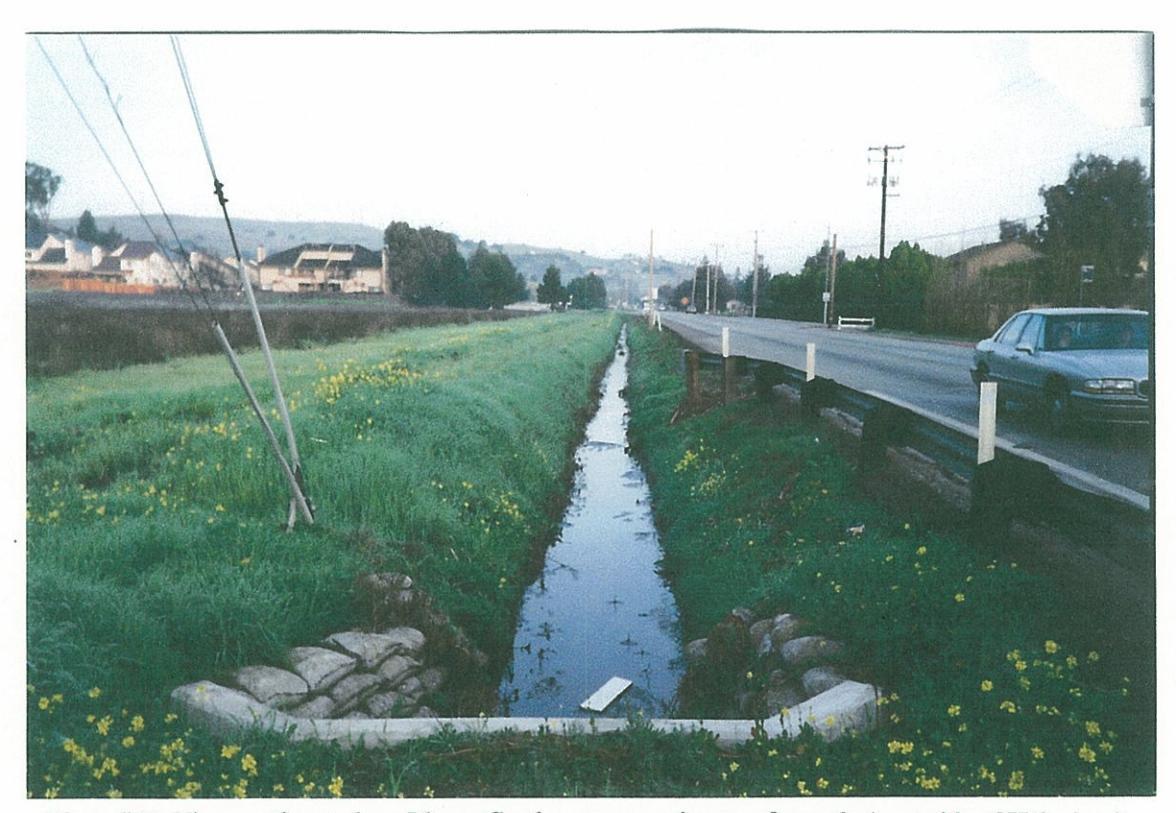
Photo #32: View northeast along Llagas Creek, eastern perimeter of parcels (west side of Hale Ave.).
