# Stinger HEIGH10

**SRK-GM14HX**

Radio Replacement Kit for select  
2014-2019 Silverado/Sierra Trucks

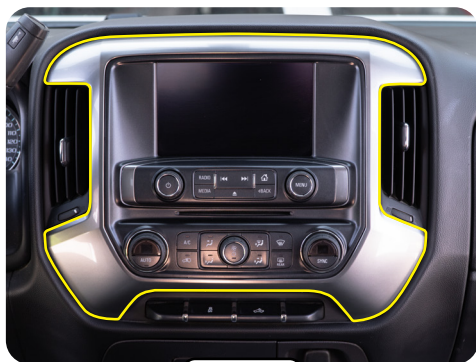
Step 1

Remove the radio display/climate control trim panel using a plastic trim tool to release the retaining clips. Unplug any wire harnesses from the back of the trim panel, if equipped.

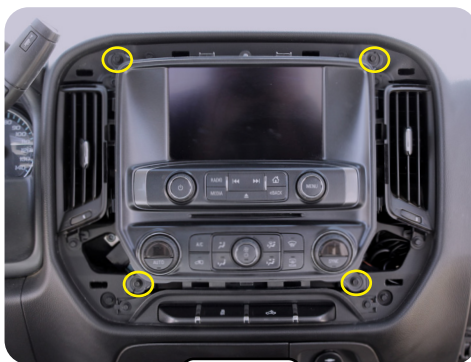
Step 2

Remove the four 7mm screws securing the radio display/climate control panel. Pull outward to release the retaining clips. Remove all connectors from the back of the panel.

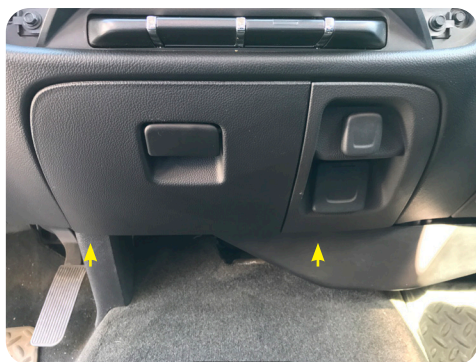
**Step 1**

Remove the two Torx T15 screws from the bottom edge of the storage compartment.

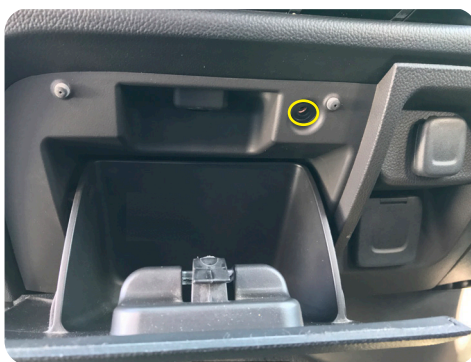
**Step 2**

Remove the upper Torx T15 screw inside the storage compartment.

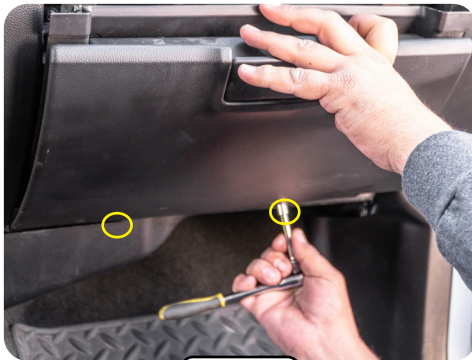
**Step 1**

Remove the two Torx T15 screws from the bottom edge of the lower glove box.

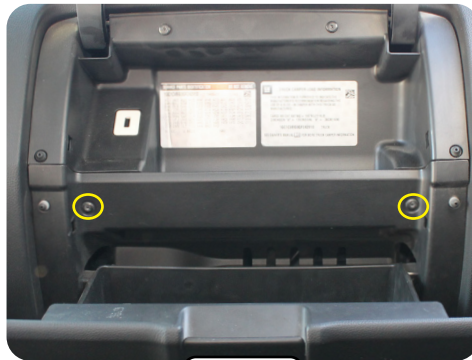
**Step 2**

Open the upper and lower glove box doors and remove the two Torx T15 screws securing the lower glove box.

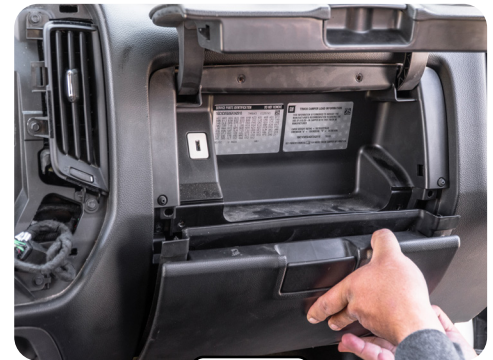
**Step 3**

Pull outward on the lower glove box to release the retaining clips and remove the lower glove box.

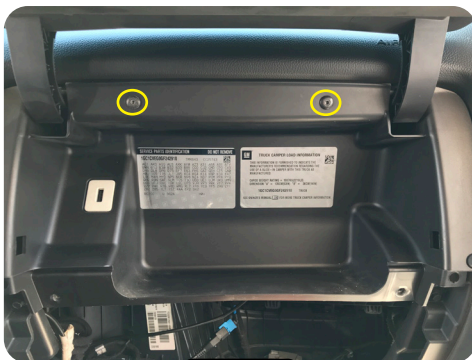
**Step 4**

Remove the two Torx T15 screws and pull to remove the upper glove box. Unplug the factory USB port from the backside.

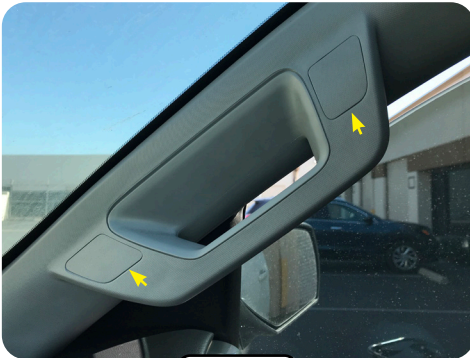
**Step 1**

Remove the inserts covering the bolts on the passenger A pillar handle with a plastic panel removal tool.

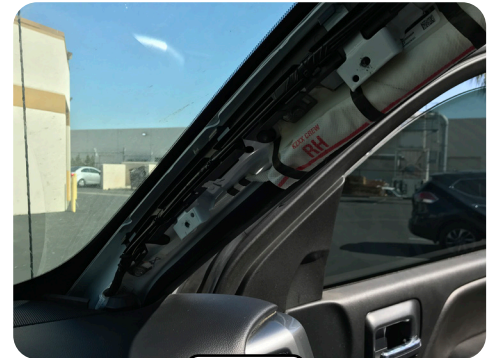
**Step 3**

Pull the trim panel to release the retaining clips and remove.

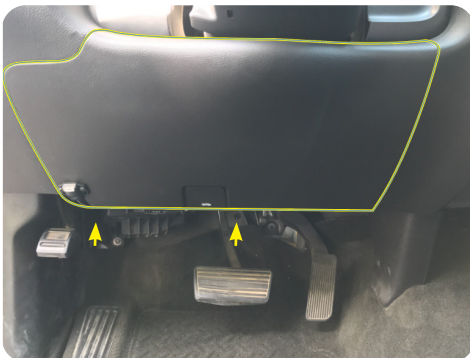
**Step 1**

Remove the two Torx T15 screws from the bottom edge of knee panel below the steering column. Pull outward to remove the panel and lay carefully on the floor board.

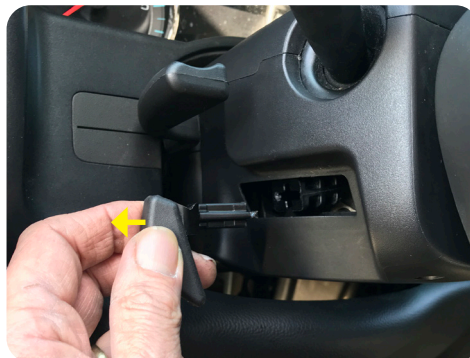
**Step 2**

Remove the plastic handle from the steering wheel tilt lever by pulling outward, towards the driver's door on the handle. A trim tool may also be used if unable to remove by hand.

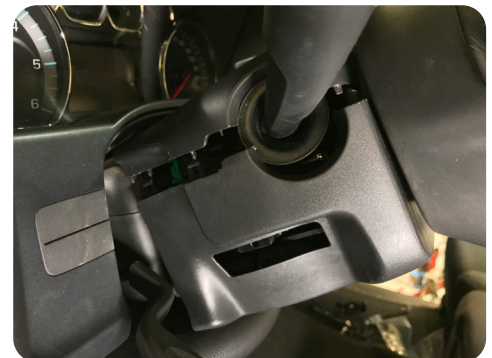
**Step 3**

Pull downward on the lower cover on both sides to release the locking tabs and remove the lower cover.

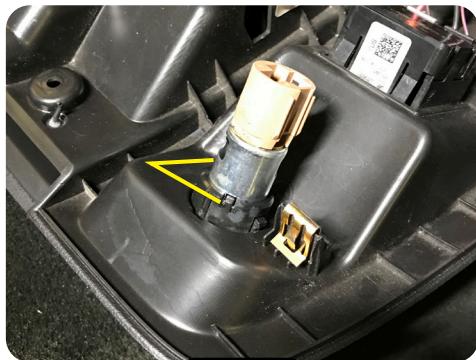
**Step 1**

From the backside of the lower storage compartment, remove the metal insert from the power outlet by releasing the two retaining clips with a small pick and pushing out the front side.

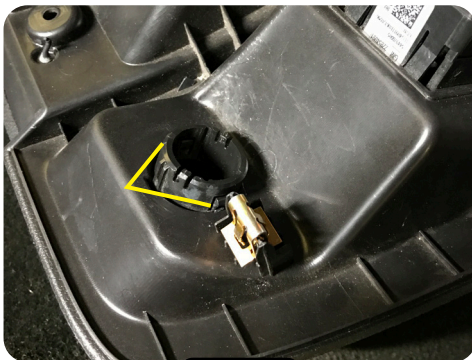
**Step 2**

Remove the plastic sleeve by depressing the two tabs and pushing out the front.

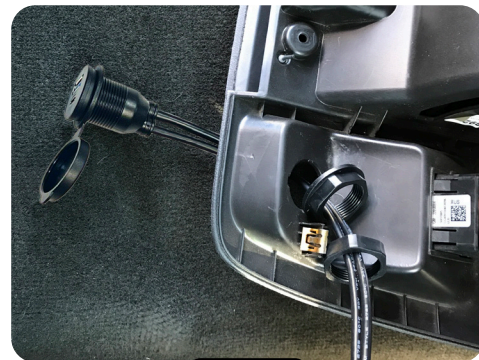
**Step 3**

Install the optional USB cover and feed the USB cables through the front of the panel. Secure with the flanged nut and then lock with the lock nut.

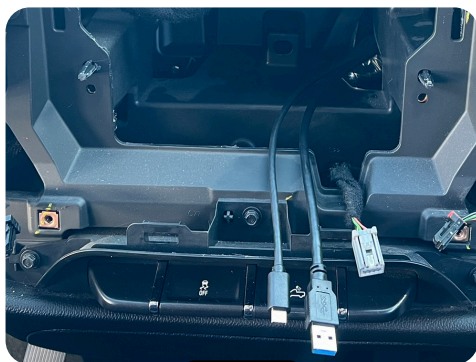
**Step 4**

Route the USB cables up and out of the right side opening at the rear of the CD/DVD opening.

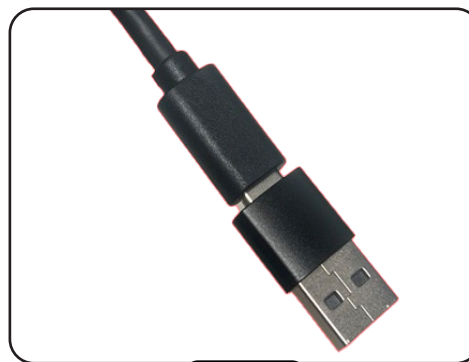
**Step 5**

Connect the USB-C to USB-A adapter that was included with the **SSUSB3** to the USB-C cable.

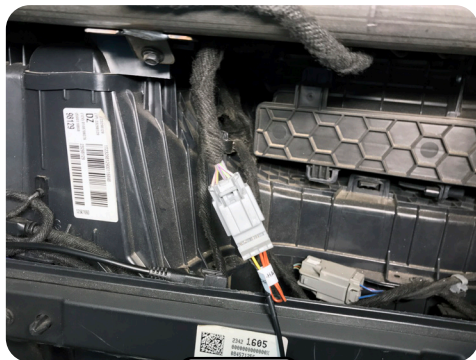
**Step 1**

Plug the gray 12 pin camera harness from the HMI module into the **CAM-GM51-HAR**.

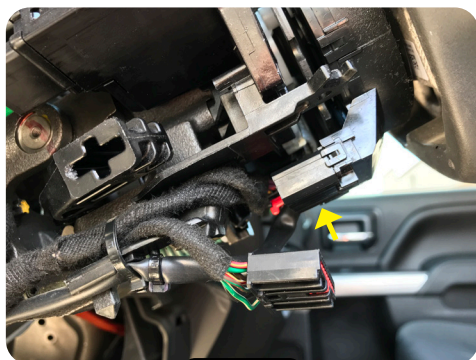
**Step 1**

Locate and unplug the black 10 pin connector located on the underside of the steering column.

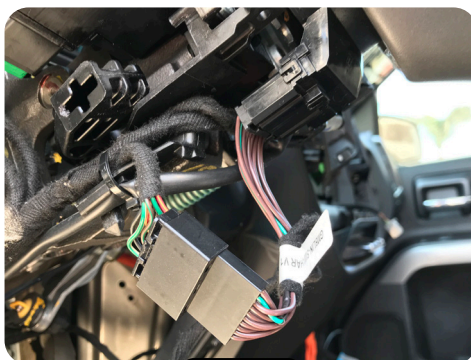
**Step 2**

Plug the male connector into the female end of the **GM5LIN-SW-HAR** and plug the **GM5LIN-SW-HAR** male end into the female connector on the steering column.

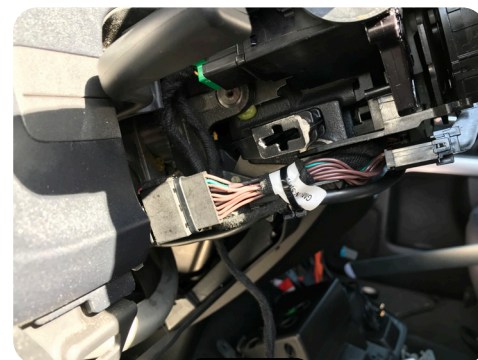
**Step 3**

Secure the T-harness to the factory wire harness. Route the 50" single lead from the **GM5LIN-SW-HAR** to the radio opening, securing with zip ties.

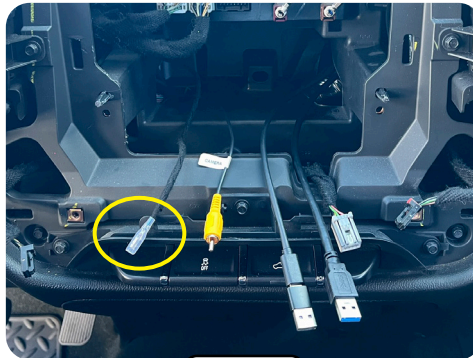
Step 4

Route the steering wheel control lead into the CD/DVD area through the left side opening in the rear of the cavity.

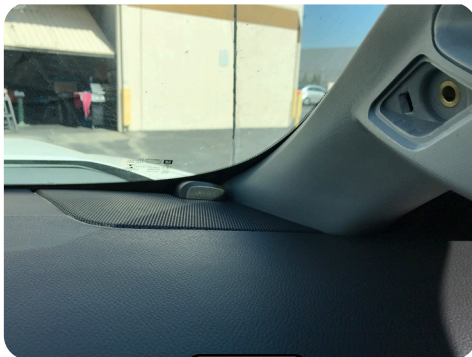
Step 1

Position the **GPS Antenna** and route the antenna cable down into the glove box area. Replace the A pillar panel and ensure the cable does not interfere or get pinched.

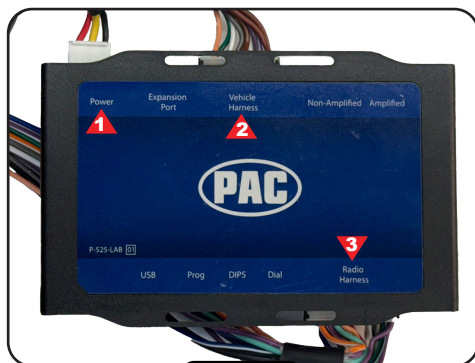
**Step 1**

From the **Main Harness (SRK-GM14HX-HAR)**, connect the “Power” (1), “Vehicle Harness” (2) and “Radio Harness” (3) connections to the GM6A-SRK module

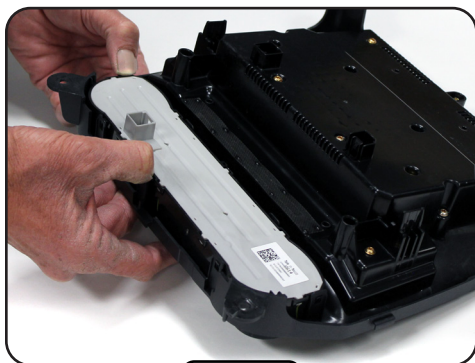
Step 1

With the factory radio display / climate control panel face down, apply slight pressure to the front of the controls while releasing the locking tabs around the perimeter.

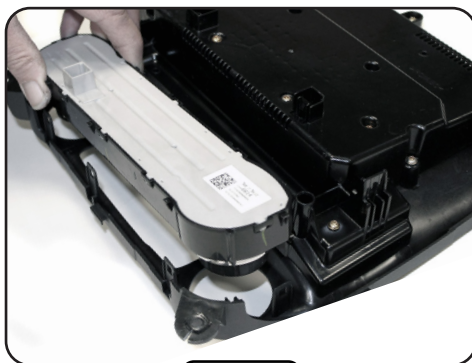
Step 2

Once all the clips are released, remove the climate controls from the factory bezel.

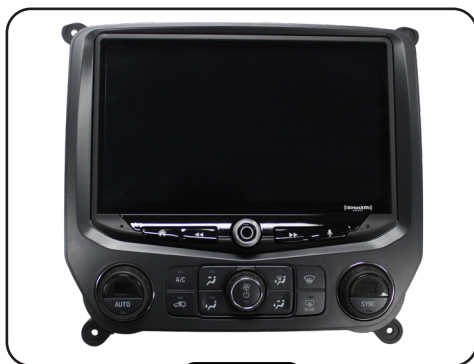
Step 1

Insert the **Touch Panel Display** into the front of the **Display Mounting Panel** and carefully turn the panel over while holding the display in place.

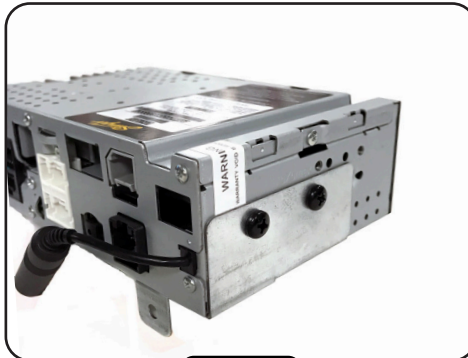
**Step 2**

Using two M5x10 screws attach one side bracket as shown above.

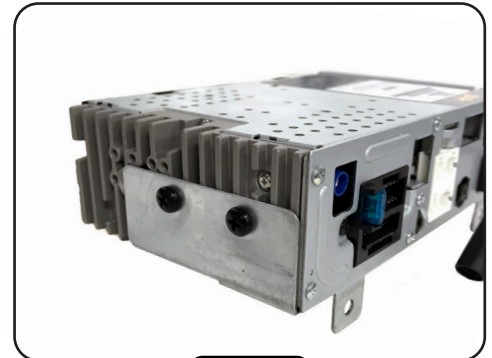
**Step 3**

Using two M5x10 screws attach the other side bracket as shown above.

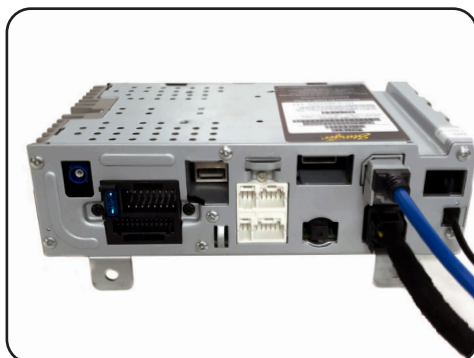
**Step 1**

From the HEIGH10 box, connect the **LVDS Display Video Cable (SE-1101)** and **8 Pin Display Power Harness (SE-1100)** to the **Radio Module**.

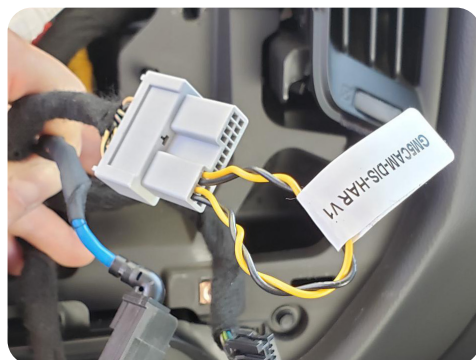
**Step 2**

**2018-19 IOB Only:**  
Plug the 20 pin harness that was removed from the factory display into the **GM5CAM-DIS-HAR**.

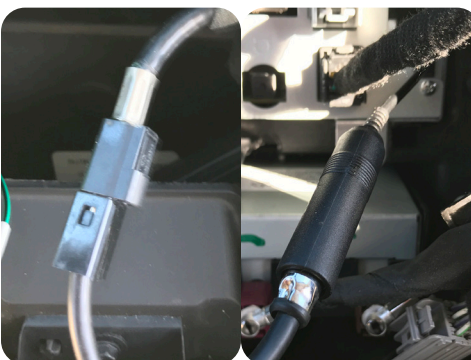
**Step 3**

Connect the **AM/FM Antenna Adapter (BAA22)** to the black factory antenna cable. Plug the other end of the **BAA22** into the antenna port on the **Radio Module**.

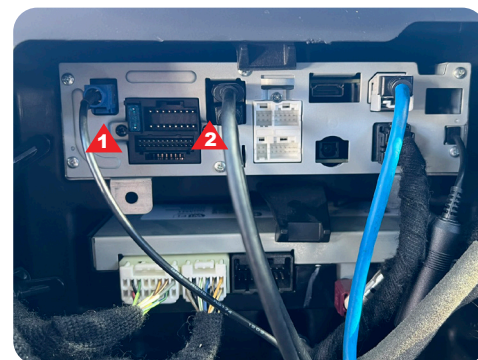
**Step 4**

Connect the **GPS Antenna** (1) and the two USB cables (2) to the **Radio Module**. Either USB cable can be connected to either USB input, but the USB on top (closest to the edge of the radio) will handle Apple CarPlay and Android Auto.

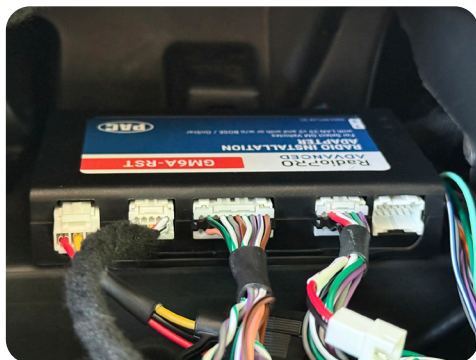
**Step 8**

Use the supplied two-sided tape to secure the **Radio Replacement Interface** in the lower CD/DVD cavity.

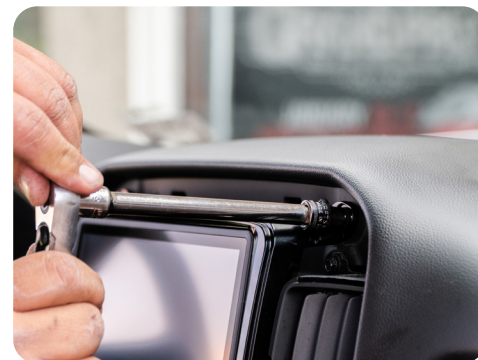
**Step 10**

Place the **Display Mounting Panel** in place and temporarily secure it with two 7mm screws.
