# *Stinger* SRX-JW18128 - Technical Bulletin

## Bluetooth Mic Replacement

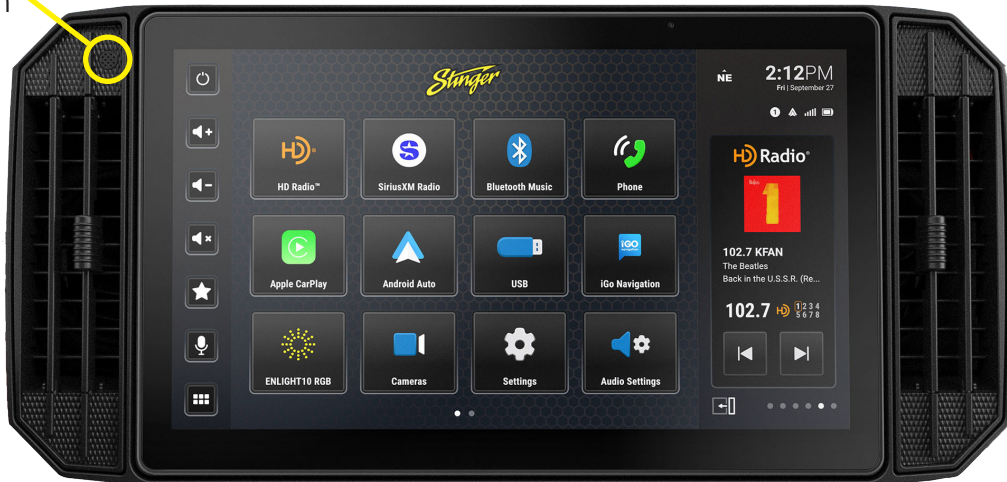
Microphone  
Location

The bluetooth microphone comes pre-installed on the SRX-JW18128 kit as it is integrated into the drivers side HVAC vent panel. If it becomes necessary to replace the microphone, follow the instructions below:
