**American  
International**  
*Car Stereo Installation Kits & Accessories*

**KIAK1242 Mounting Kit**

## **VEHICLE APPLICATIONS**

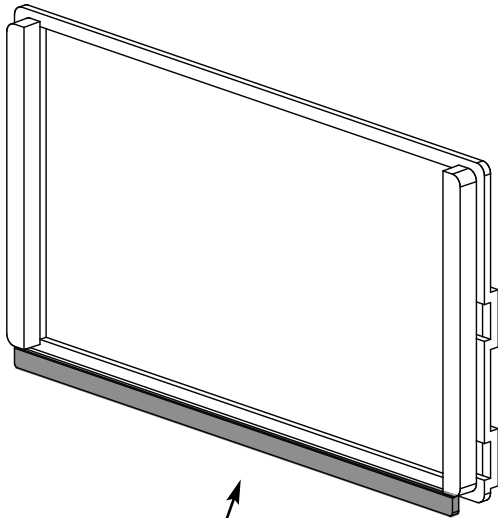
Fig. A

1. See Figure A.
2. Remove all mounting tabs from both sides of ISO mount brackets except those for your vehicle application (See Figure B).
3. Attach left and right ISO mounting brackets to main bracket.
4. Install radio into kit using screws supplied with radio (Do not tighten screws at this time).
5. Adjust radio forward or backward for best look.
6. Tighten screws after adjusting radio.

**2001-2005 Kia Optima DO NOT remove bottom trim.  
For ALL other installations remove bottom trim.**

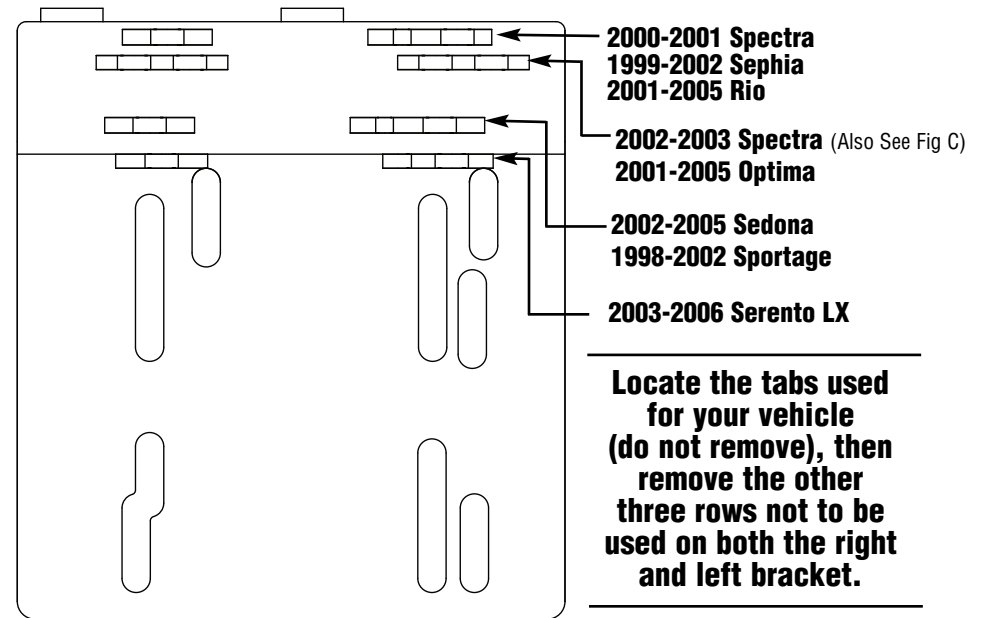
Fig. B

VIEW OF RIGHT SIDE BKT.

CUT OR TRIM PLASTIC 5/16" INWARD FROM THE OUTER EDGE OF THE LOWER MOUNTING TABS AS ILLUSTRATED ON BOTH LEFT AND RIGHT MOUNTING BRACKETS SHOWN IN FIGURE B
